**Foundation protection of tarbela
hydro power station building
Units 5—8**

ENGR. M. R. CHAUDHRY
B.E. Civil, M.S. Civil Engg. (Minnesota)
Fellow ASCE, Fellow I E. Pak.

FOUNDATION PROTECTION OF TARBELA HYDROPOWER STATION BUILDING (UNITS 5-8)

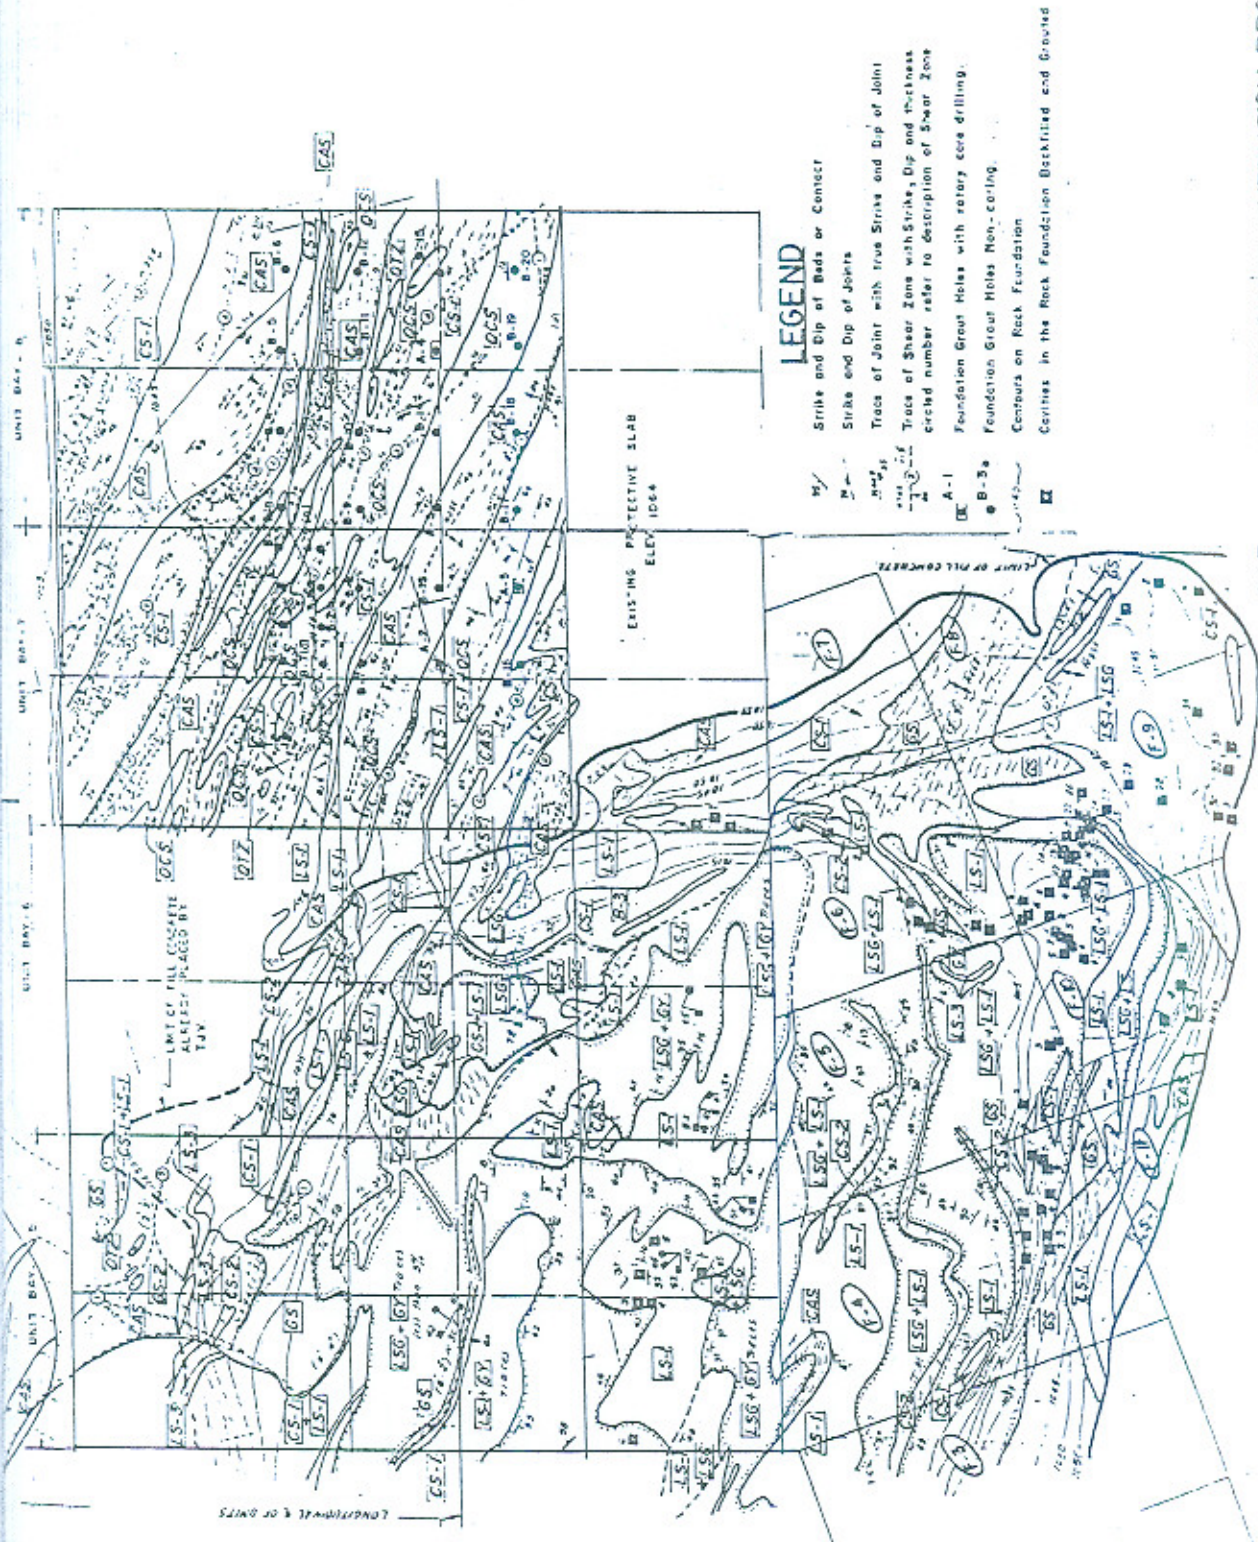
FIG-3 FOUNDATION GEOLOGY UNITS 5-8

The sub-soil investigations for the work of units 5-8 were carried out during April/May 1977. The fill concrete covered the area of units 5-6 whereas the area of units 7-8 was covered mostly with overburden and the bed rock was exposed in patches at a few places. The foundation rock consists predominantly of soft to medium hard chlorite schist which is closely jointed and fractured. Interbedded between the chlorite schist are soft beds of carbonaceous and graphite schists. Weathering of rock in the later units is pronounced even at appreciable depth. Joints intensity also does not decrease with depth. Joints, however, appear to become relatively tight at the design foundation elevation of the units i.e. below elevation 1040. Very soft pockets, some shear and gouged zones are also present at depth as is evident from sub-surface exploration logs (Fig. 2) The description of foundation rocks as mapped in Figure-3 is detailed below:—

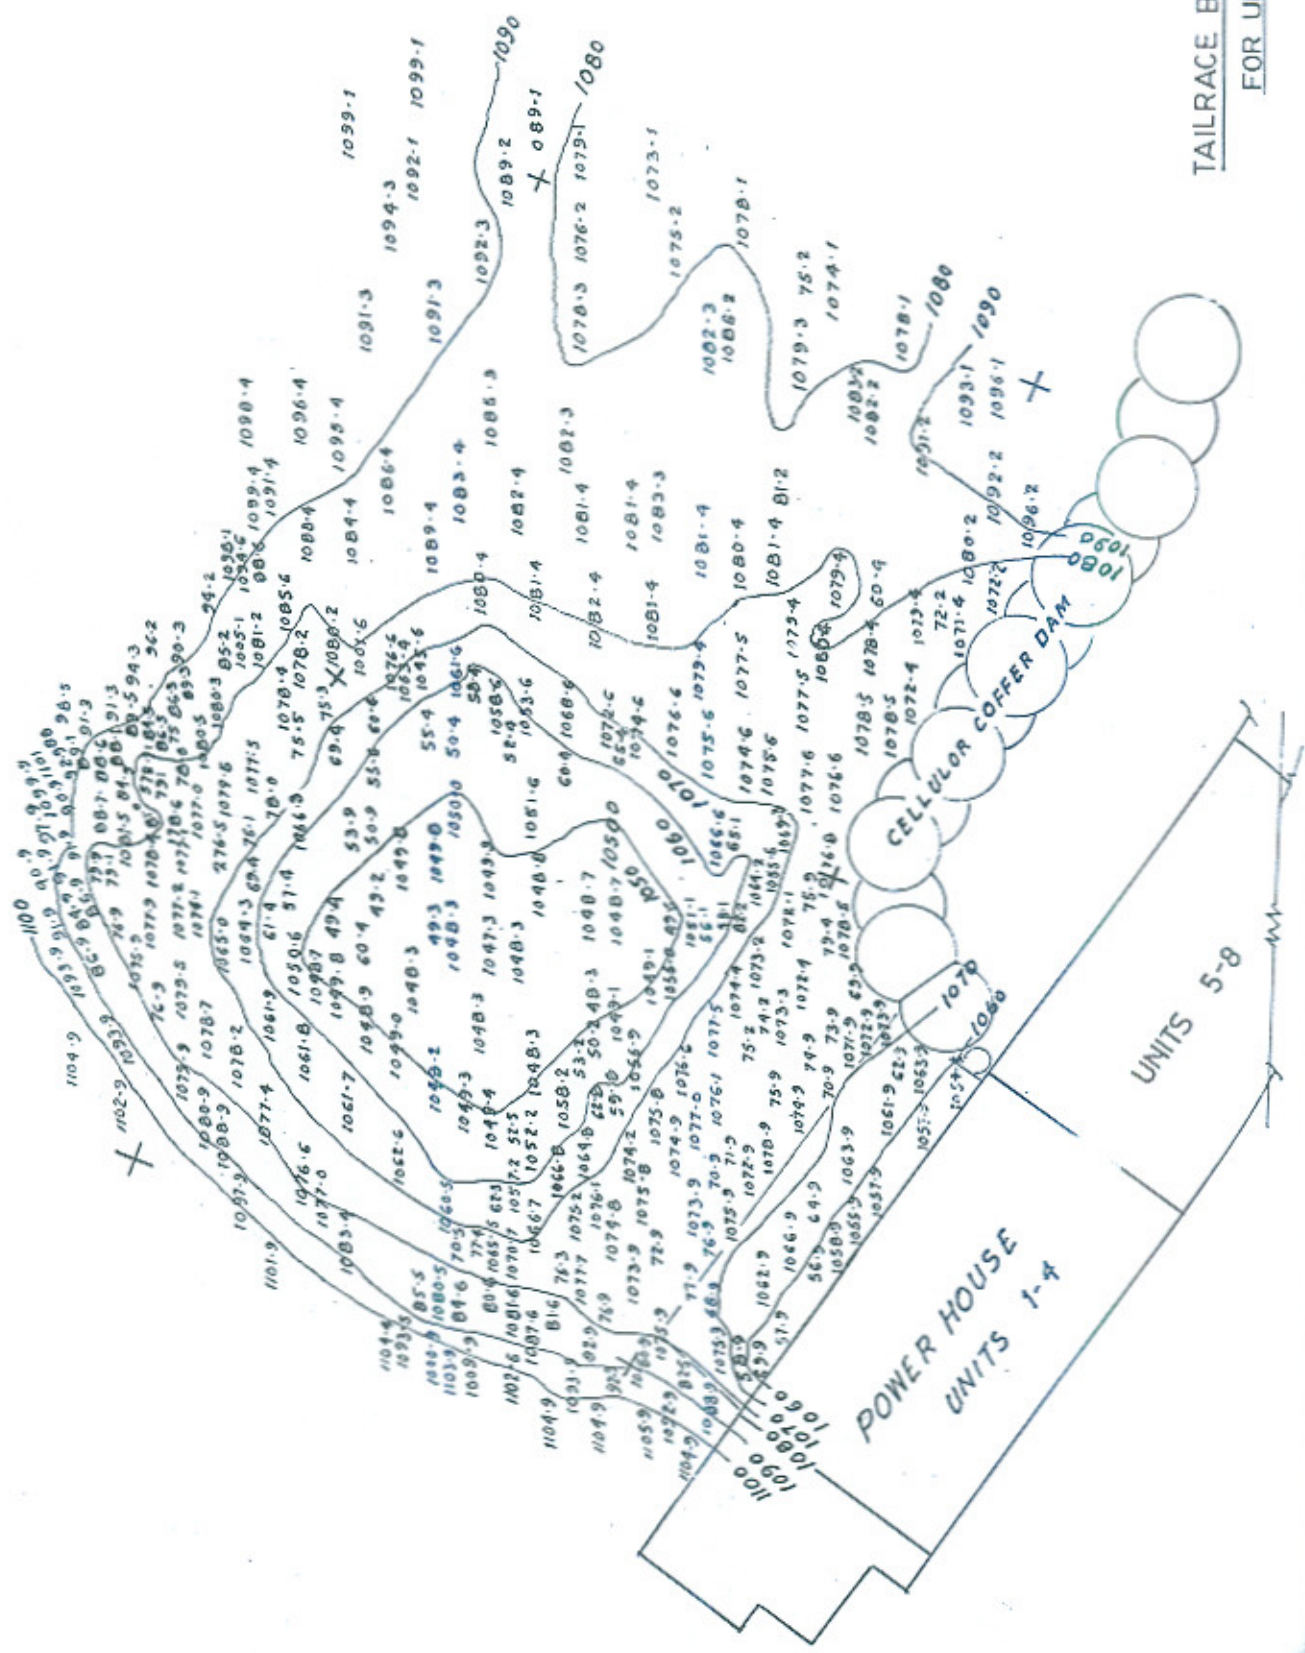
TAILRACE BED SOUNDINGS
FOR UNITS 1-4

It was suggested to carry out the soundings in the tailrace area of units 1-4 in order to find out the bed levels as it was possible that scouring has taken place because of presence of similar soft schists as no bed protection was provided in the tail race of units 1-4. The soundings observed in November 1979 (Fig. 5) show that scouring has already started in the area adjacent to the draft tubes. It was therefore essential that protective measures should be provided in the tailrace of units 5-8 beyond the draft tubes.

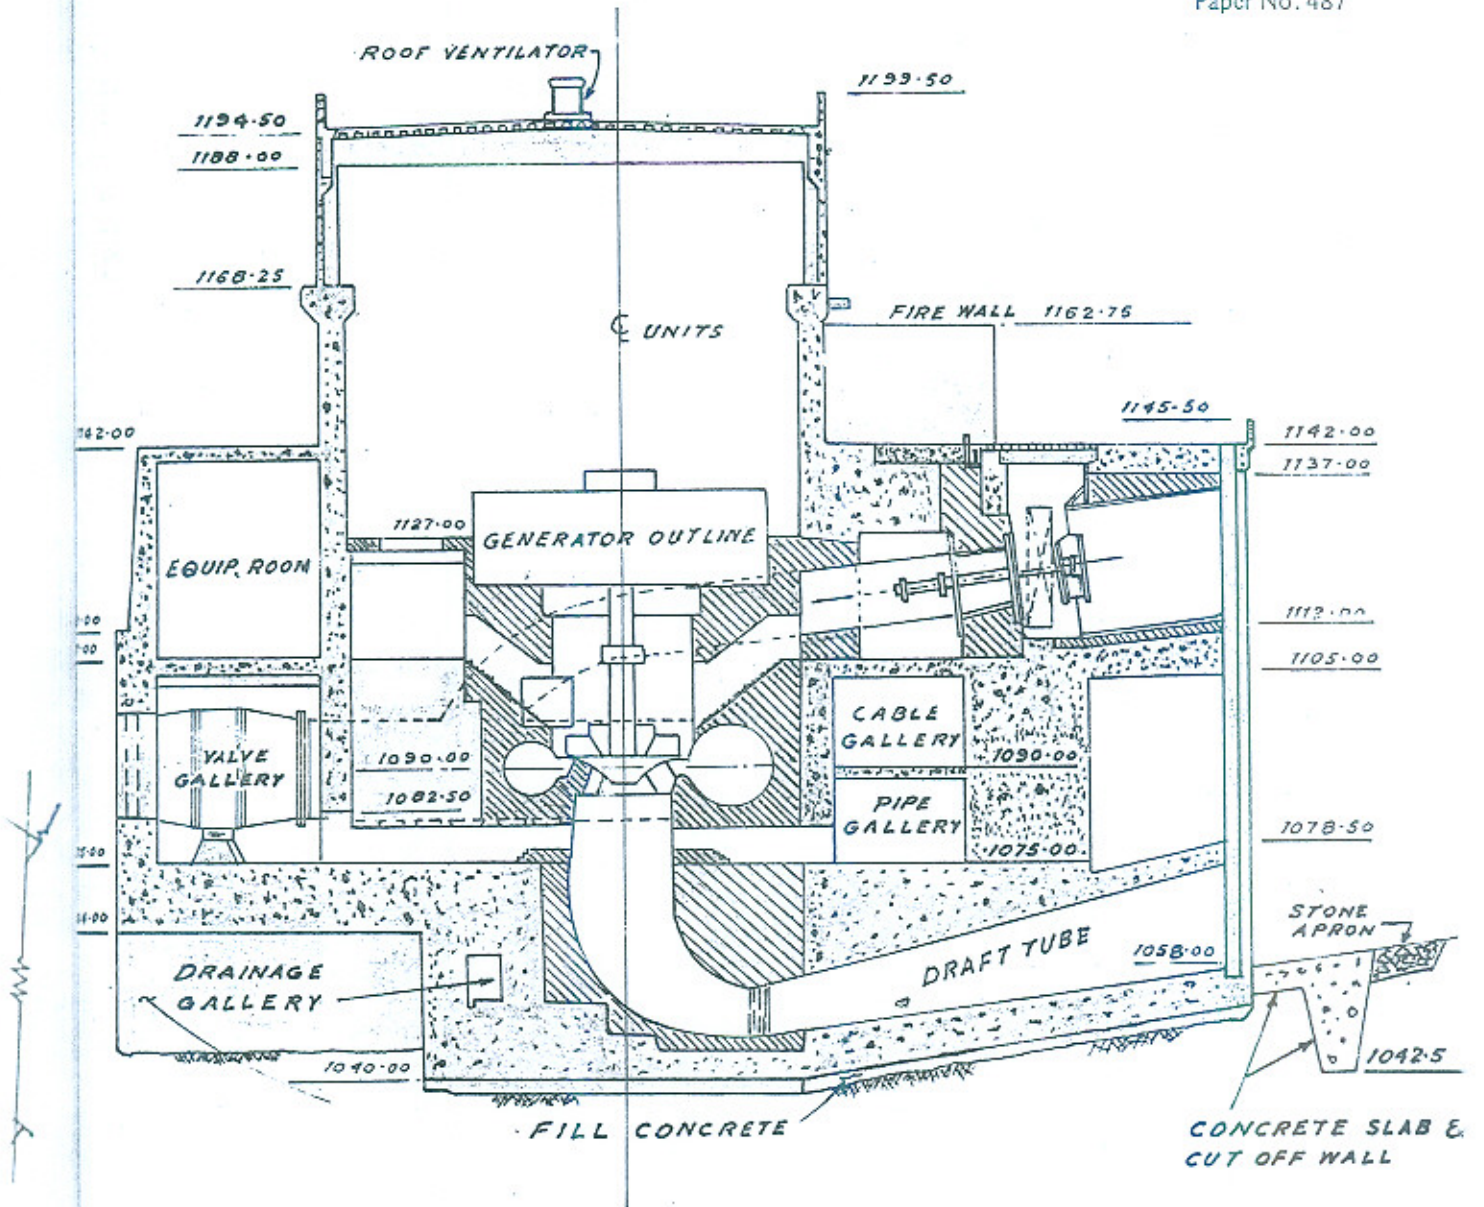
FIG-4

The Author visited the Power station building site of units 5-8 in September 1979 when foundation excavation was complete and recommended provision of concrete slab and cut off wall (Fig. 4) in the tail race area beyond the draft tubes because of location of soft beds of carbonaceous and graphite schists. These schists become very soft when saturated with water. It was noticed that there was no bed protection provided for the tailrace area beyond the limit of draft tubes even for units 1-4. The velocity of water coming out of the draft tubes is from 8 to 10 feet per second and this will definitely create pits close to the Powerhouse structure which may ultimately result in un-equal foundation settlement and cracks may

appear in the building. This could create operation problems for the turbines.

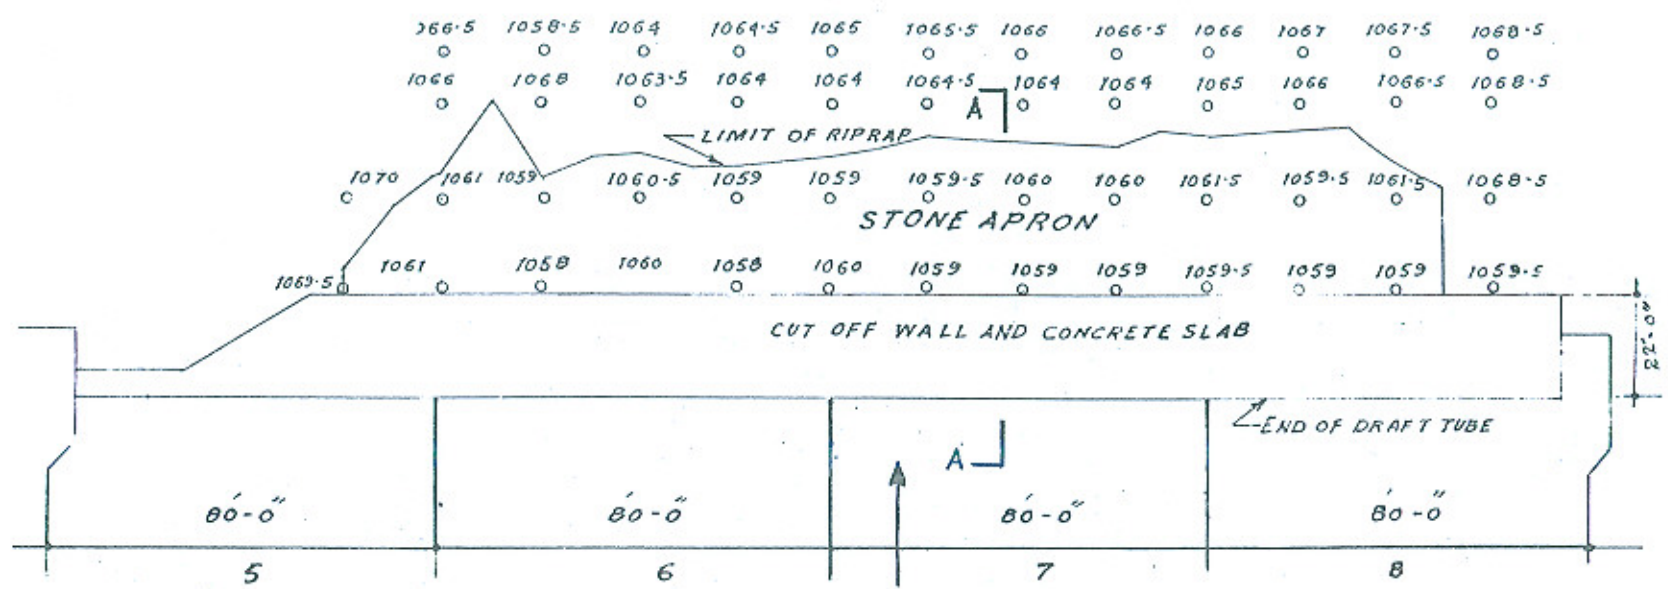
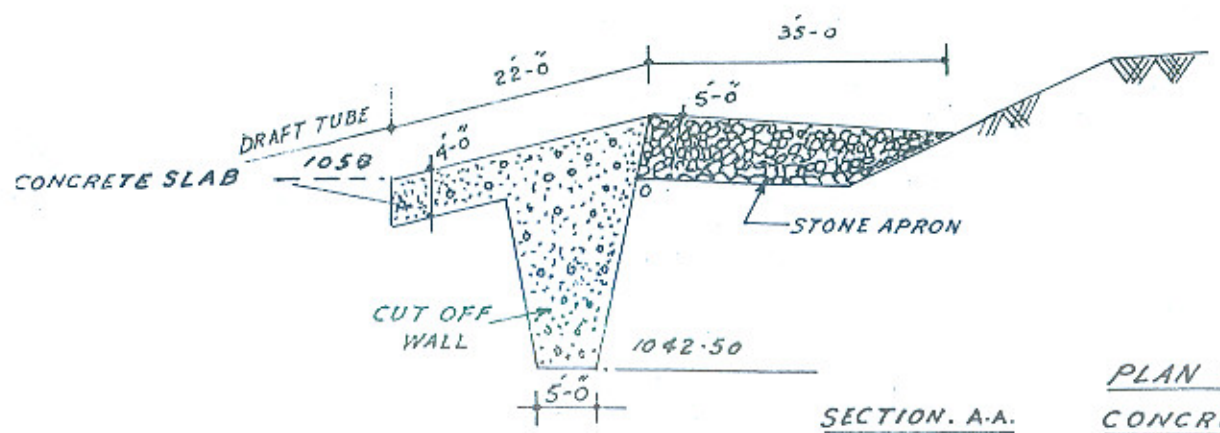
PLAN & SECTION OF
CONCRETE SLAB &
CUT OFF WALL

The detailed design and the construction drawings (Fig.6 & 7) for the protective slab and cut off wall were prepared by NESPAK. The length of protective slab was restricted because of shortage of space due to location of Cellular Cofferdam. In view of this the cut off wall had to be deeper. The protective slab and cut off wall were constructed in reinforced concrete having compressive strength of 3000 psi. The length of the slab was 22 feet and thickness was kept as 4 feet. The cut off wall was 5 feet in width at the bottom and was taken to elevation 1042.50 whereas the draft tube invert level was 1058.00. The stone apron was provided at the end of protective slab which can launch if scouring takes place and will save the cut off wall from damage. The length of the stone apron is 35 feet and the thickness is 5 feet. The stone size varies from 90 to 200 pounds as these sizes cannot be disturbed by the 10 feet per second velocity of the water coming out of the draft tube.
