**Mangla Dam Project
Appraisal of performance of
structures and bedrocks**

ALTAF-UR-REHMAN
Chief Engineer, DMO, WAPDA

SYNOPSIS

Mangla Dam Project structures have performed satisfactorily for almost 20 years since impounding in July 1967. Appraisal of the Performance as per the following aspects has been done. Foundation & rim behaviour has also been examined.

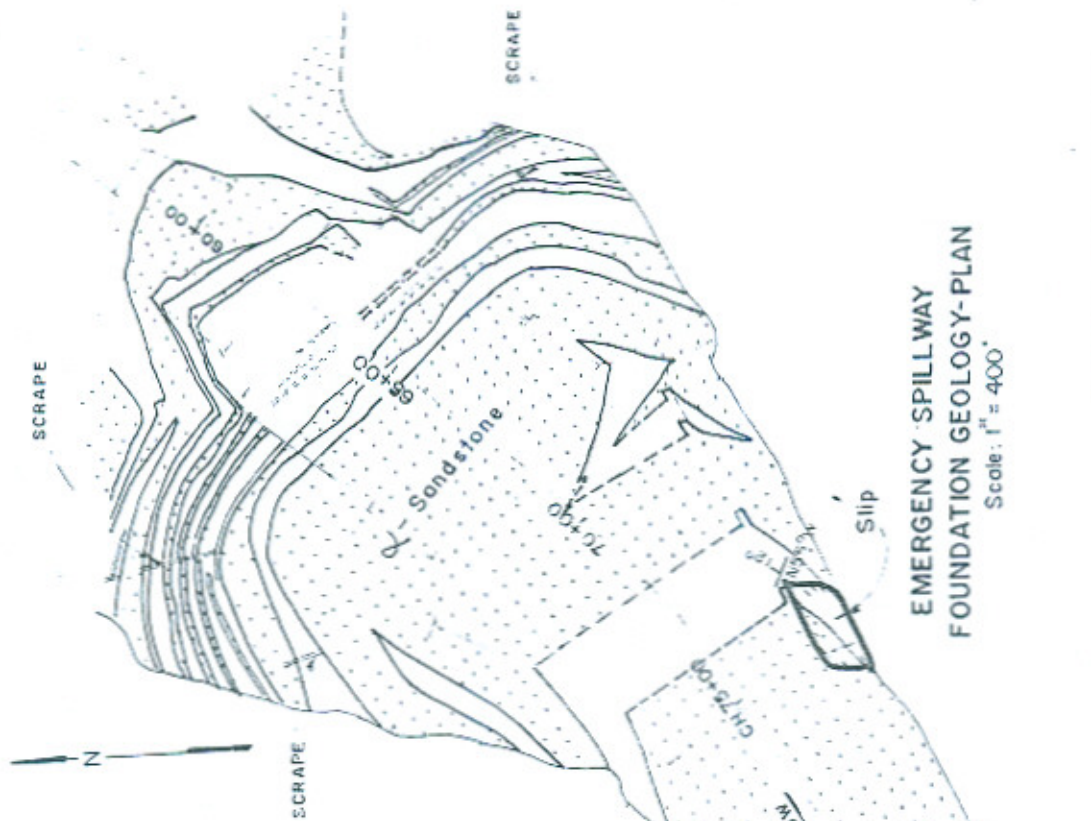
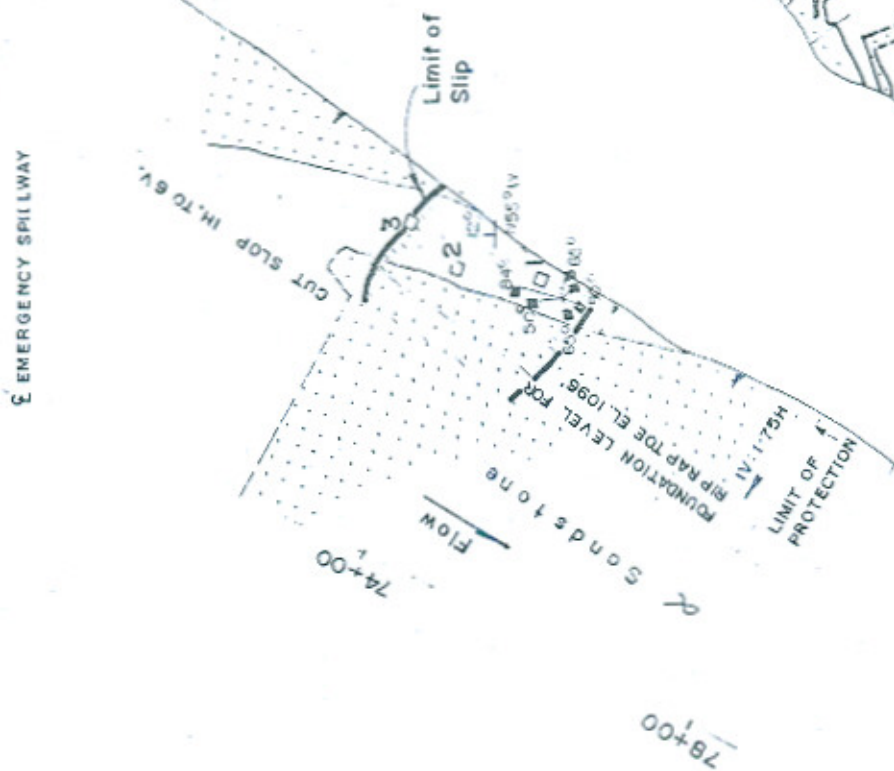
MANGLA DAM PROJECT
EMERGENCY SPILLWAY - TAIL RACE
EMBANKMENT SLIP LOCATION

A slide in tailrace of emergency spillway had occurred in 1973 along bedding plane shear zone at 12° . It occurred along the leftside of the channel which has bedrock dipping into the channel. It was caused by rain water seeping along the shear zone and reducing the effective stresses. Another slip along the same plane occurred in August 1983. Exhibit-2. When the slipped material at toe had been removed to reinstate the embankment. Multi reversal shear box test was carried on the slip surface material and indicate residual values of 12° & $C = 1.0$ psi, at clay fraction of 22%.

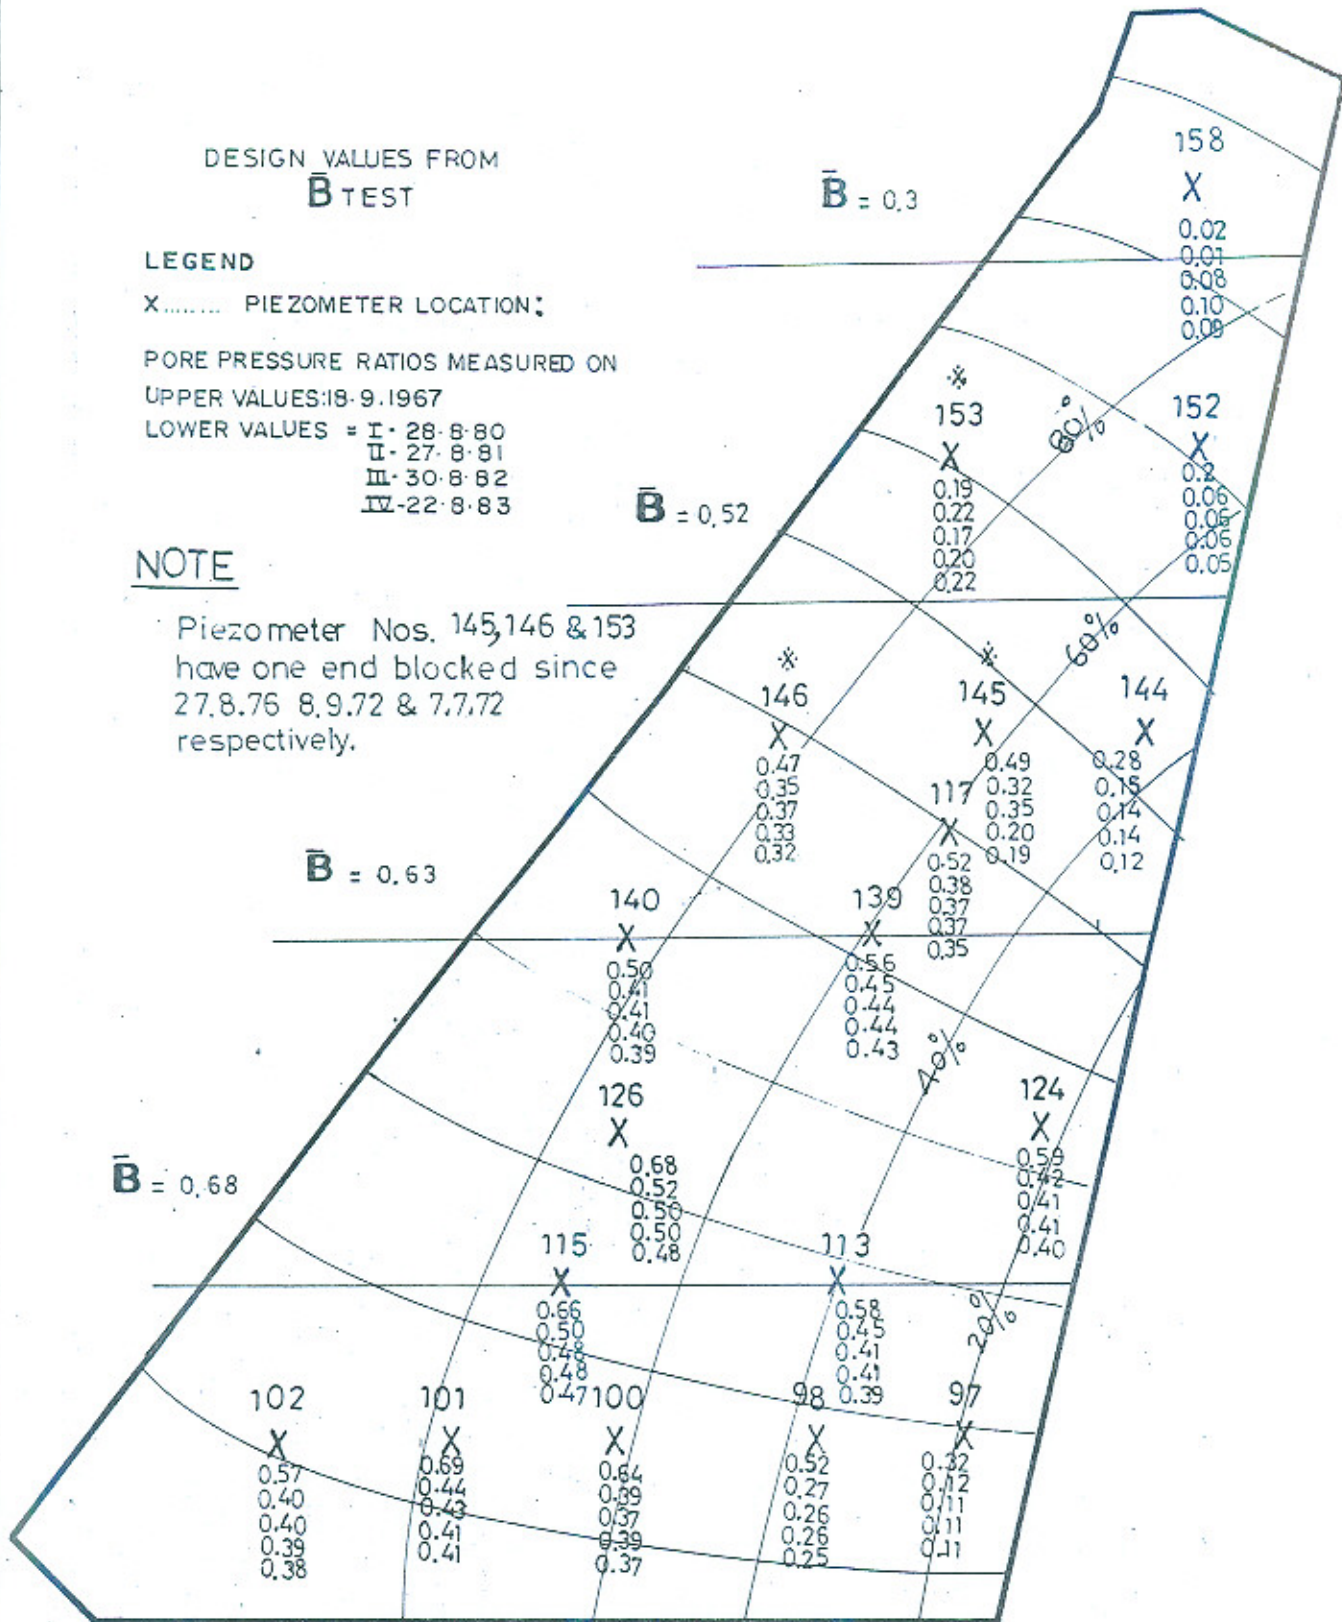
MAIN DAM ROLLED CLAY CORE PORE PRESSURE RATIO (ru)

The fill of the core is near saturation & the rise of reservoir is reflected by response of piezometer by the pressure on the upstream face & by loading action also i.e. if reservoir rises above the tip location. During drawdowns the core piezometers respond to fall of reservoir with a time lag.

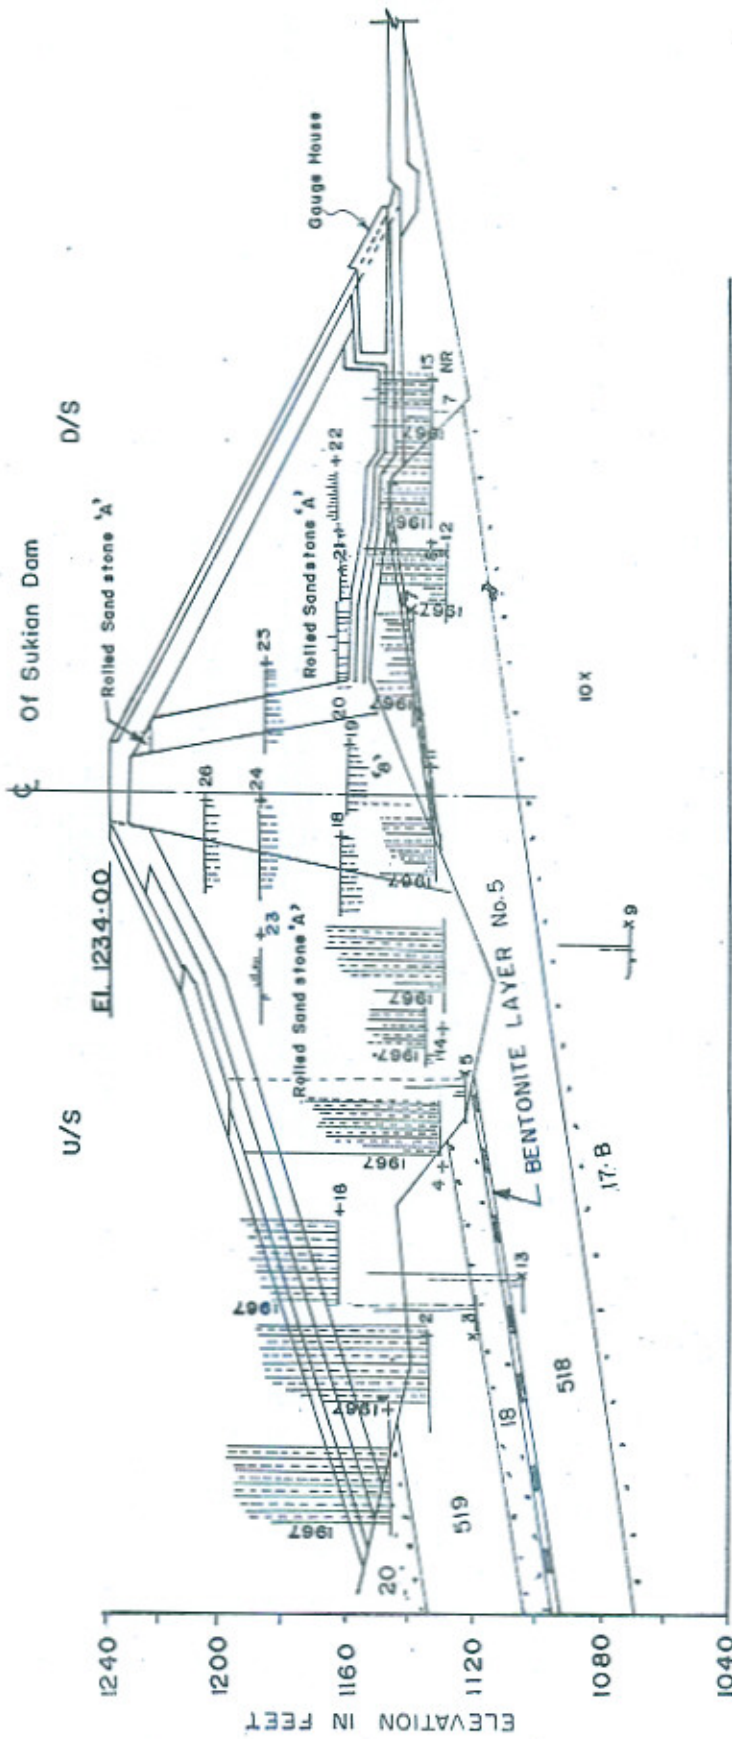
**MANGLA - SUKIAN DAM
LOCATION OF PIEZOMETERS
AT CH. 311+00**

Only one instrumentation section for monitoring of typical sandstone fill was established at Ch. 311+00. The embankment at this location is about 90 ft high and only reservoir above 1150 SPD starts affecting the piezometric heights and in the short interval between elevation 1150 to 1202 the conservation level, flownet does not develop at all, Exhibit-6 shows the maximum of the annual pressures recording. All piezometers indicate negative pore-pressure so far.

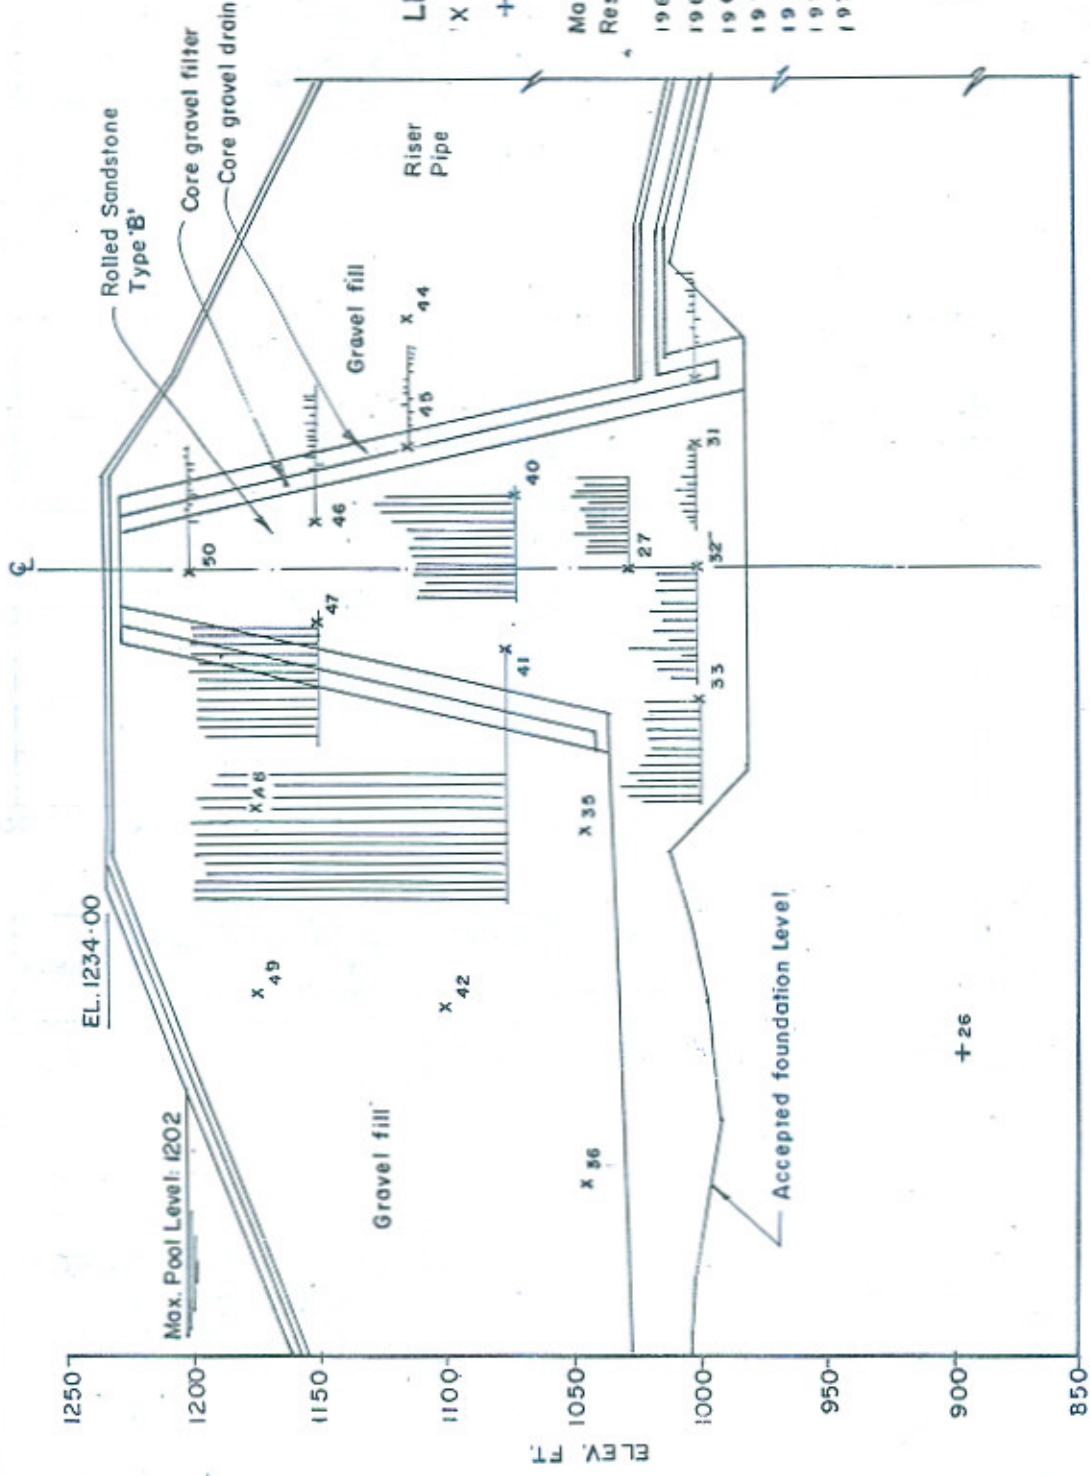
**MANGLA DAM PROJECT
INTAKE EMBANKMENT (CORE)
PIEZOMETRIC HEIGHTS
SECTION AT CH. 133+81**

The maximum pore-pressures developed over the annual impoundments in the Intake Embankment are as per Exhibit-7. Proper flownet in the sandstone core did not develop because the sandstone in the foundation is more pervious than the sandstone fill of the core. The sandstone in the foundation has a permeability of the order of 10^{-3} to 10^{-4} Cm per second, whereas the sandstone fill has the permeability in the range of 10^{-6} Cm/Sec. The grading of the sandstone fill placed is as per Exhibit-8.

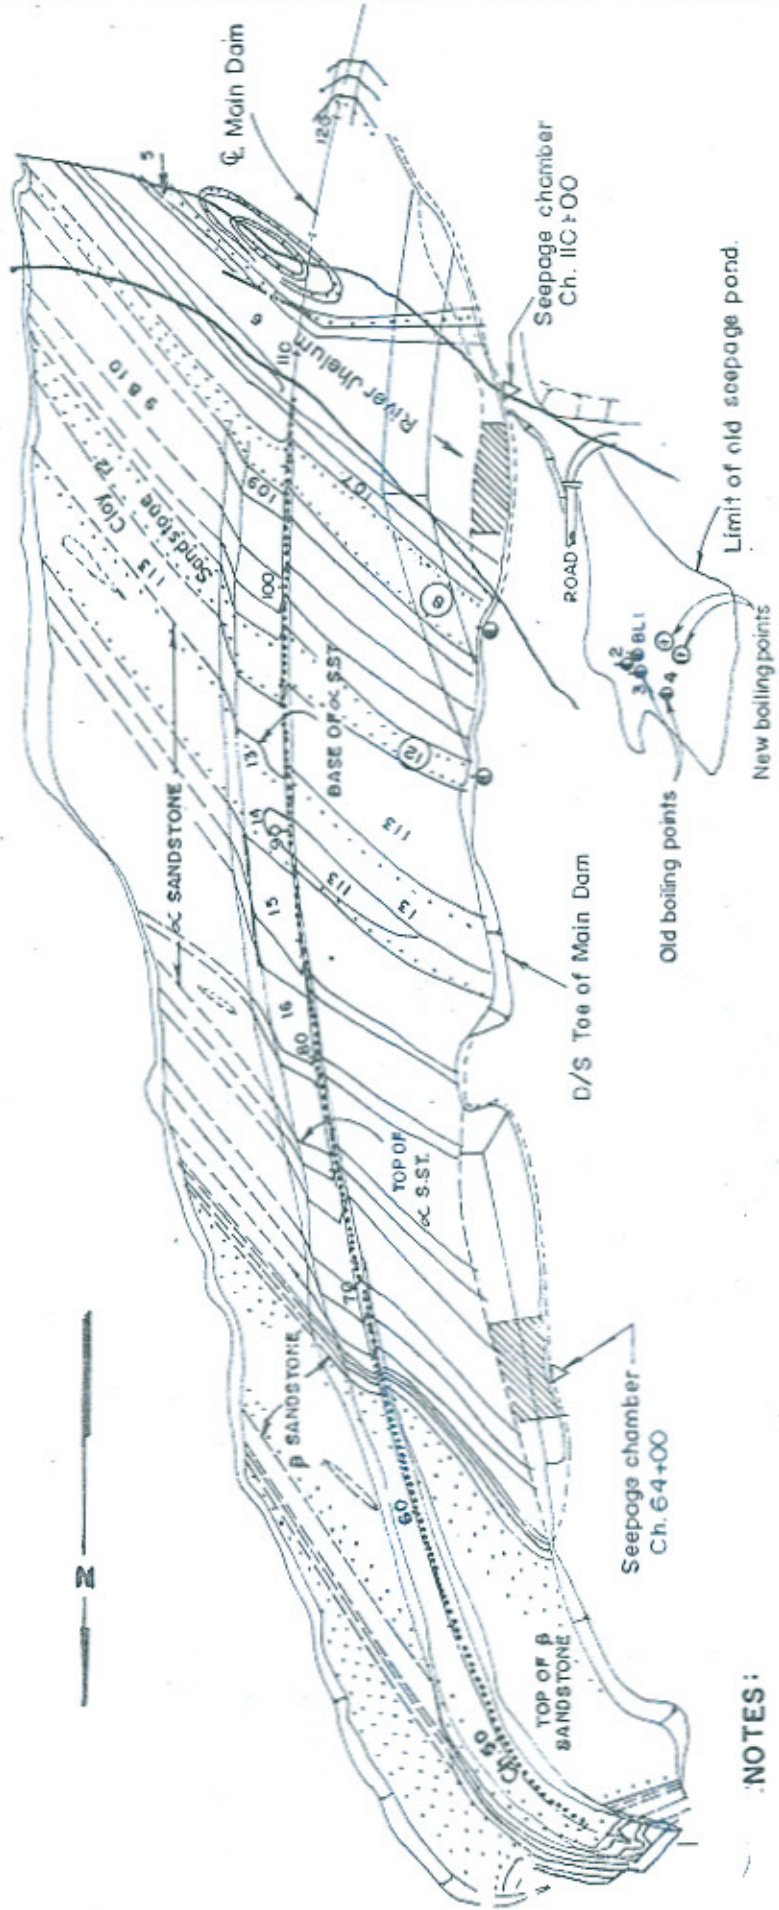
**MANGLA DAM PROJECT
MAIN DAM - GENERAL GEOLOGY
AND D/S BOILING LOCATIONS**

Feeble boiling was noticed at downstream toe chainage 95+66 just north of southern toe weight when a shallow (\pm 1 feet deep) pit was dug by a labourer in 1968. This was treated by weighted filter. Further feeble boiling was noticed intermitantly along the toe of southern toe weight for several years & cured its-self with the sand accumulating from the slope wash however simple G.I. Pipe shallow standpipes were installed for monitoring pressures & did not record any appreciable pressure in the alluvial but only fluctuation with change of reservoir of a few feet with max: levels fraction of a foot above the ground level. Exhibit-10.

On filling the pond/during the filling which was done upto 2' above normal pond level, boils appeared at several places on the spillway side periphery Exhibit-10. There was also boiling in the collector drain later on. The boils were ringed and are being monitored.

The pressures in the sandstone will be treated by additional drainage wells at toe. Drainage wells have been previously provided downstream of the core at 12½ C/C & in some portion at 6¼ C/C. This location does not help monitor their performance. Also the pressure in the sandstone No. 12 & 13 at toe are inspite of the wells system, although pressure in sandstone-5 does not have the benefit of the drainage curtain of the Intake Embankment.

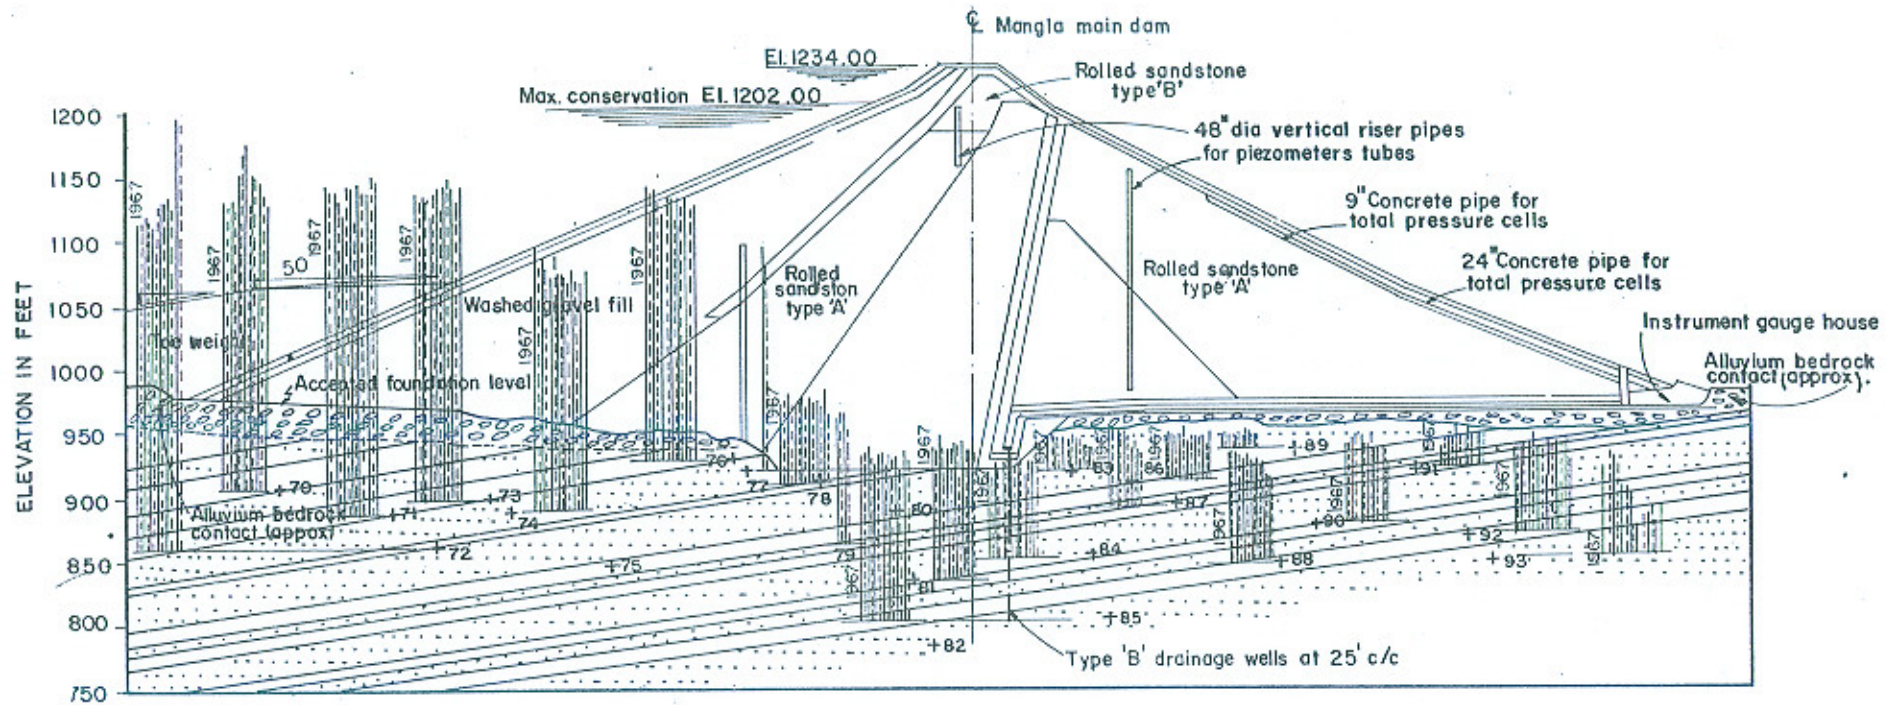
**MANGLA DAM PROJECT
GEOLOGICAL SECTION AT
CH. 77+50 SHOWING
FOUNDATION PIEZOMETRIC HEIGHTS**

Pressures in foundation of main dam are instrumented at Chainage 77+50 & Ch: 86+35. Behaviour over the years is plotted as piezometric heights Exhibit-13. At Ch: 77+50 pressures in foundation under the downstream shoulder are below filter mattress & have remained so. At Ch: 86+35 on piezometer No. 21 records pressures above filter mattress, however the downstream piezometers at same section do not reflect similar behaviour. Pressures along toe has been discussed earlier.

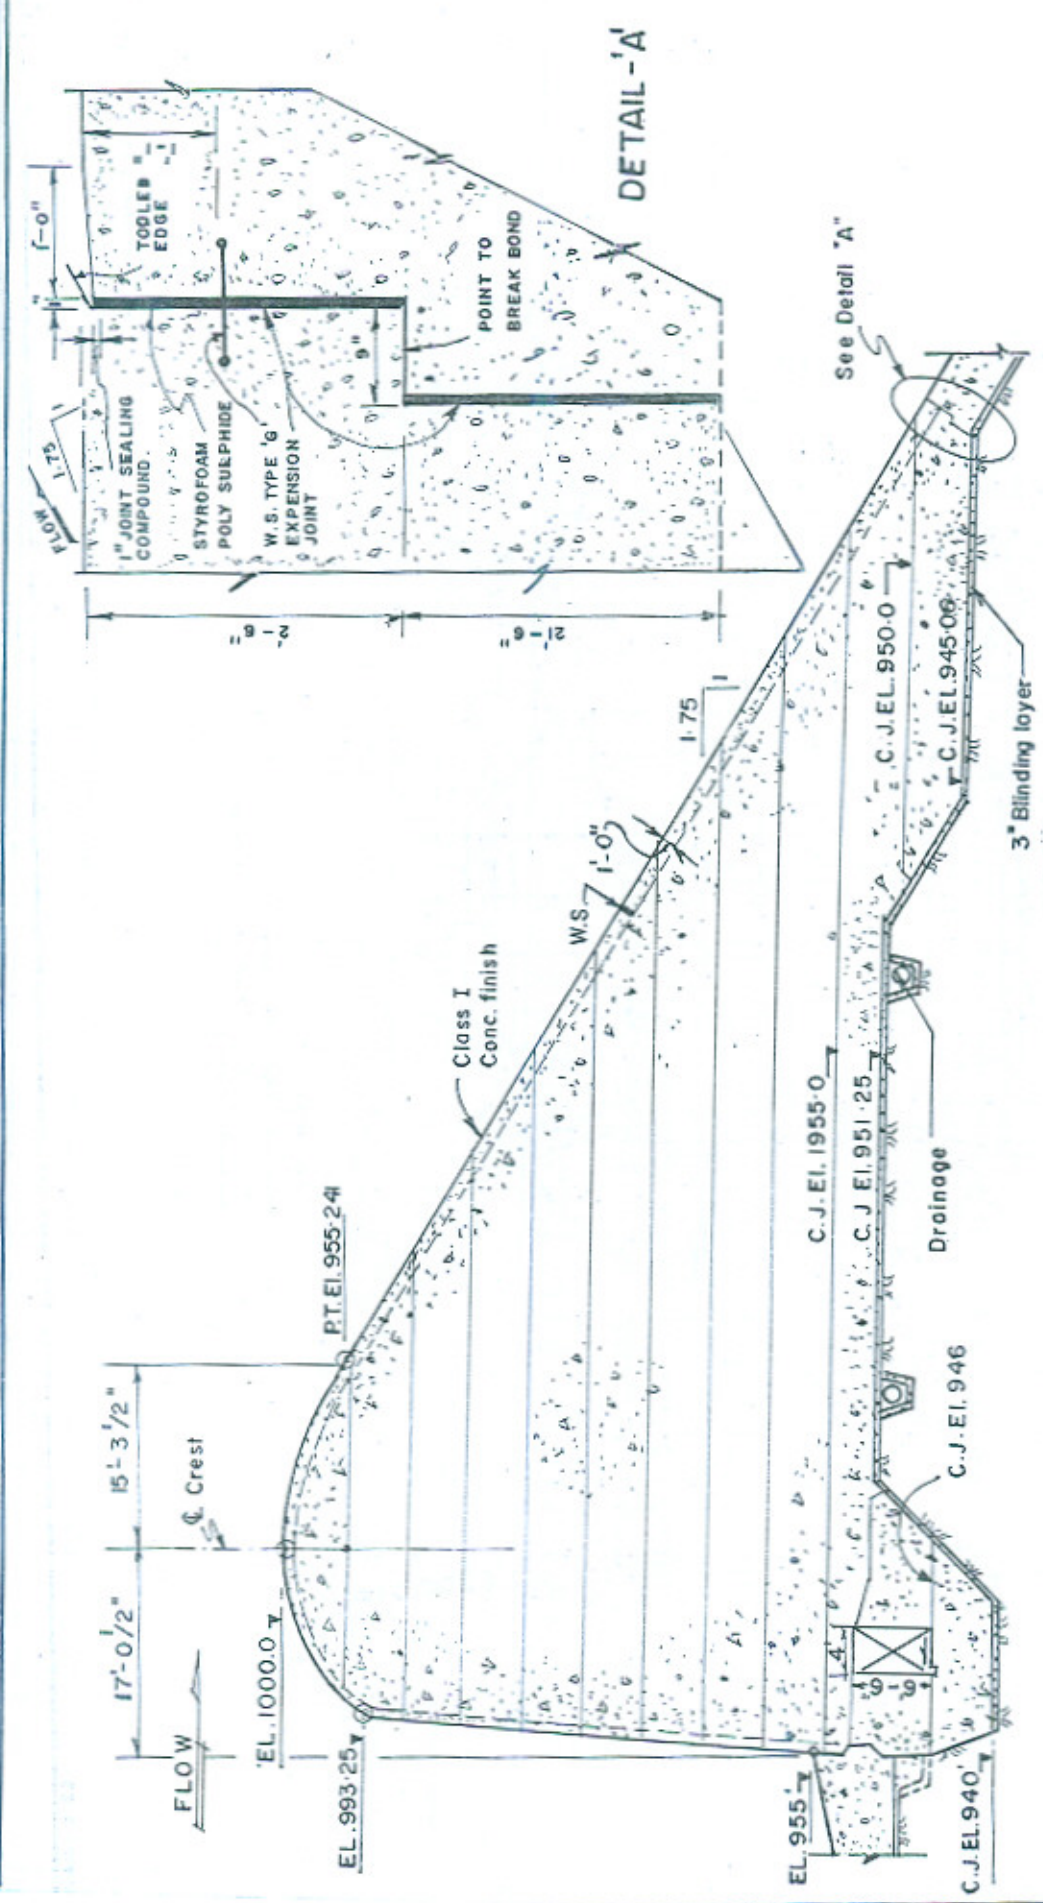
**MANGLA - MAIN SPILLWAY
CROSS SECTION OF WEIR SHOWING
DETAIL OF EXPANSION JOINT BETWEEN
LOWER CHUTE & WEIR**

The expansion joint between weir & lower chute Exhibit-21, with provision of movement along the chute (after a closure pour left unpoured for a year) and shear failure of weir toe & in almost all the blocks of weir occurred due to settlement as any vertical movements, would lead to concrete failure by shear. The same happened due to swelling of clay bedrock for weir toe of emergency spillway.

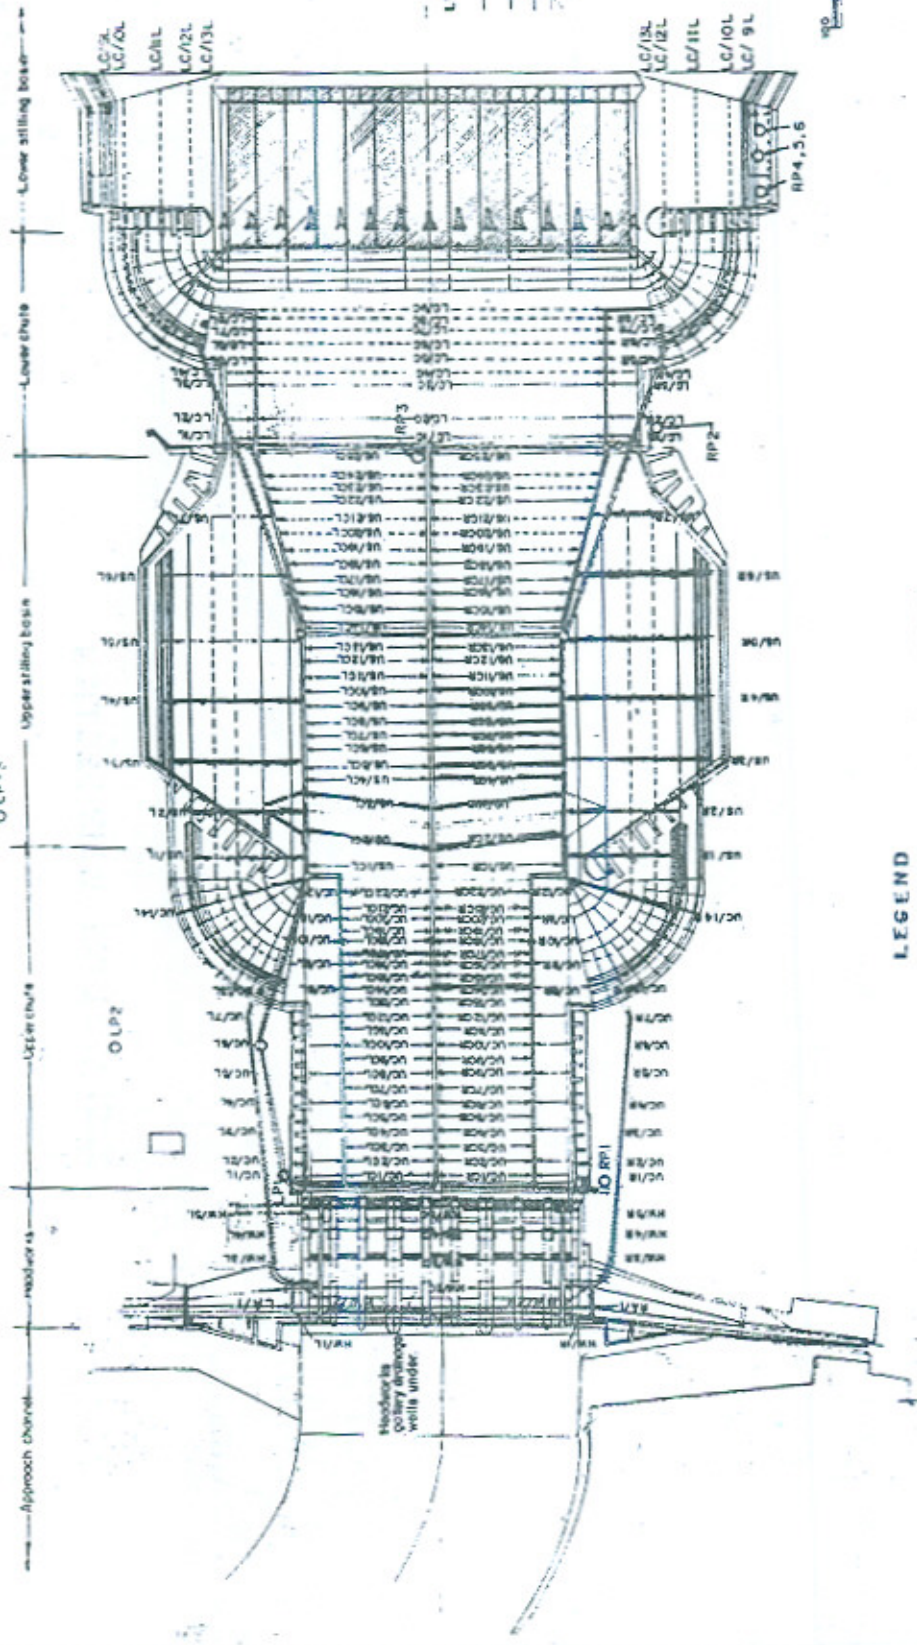
MANGLA DAM PROJECT
 MAIN SPILLWAY
 UNDERDRAIN SYSTEM - PLAN

The sandstone bedrock contains on the average 20% carbonate as binder. This is removed as bicarbonate by the seepage water and deposited in the 8" diameter, hume concrete pipes conveying the seepages/leakages from the drain to the various galleries. The concrete pipes have been placed with open joints & also bend into the gallery. Encrustations are hard & have to be chisilled & this may damage the drain, causing filter migration/exposure of foundation with movement of fines by seepages if large enough. Cleaning with use of sulphamic acid will attack the concrete pipes & the filters which is undesirable Exhibit-22. Drains of the central gallery have two ends accessible & cleaning with water is possible. The side drains are adjacent to bedrocks & the ones getting encrusted. Encrustation is being removed but there has not been indication of inadequacy, and need for additional so far. Effected drains are at Exhibit-22.
