Marala Headworks—Site Investigation

By
H. J. ASAR*

Introduction

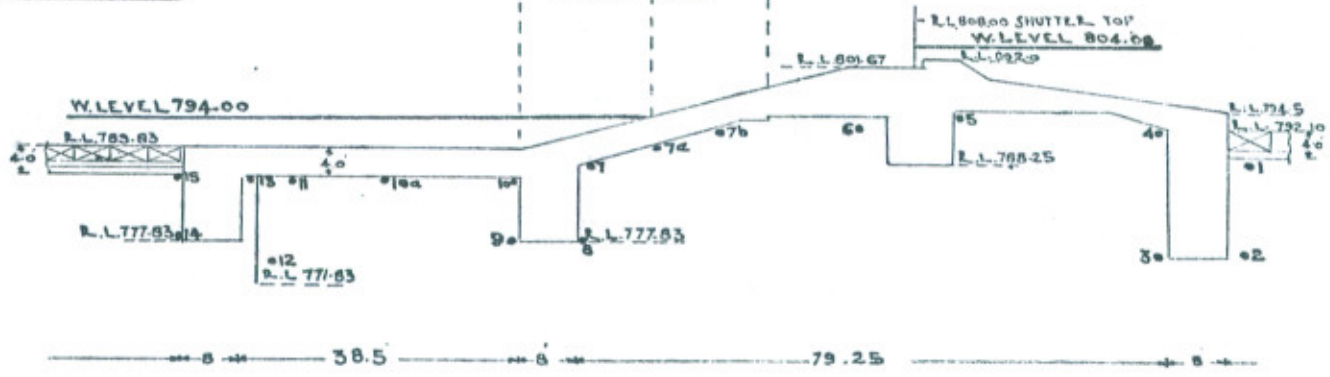
PLATE VII

Plate VII shows location of pressure pipes on weir profile and anticipated and observed (1962) average pressure lines for weir bay 6 line 450/L. The observed pressure at key points are very close to computed figures in this bay. In other bays the pressure points observation are very few and in some of these, observed pressure are excessive.

UPLIFT PRESSURE DIAGRAM
 WEIR BAY 6

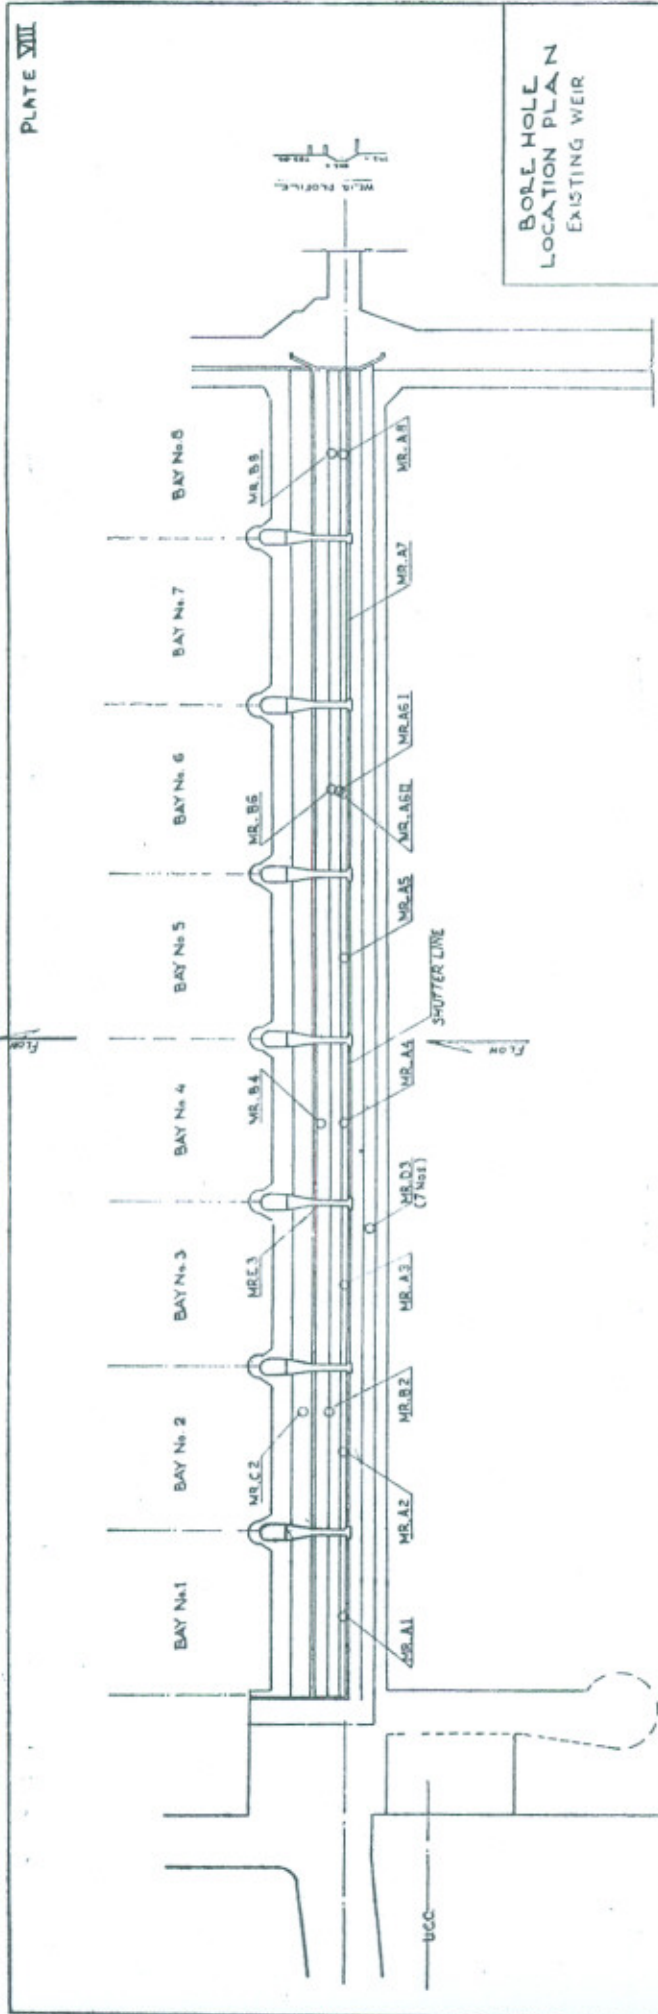
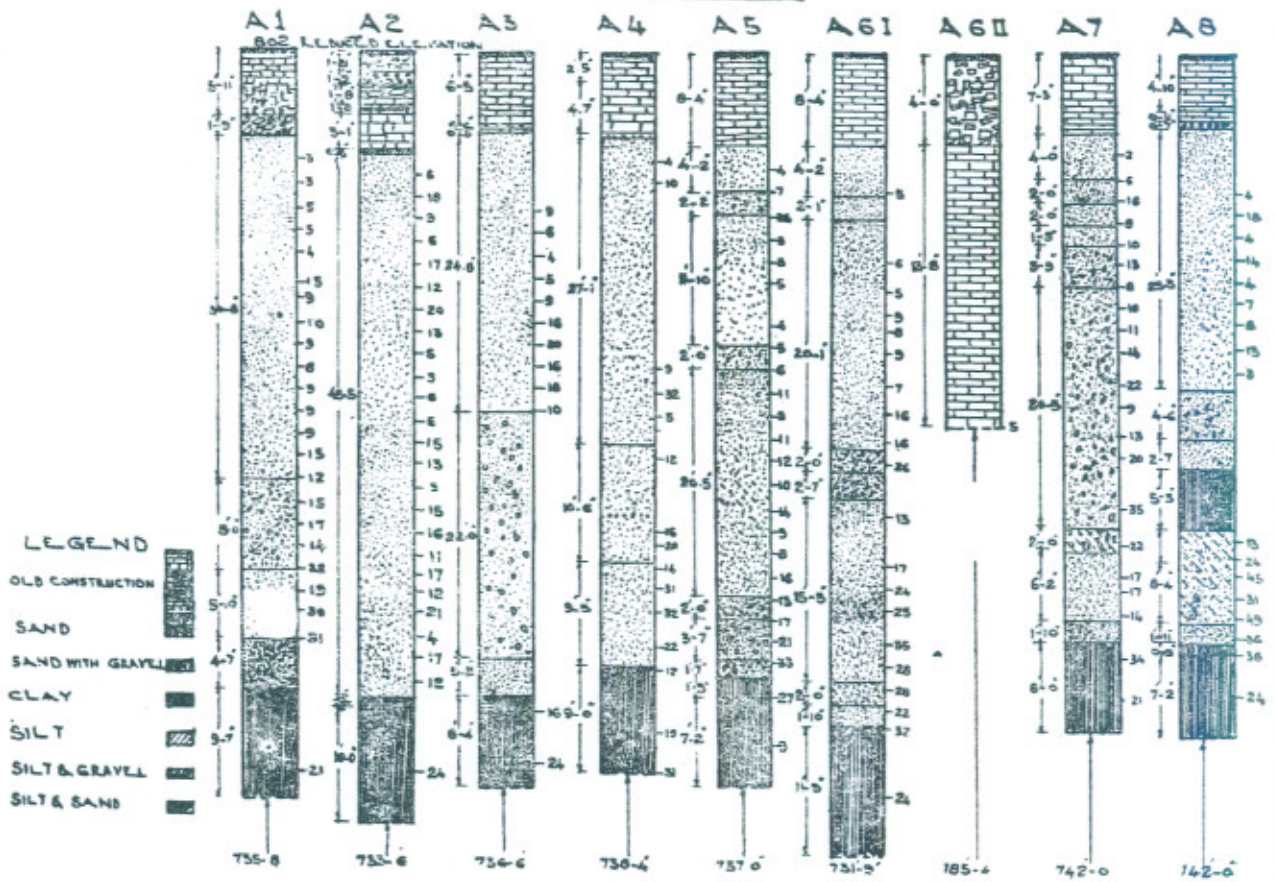
PLATE IX

In the sandy layers below the weir disturbed samples by standard split spoon were taken. The spoon was driven 24 inches deep into soil from bottom of a cleaned hole by blows from 140 lb hammer with 30 inch drop. Number of blows was recorded for every three inches of penetration. The 'N-count' representing number of blows for one foot penetration from 6 inch to 18 inch depth was worked out and are shown in the bore logs (Plate IX).

The blow count for sand under crest upto elevation 780.00 and even lower still in some locations is below five indicating very loose sand. As the bed sand in the vicinity of headworks is of medium compaction with average blow count of 15 to 30 it appears that during construction operations or thereafter through seepage flow underneath fines have been washed off from sand resulting in loss of density and resistance to penetration.

It is of particular significance that in some holes such as A₃, A₄, and B₈ the blow count was zero indicating cavities and hollows underneath.

1. Cement grout foundation under pressure through holes spaced 30 ft. on along crack line about 20 feet from the shutter line.
2. Limit head across to 10 feet for minimum period.
3. Examine weir glacis for cracks every year and take care of these.
