Remodelling Balloki Headworks

RANA MUHAMMAD ASLAM CHOHAN*

*Deputy Project Director, Remodelling Balloki Headworks Project, Balloki.

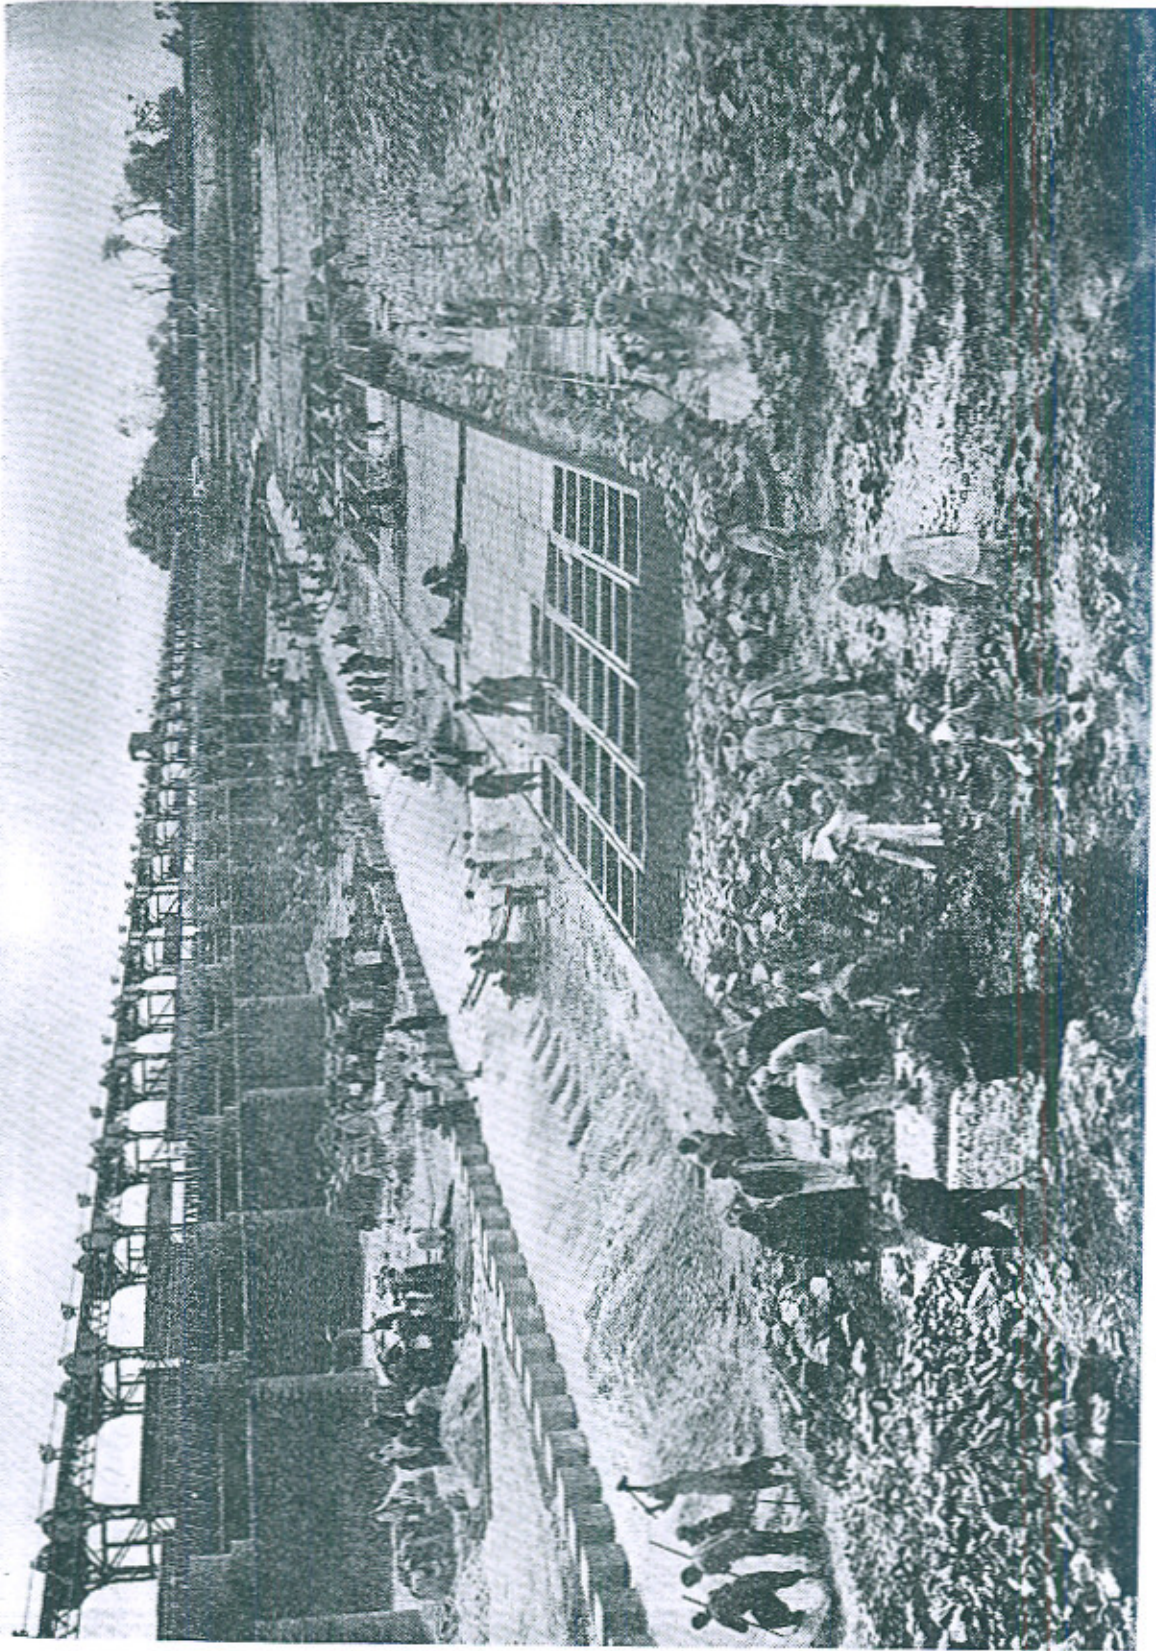
Remodelling Downstream floor at Balloki Headworks (Right side)

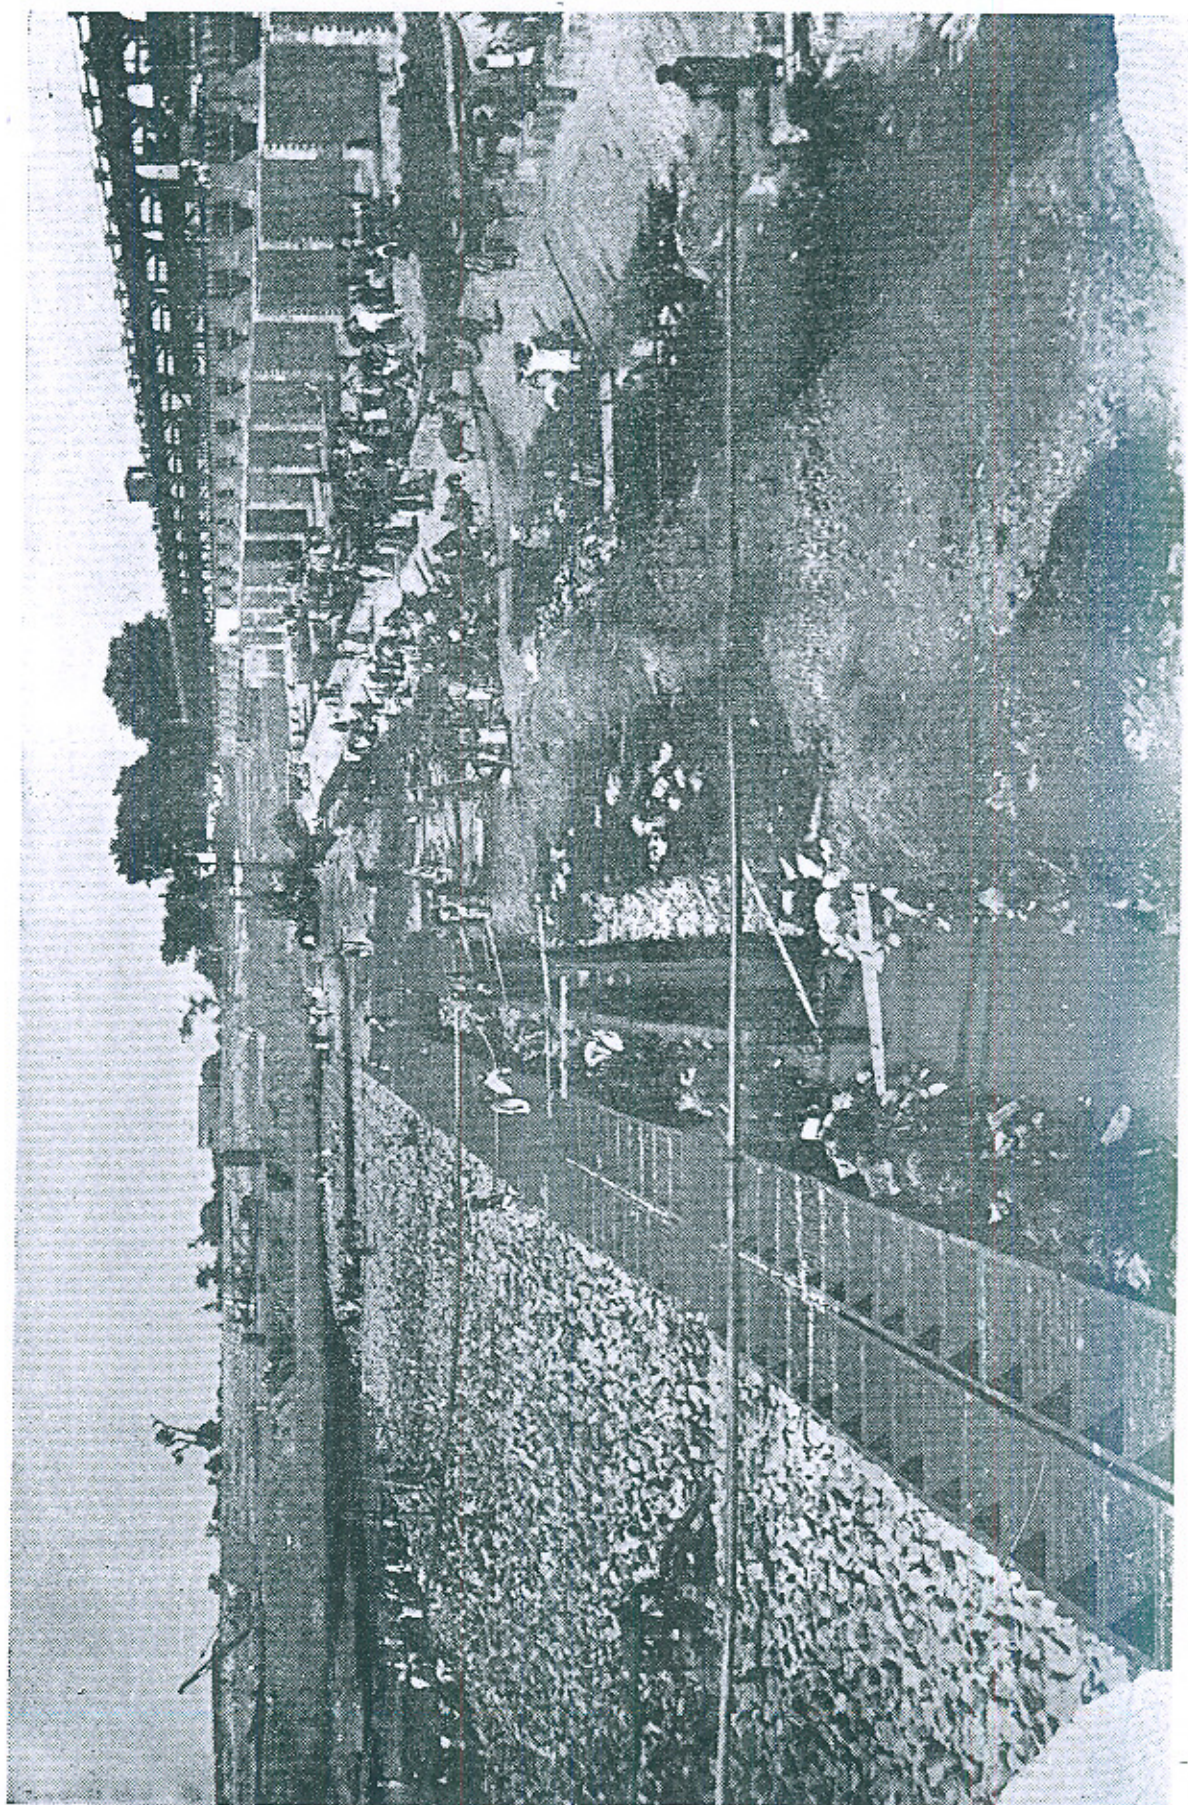
Remodelling Downstream floor at Bailoki Headworks (Left side)

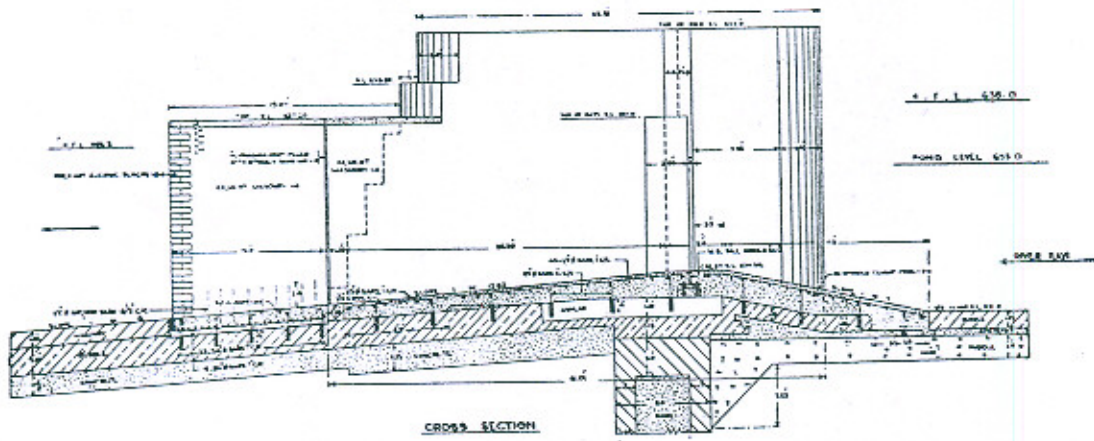
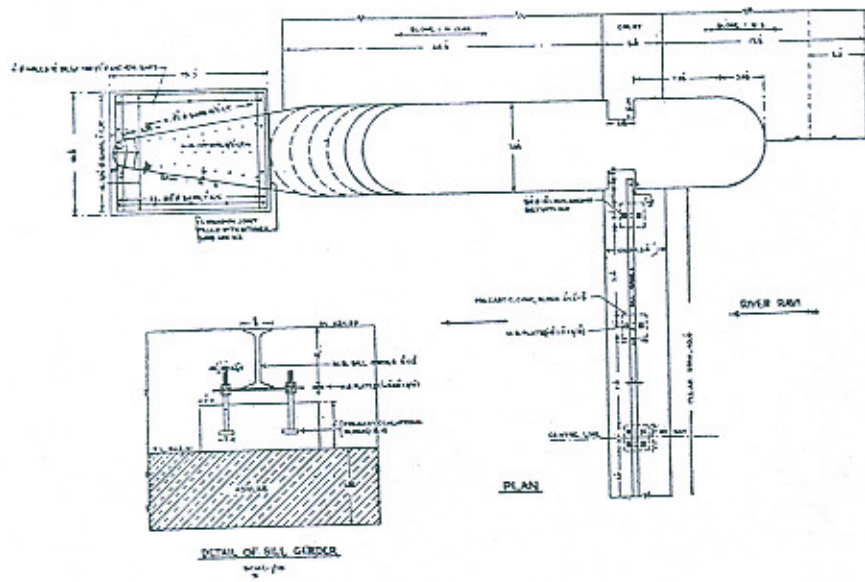
PLAN W.P. 12

- (iv) *Providing sill girders.*—The existing structure did not have any sill girders for resting the weir gates which resulted in heavy leakages and waste of precious water. On raising of crest in reinforced cement concrete 1 : 2 : 4, opportunity for providing sill girders was also availed of Rectangular bed blocks with anchor bolts, were precast and placed at suitable intervals in each bay. Two number sill girders (Mild steel I-Section Girders 12" × 5"—each 21'—2" long) were then seated over the bed blocks in each bay levelled properly and adjusted in the alignment of weir gate before concreting for raising of the crest.

REMODELLING BALLSOD HEAD-WORKS
PLAN SHOWING DETAIL OF RAISING CREST,
SILL GIRDERS AND EXTENDING PIERS
SCALE: 1/20

As already explained, the accretionary trend on the Downstream and river-approaches being on the left side both on Upstream and Downstream of the Headworks, rendered the Barrage to work non-modularly particularly in the right half, and had an adverse effect on the discharging capacity. In addition, the location of Upstream floor at R. L. 621.00 (lower by only 1.5 ft. from the existing crest) was considered unsafe and deserved a more cushioning effect to obviate recurrence of damages. All these factors combined together necessitated raising of the crest. Excessive raising was more beneficial, but it was apt to have a corresponding effect in increasing flood levels and greater submergence of the surrounding areas. The raising of crest was therefore restricted by 2.0 ft. (from R.L. 622.50 to R.L. 624.50) which in turn raised the high flood level at Barrage from R.L. 637.00 to R.L. 638.00 corresponding to a discharge of 2,25,000 cusecs as advised by the Flood Commission. The raising of the crest as shown in Plate No. 12 involved:—

- (i) Extend the pier up to tail end of the well foundation (1st stage) monolithic with the existing pier.
- (ii) Provide an expansion joint and
- (iii) Extend the balance portion (Second stage) resting over an independent reinforced concrete raft built after dismantling upper layer of existing stone masonry.

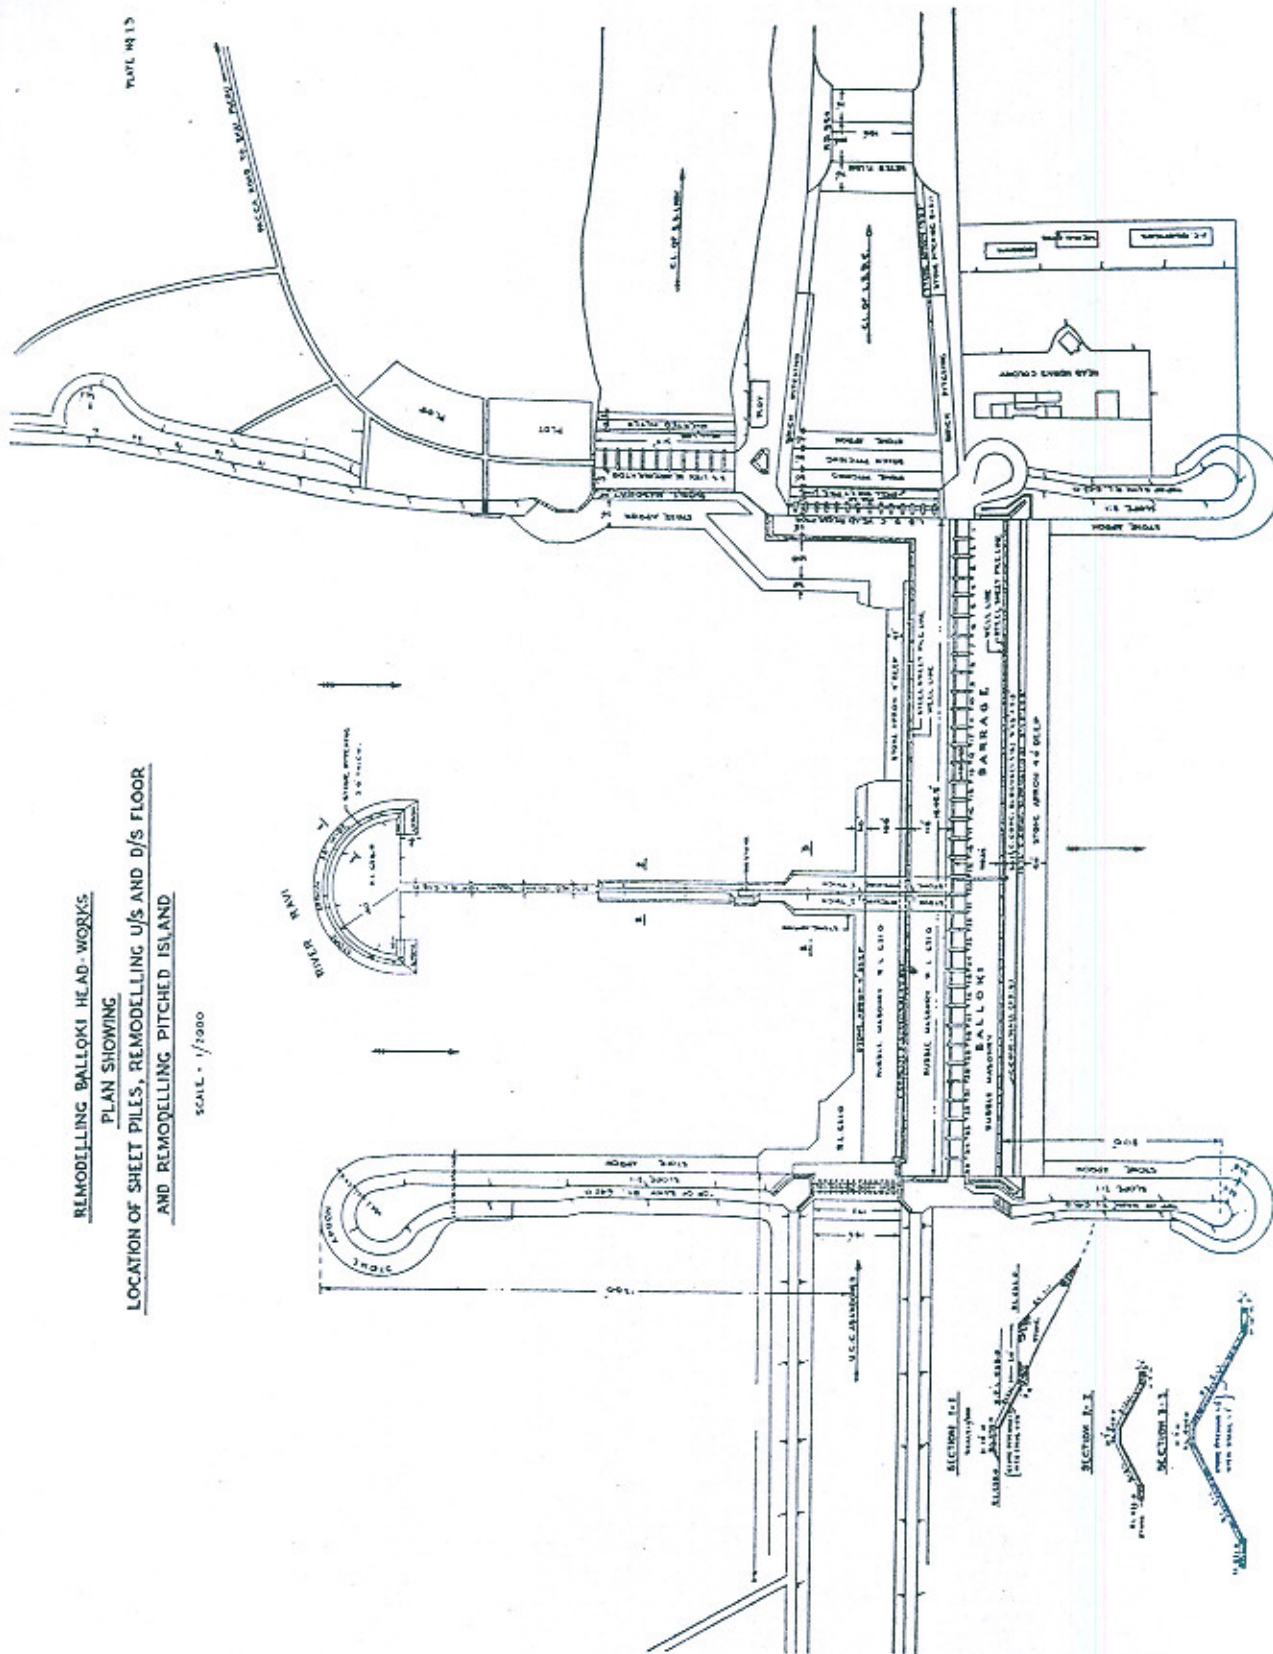
PLATE No 13

REMODELLING BALLOKAI HEAD-WORKS
 PLAN SHOWING
 LOCATION OF SHEET PILES, REMODELLING U/S AND D/S FLOOR
 AND REMODELLING PITCHED ISLAND

- (i) Stone pitching and aprons of semi-circular nose which stood badly damaged by repeated floods of the preceding years were properly designed and rebuilt during the winter season of 1963-64.
- (ii) Model tests indicated necessity for protection of earthen shank in a length of 900' as this reach was liable to come under river action during floods. Accordingly at the time of Remodelling the Barrage, during the year 1964-65, both sides of the earthen shank adjacent the gate line in a length of 900 ft. were protected with stone pitchings and aprons.

The extent of the work executed is depicted in Plate No. 13.
