REPAIRS AND REMODELLING OF RASUL WEIR, 1929-1931.

By T. A. FOY, EXECUTIVE ENGINEER, I. B.

On the 28th August, 1929 the river Jhelum came down in high flood owing to heavy rain throughout the Jhelum valley. This flood caused extensive damage to Rasul weir and it is the purpose of this paper to give the history of the flood and of the consequent repairs; these repairs led to the remodelling work which is also described.

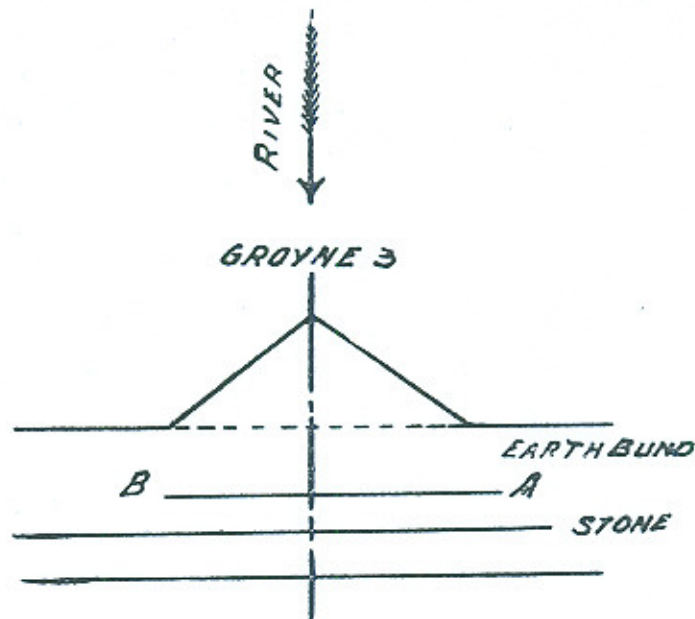
In bays, 3, 4 and 6, the earthen bund was placed outside the stone barrier to enable a staunch bund to be built. This alignment crossed the remnants of groynes 3 and 4. At both these junctions of the groynes with the stone barrier difficulty was experienced in getting a staunch bund. The first attempt was by thickening up the corner at the junction of groyne 3 as shown on the sketch. When this was done a trench was

made on line A B and this was puddled with clay and sand. This was moderately successful in the case of groyne 3.

It was a total failure in the case of groyne 4. The leakage entering through groyne 4 found its way along the stone barrier and forced an exit at point C on the stone barrier, plate 3.

The next attempt was to build an earthen bund inside the stone barrier to within 50 feet on each side of point C and adding a reverse filter of small stone on the inside of the stone bund over this 100 feet. This reduced the discharge considerably but it was still greater than could be coped with by the pumps.

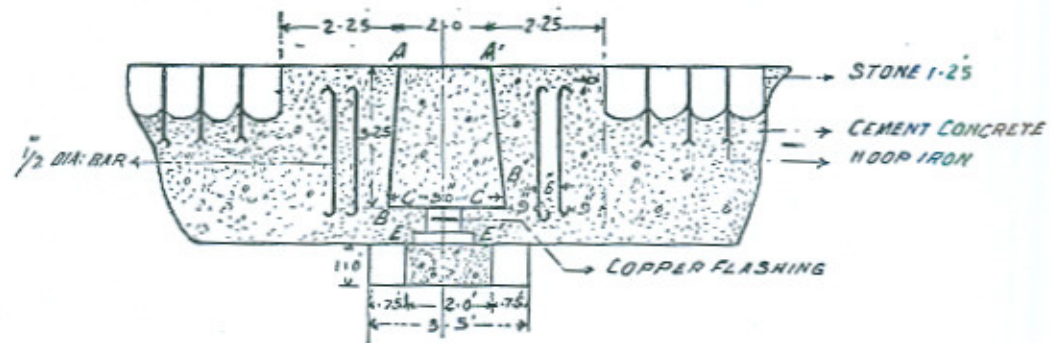
These expansion joints were examined the following year. There are always bound to be contraction cracks in concrete due to the setting contraction. These joints by providing a plane of weakness gave a definite line instead of an irregular crack. The joints were obviously working as contraction joints. In the morning when the temperatures were low, there was a distinct film of moisture all along the joint. As the temperature increased, this tended to disappear until by afternoon no moisture was visible. The trapezoidal section of the concrete sealing block effectively prevented any possibility of uplift.

The work was divided up into portions suitable for one day's task and the concrete was poured in one unit, *i.e.*, not in layers, and worked with rods. Each day's work was separated from the next by an expansion joint. The construction of these is clear from the sketch below.

A compartment wall, 3.5 feet wide and one foot deep below the bottom level of the floor, was first constructed. On this was built .75' of brick masonry to house the copper flashing and a further seal above the copper flashing was given by working in puddled clay in the one inch gap between the bricks. The concrete of the floor was then poured up to the line ABCDE, being held by timber false work. The following day's work was similarly finished off and some days after the concrete wedge shaped and seal ABCC' B'A' was poured.

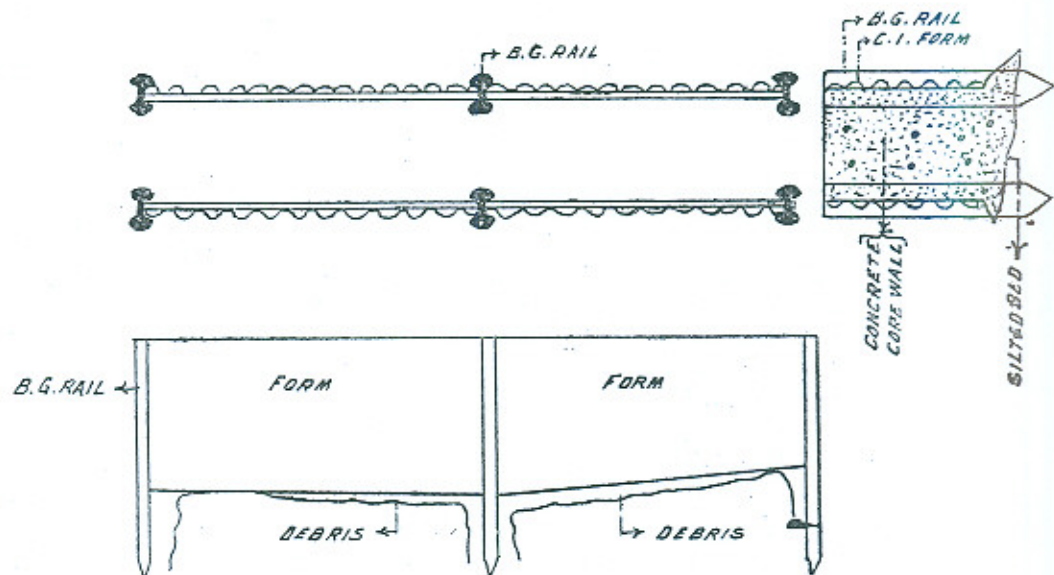
The repairs in bay 4 were the heaviest as the entire weir section was wiped out on approximately half the bay, see plates 6 & 7. The principal difficulty was the replacement of the lines of wells. These had been washed away but the debris and in places tilted wells existed at varying levels. Piling and sinking new wells were considered as a method of repair but were rejected owing to the mass of debris which would have had to be pierced. The alternative adopted was a concrete core wall. By careful probings and verification of these by divers, the main blocks of debris and the tilted wells were located. Broad gauge rails were sharpened and driven with a monkey into these gaps, the long axis of the rails being on the river axis. The rails having been driven, corrugated iron sheets were cut to the exact shape to fit the bottom and stiffened with angle iron. The sketch below shows the method adopted:—

These sheets were slid into the grooves formed by the heads of each pair of rails and formed a false work for the concrete core wall. This core wall was then placed by skipping concrete to fill the cavity between the forms.

As the form work did not touch the debris along its entire length but was held on the highest point of debris, it permitted the concrete to fan out at the bottom which considerably increased the strength of the wall. The wall was brought up to R. L. 704 by skipped concrete and was here bonded with bent tram rails of 14 lb. section. The reason for this is that we were not ready at that stage to proceed with the further work.

Plate 6 shows the exact R. L. to which the concrete was poured. B, C, and D lines of wells were treated in this way and were replaced by a mass concrete wall. The maximum depth attained was about 689

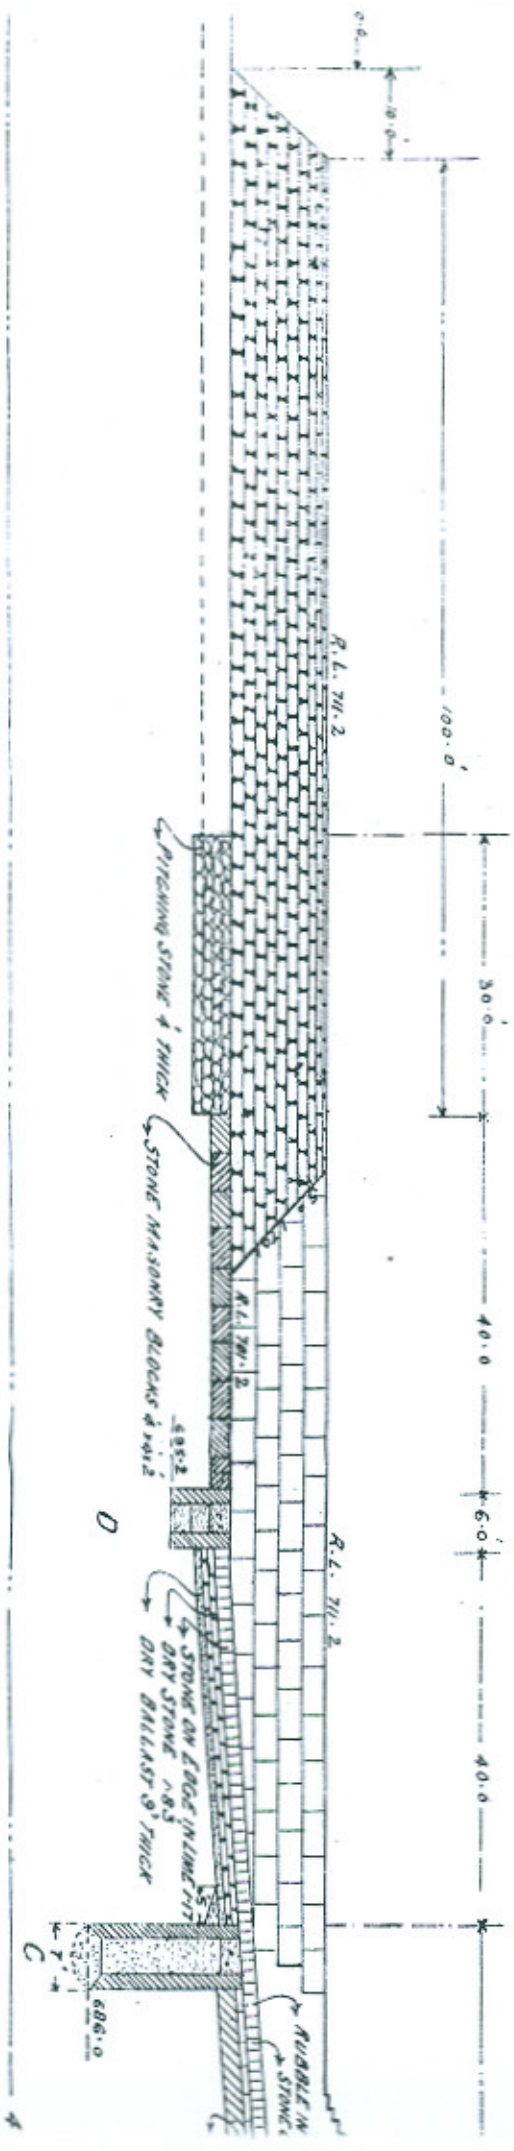
RASUL WEIR DIAGRAMATIC SECTION

SHOWING FLOOD WATERWAY 29-8-29
