PRESSURE OBSERVATIONS AT JAURIAN AND
DUGRI SIPHONS

BY P. A. TURNER, ASSISTANT ENGINEER.

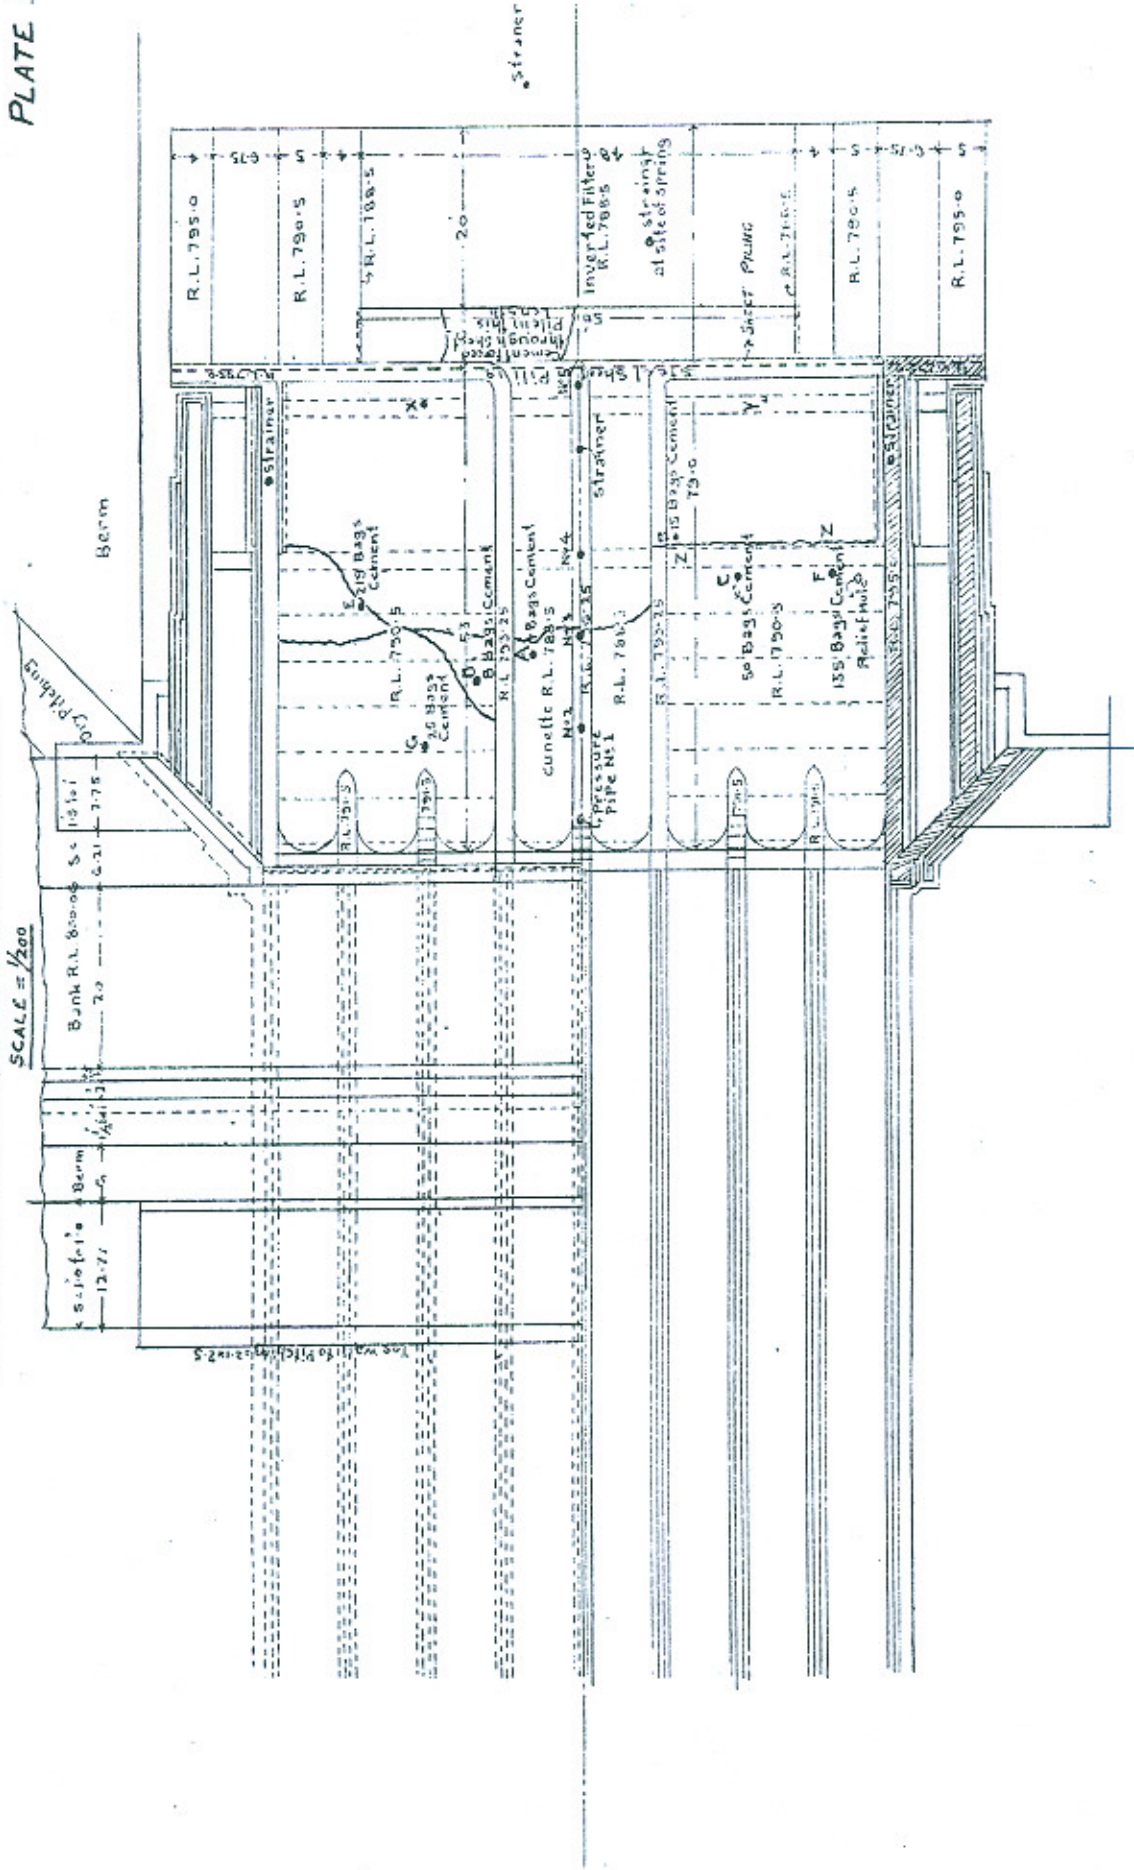
PLATE III

Further grouting during January was discontinued when it was noticed that on reaching 219 bags in pipe E the grout was getting past the line of sheet piles and was appearing in the inverted filter. The area in which this took place is shown in plate III. The fact of the cement getting past the sheet piles indicated the presence of cavities adjacent to the line of piles and the fall in the pressure of pipe No. 5 also indicated this. That the grout passed and spread almost under the entire floor was indicated by the pressures which were observed while the grouting was in progress. These rose in all the pipes as the grouting progressed, in some more than in others, according to the extent of the cavities adjacent to them. All existing cracks both along the high floor and at

While grout was being forced into pipe F, which took in all 155 bags, cement discolouration appeared in the spring indicated by the position of the strainer. (See plate III). This showed that creep under the floor was directed to this central spring.

UPSTREAM FLOOR DUGRI No. 1 SIPHON

The presence of cavities having thus been established, it was decided to pump in neat cement grout under the floor. Plate III shows the various pipes lettered A, B, C, etc., through which grouting was done and the number of cement bags consumed in each grout hole. The total number of bags consumed was 476. The grouting was carried out in two instalments, 276 bags being pumped in during the January closure and the balance 180 bags during a 12 days closure in April.

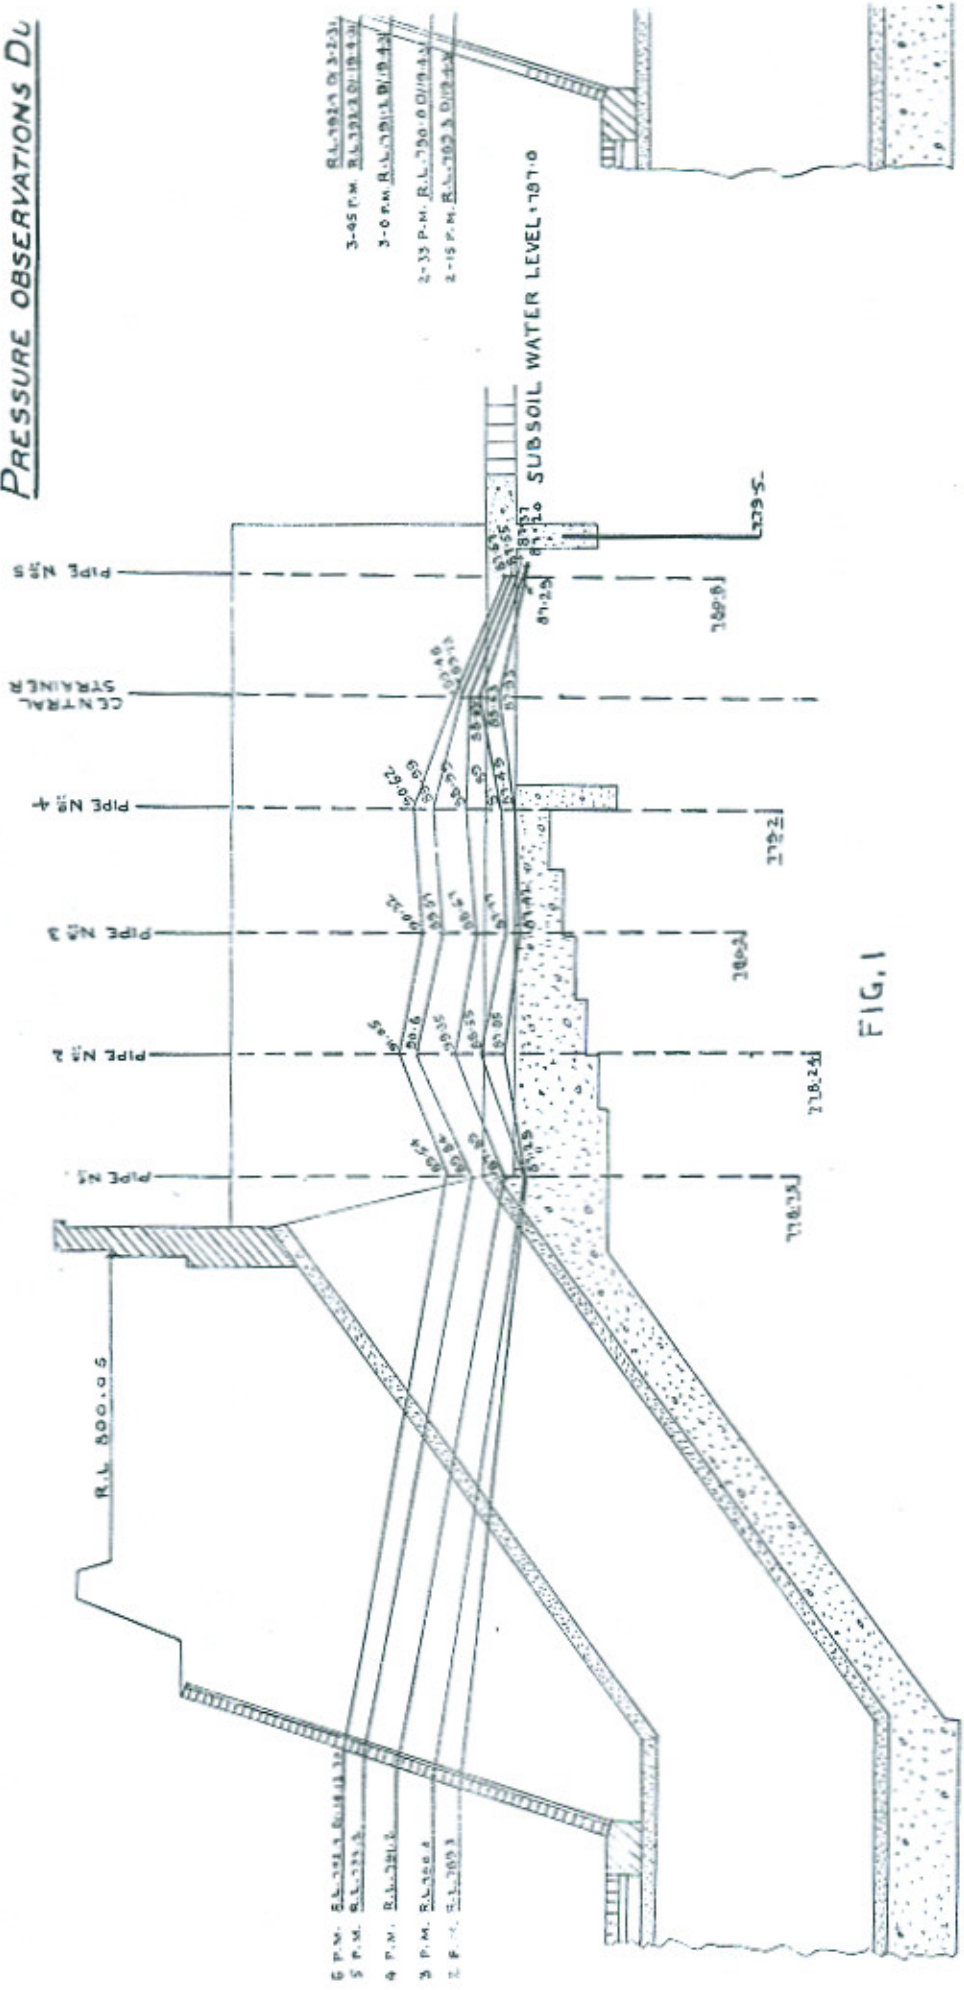
FIG. 1

A series of observations were made on 14th December 1930, on re-opening the canal, to see the effect of a gradual rise of the water level in the canal on the pressure under the floor as indicated by the pressure pipes along the central wall (see plate III for their positions). The results of these observations are shown plotted in figure 1, plate IV. It will be seen that the pressures in the various pipes for the same canal gauge do not follow any regular gradient and produce a zig-zag line, while from pipe No. 4 to the central strainer, and on to pipe No. 5 they slope down rapidly.

PRESSURE OBSERVATIONS DUGRI NO. 1 SIPHON IN RISING GAUGE

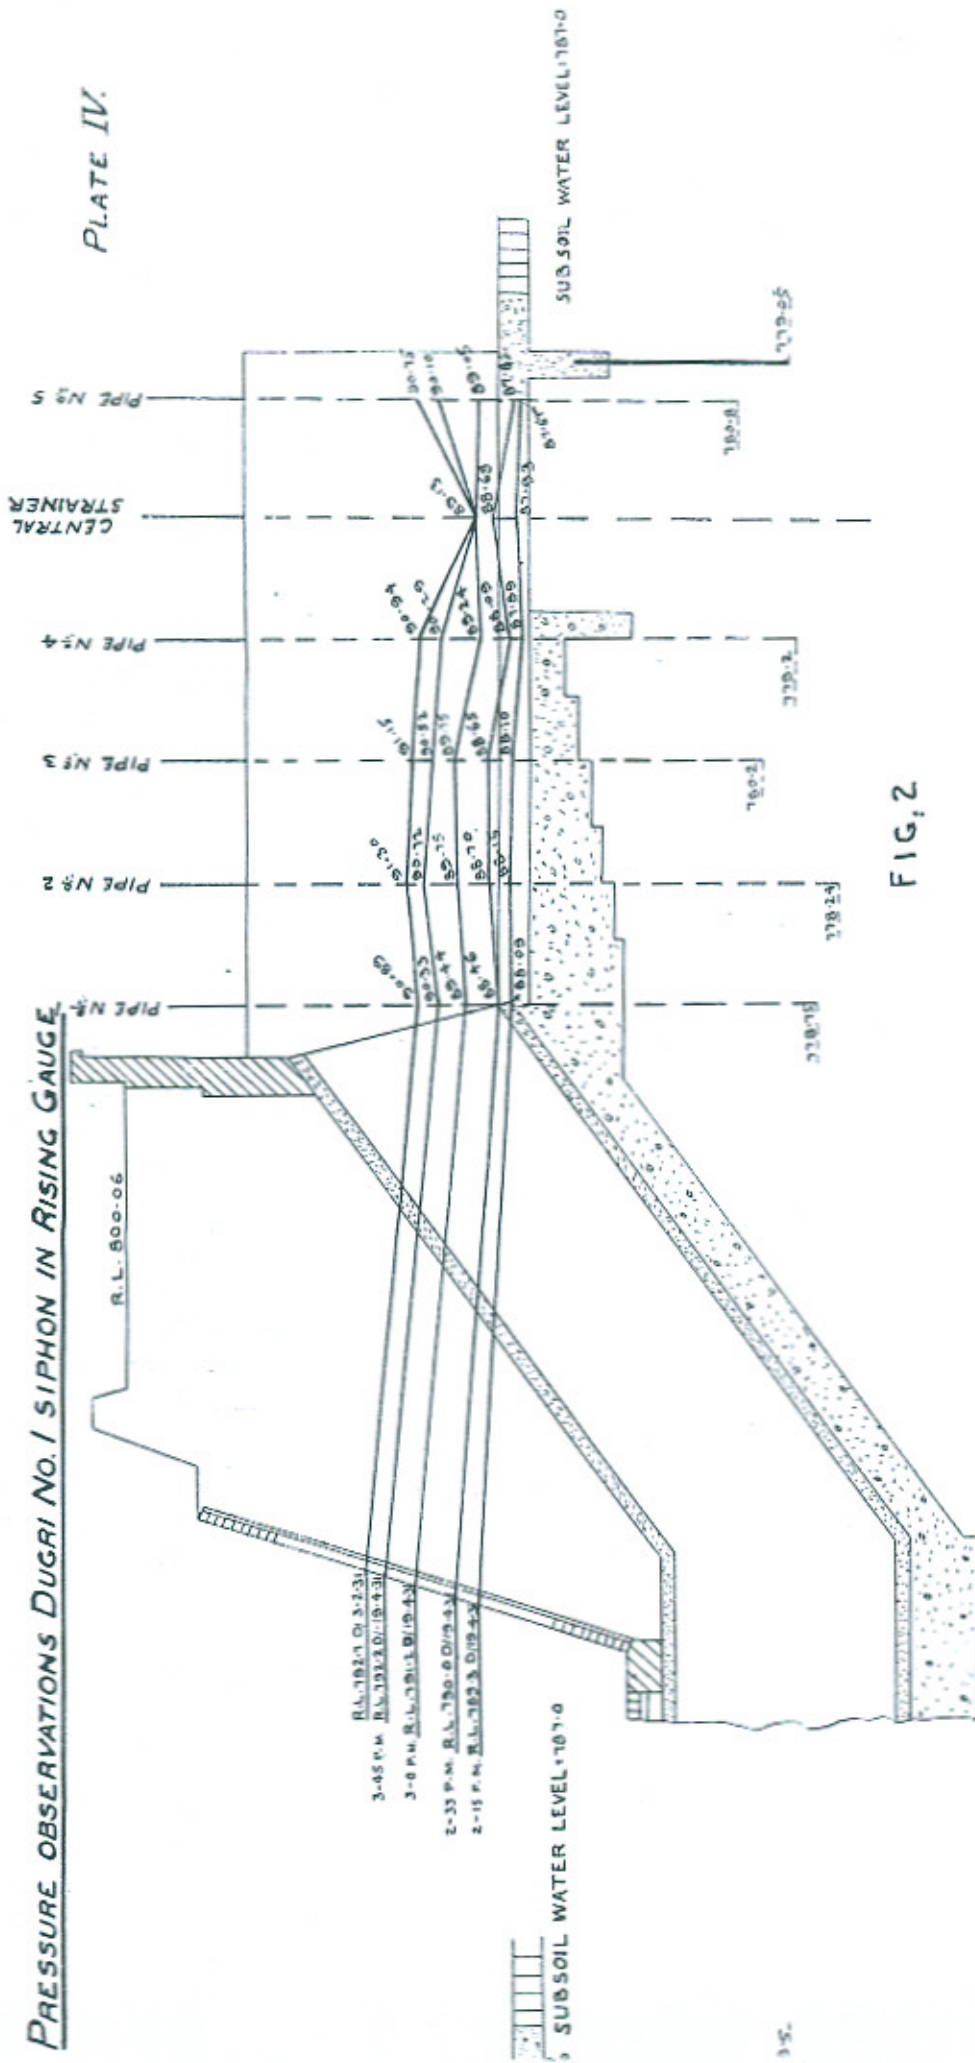
FIG. 2

Similar observations on the rise of pressure in the pipes were taken on 19-4-31 after the grouting of the cavities and are shown plotted in figure 2, plate IV, spring level being again down to 787.0. These two diagrams indicate the extent to which the cavities have been filled and flow past the sheet piles reduced.

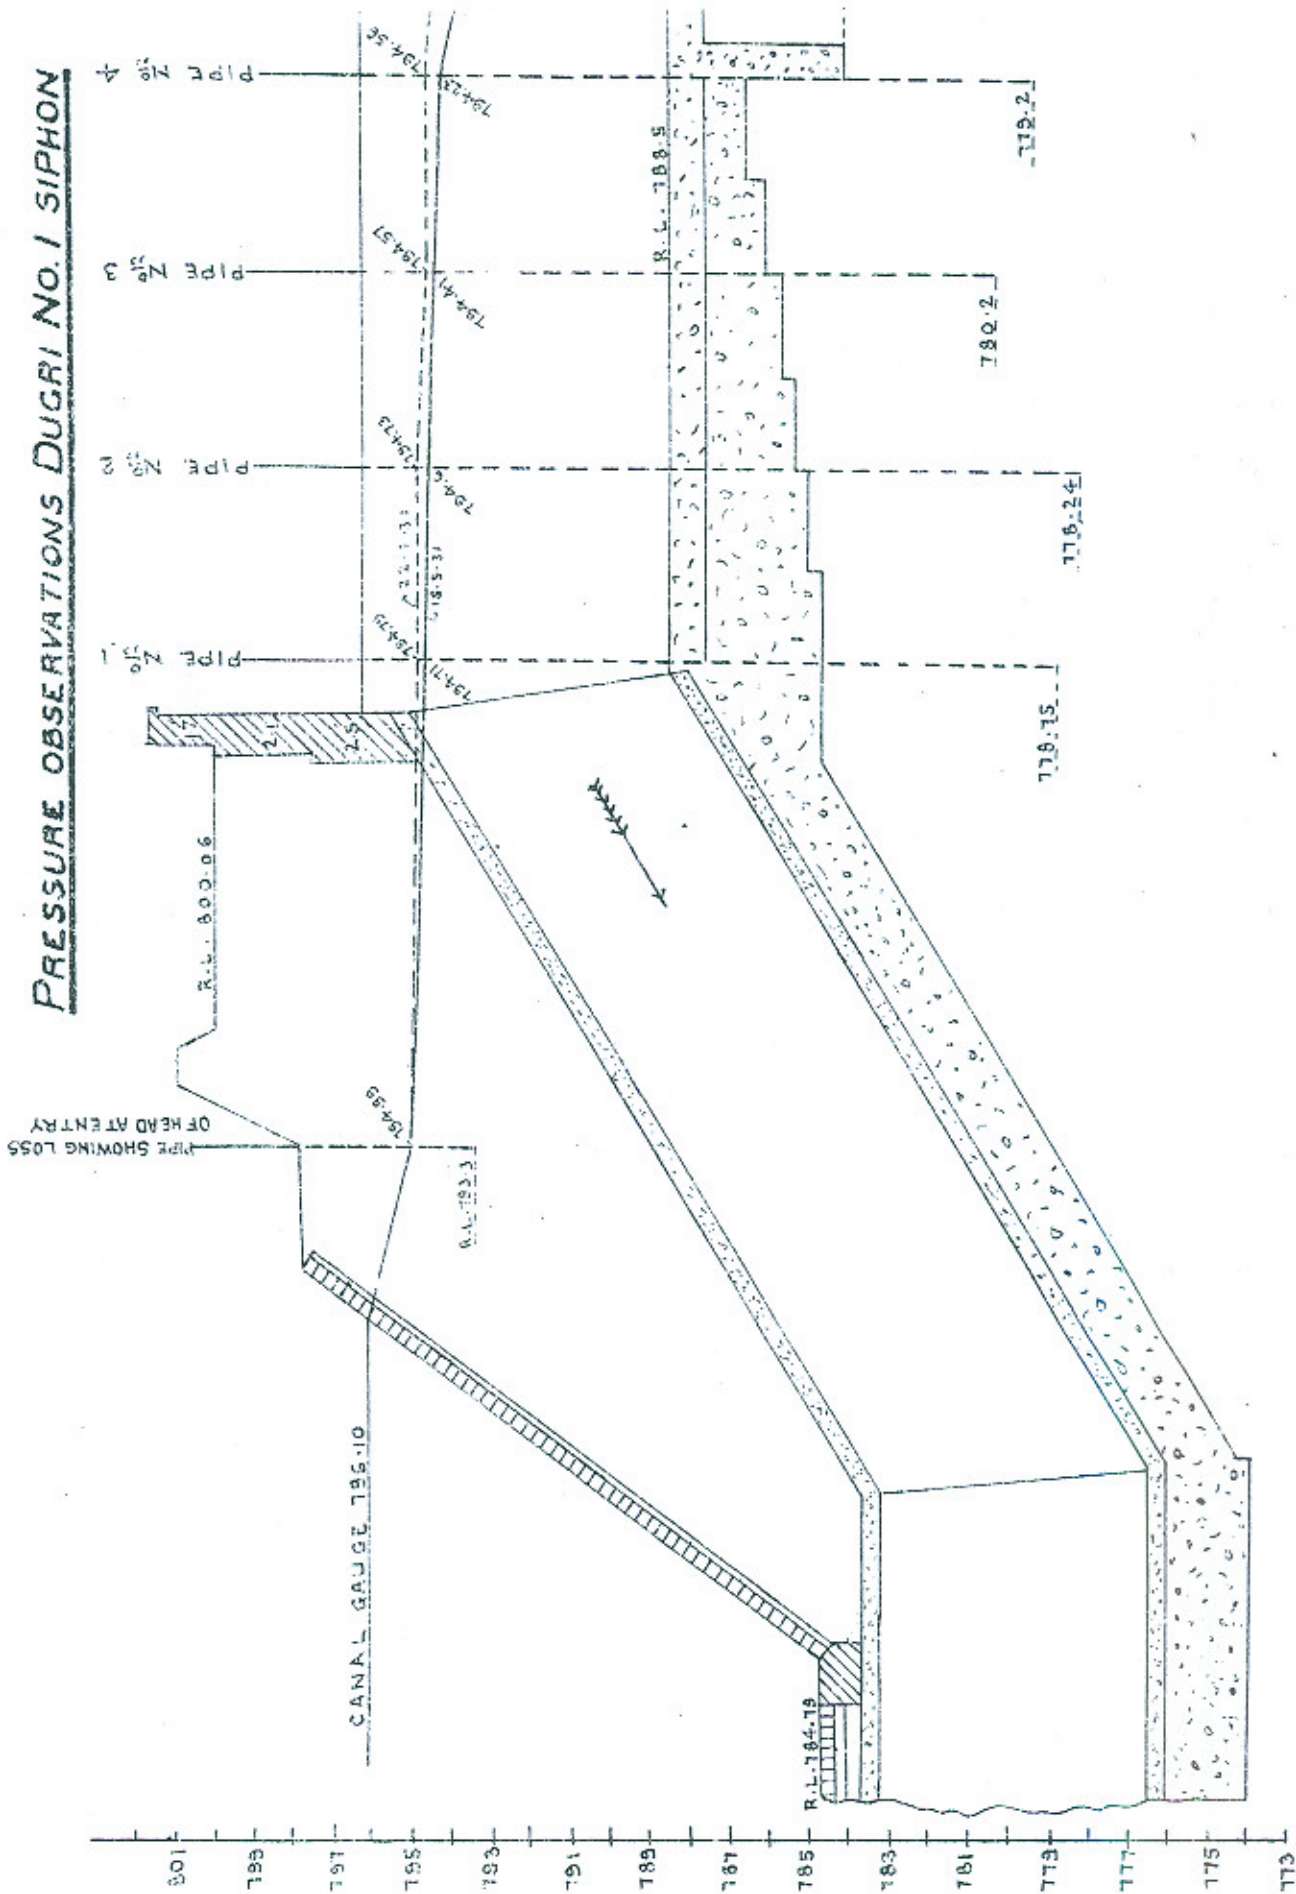
The effectiveness of the grouting in restoring the pressures is further illustrated on plate VI. With the cunette free water level '57' higher on 6th July, 1929 than on 12th May, 1931, the rise in the pressure gradient due to the filling up of the cavities is very marked. It has further been observed that in the absence of cavities, a rise in the free water level over the cunette, produces relatively a small rise in the pressure gradient. This is shown on plate VI. The canal gauge is identical on both dates but cunette free water level 1.28 feet higher on 22nd April, 1931 than on 16th May, 1931. The maximum rise is in pipes 4 and 5. A contributory cause of this is possibly the increased head on the central strainer which discharges into the cunette at R. L. 789.0.

PRESSURE OBSERVATIONS DUGRI NO. 1 SIPHON

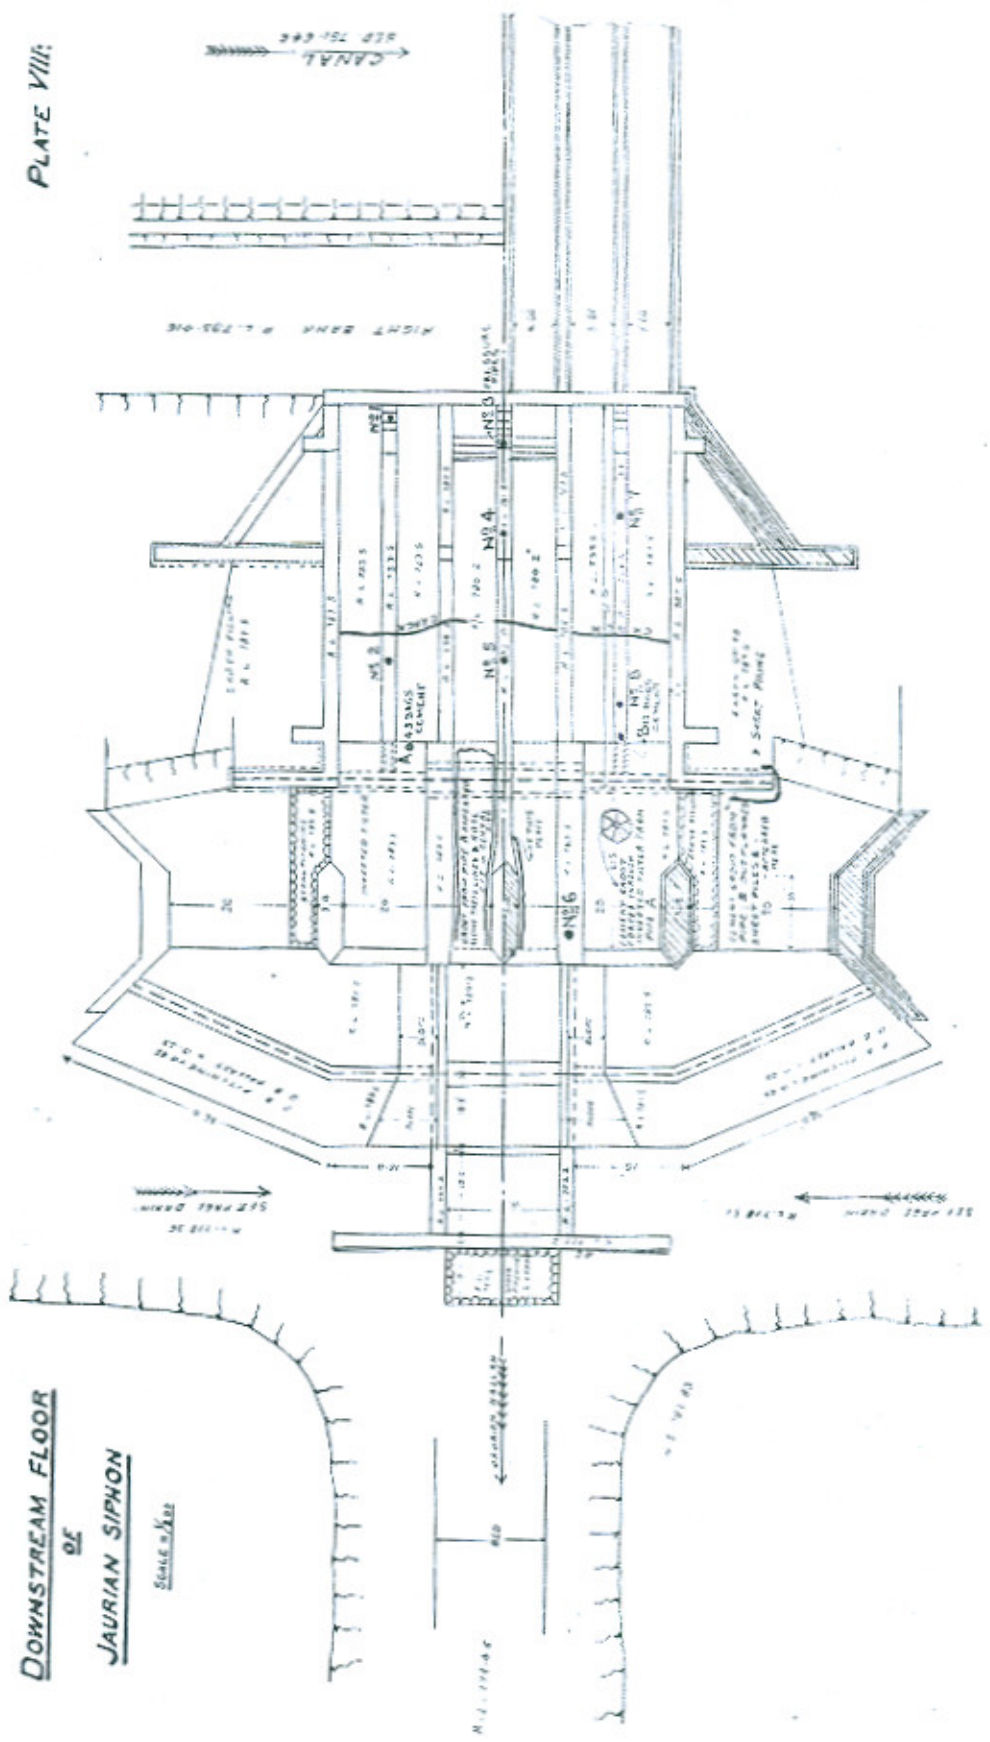
DOWNSTREAM FLOOR
OF
JAURIAN SIPHON

The positions of the grouting pipes have been given in plates VIII and IX. The downstream floor was treated first with very satisfactory results. Grouting was commenced with pipe A in the right half high floor (see plate VIII). This pipe consumed 43 bags but grouting was stopped at this stage when a quantity of grout suddenly burst through the inverted filter on the left side, immediately above the railway bridge.

The grout, in this case also, went past the sheet piles and, it is presumed, under them as in the case of Dugri siphons. Before this stage was reached, however, it was noticed that grout had found its way along the cunette and in addition to coming out on both sides of the central railway pier at its junction with the cunette floor, it had also risen to a height of 5 feet above the cunette floor through the masonry of the central pier till finally all cavities had been tamped. Pipe B was next treated but the results here were not satisfactory as the grout outflanked the line of sheet piles from the extreme left after only 12 bags had been pumped in and burst out downstream of the left wing wall as shown on the plan.

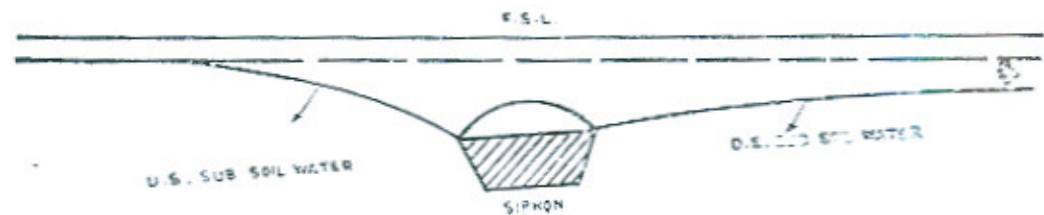
The next point is about the author, is observations on the drop in the water level between the upstream and downstream points of the Jaurian Syphon. If I draw a section through the subsoil watertable parallel to the canal at this syphon it will be something like this.

The drop in the upstream and downstream waterlevel is 2.6 ft. and the increase in what the author calls the loss of head between the upstream and the downstream points is also 2.6 ft. This shows that this drop is due to the draining action of the syphons and not as the author supposes on page 155 as follows :—
