## PAPER No. 253

### OBSERVATIONS ON LINED (HAVELI) CANAL

BY SOM NATH KAPUR, I.S.E.

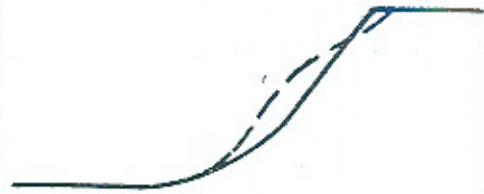
**FIG. 1**

In Summer of 1939 after a rain fall the canal showed two bulges at R. D. 39,000 and 46,000. In both these reaches high spoil banks existed behind the banks and it was considered that rain water had gone behind the lining and bulged it, as per sketch in margin. These bulged portions were dismantled and relaid. It appeared that surface drainage of top of lined canal banks was an important factor and needed serious consideration.

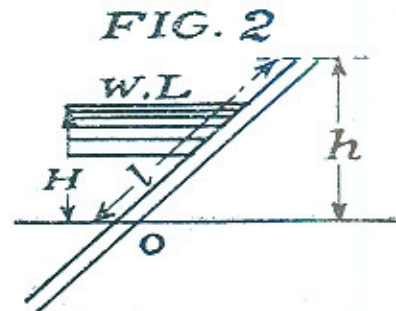
Consider a 6 inches thick lining with water pressure  $h$  &  $H$  on the two sides. Taking moments round point  $O$ .

Resultant moments in case of equilibrium are :—If  $w$  &  $W$  be the weight of water and lining per c.ft.

which means that lining will not be able to stand a head of more than 1.6 ft. If therefore water gets behind the lining either as a result of rainfall or wave action the lining will be pushed forward and will probably crack somewhere below the N. S. It is seen that the sides and bed are continuous, this might also result in water getting under the lining and the section would be subjected to stresses as per sketches and in addition to cracking the sides may also tend to lift the bed.

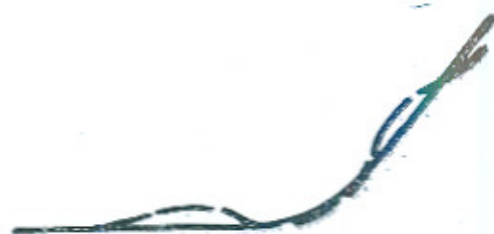
FIG. 5

It also points out clearly that the section should be statically sound and suitable to withstand the pressures that may come on to it if the bank recedes or water enters behind it. To prevent cracks subsequent to segregation and the lining functioning as a cantilever with the weight of water on it a steep side slope would be desirable as it would provide less weight and less moment arm against overturnings but to prevent water entered behind overturning the lining, a flatter side slope would provide more resistance due to greater weight and longer moment arm.

It is also a matter of consideration how in an unsupported section the weight of sides would be transferred over the curved section on to horizontal bed and if this would not tend to cause a distortion as shown and it would appear desirable to construct the sides founded on toe walls independent of and weighted by the bed.

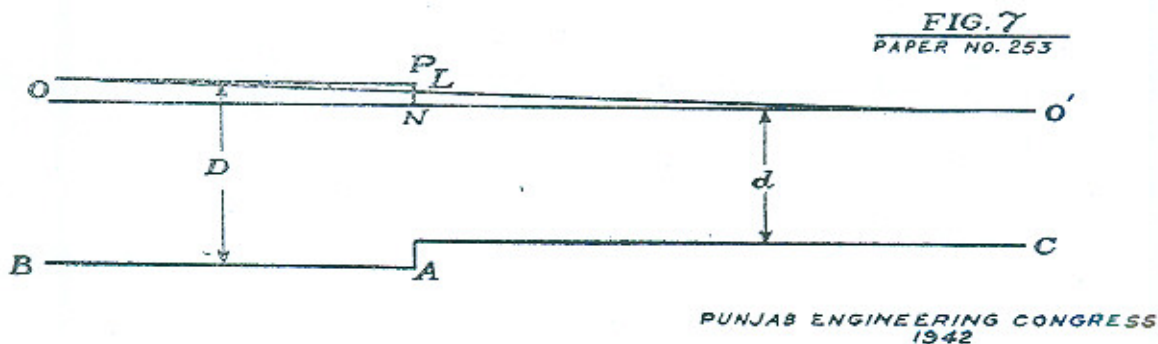
It would seem that the velocity increases in certain sections and if the water line were to be constant it would mean a jump in total energy line which is not possible and therefore afflux is caused at all these sites.

Reach 2,000 to 20,000 produces a hump and at low supplies it must therefore cause considerable afflux. Further these abrupt changes must cause a certain amount of afflux as explained below. Let  $OO'$  be the supply line with no discharge off-taking at A and let depth ( $d$ ) be the natural depth for this discharge for the section. If discharges in reach BA is increased to correspond to a depth  $D$ , there will be no drop at point A and water line would follow  $OLO'$  and N. L. would measure the afflux.

It would, therefore, seem desirable that design should provide decreasing velocities towards the tail and the changes in sections if there is to be no drop in water levels should be smooth and gradual and should cover about 500 Lft. of the channel so that transition is gradual and causes no afflux.
