SAFETY OF SO-CALLED SMALL DAMS IN PAKISTAN

**BY
Altaf ur Rehman**

Altaf-ur-Rehman¹

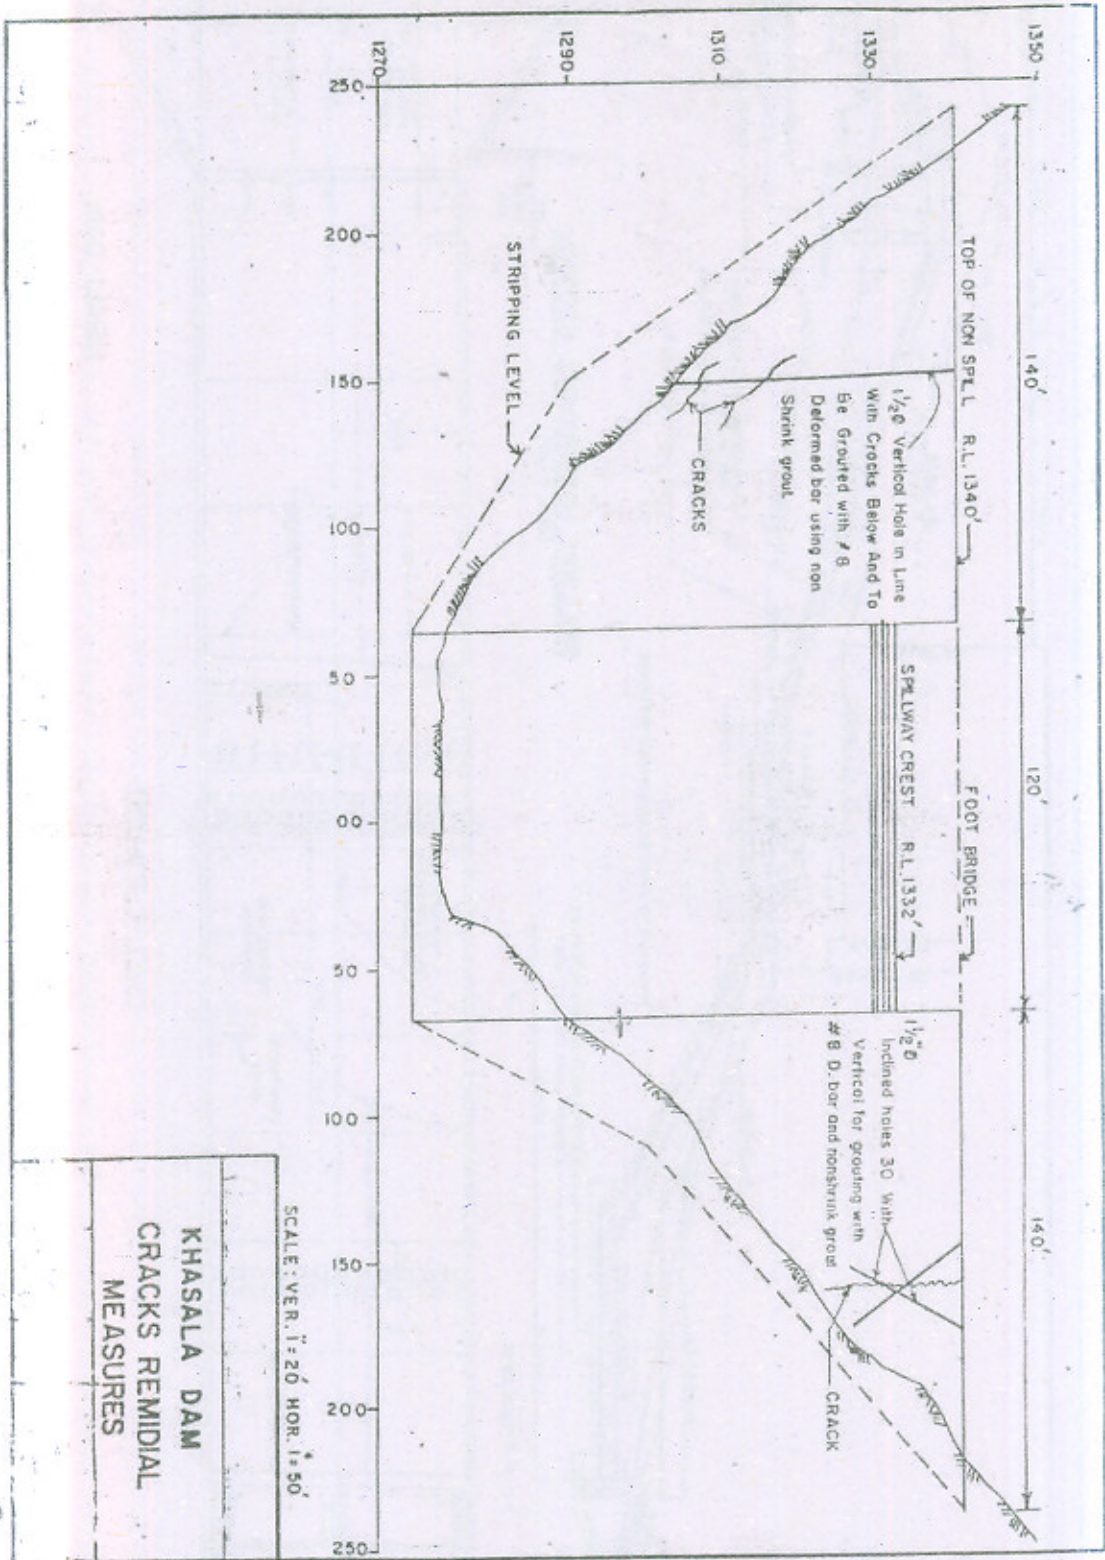
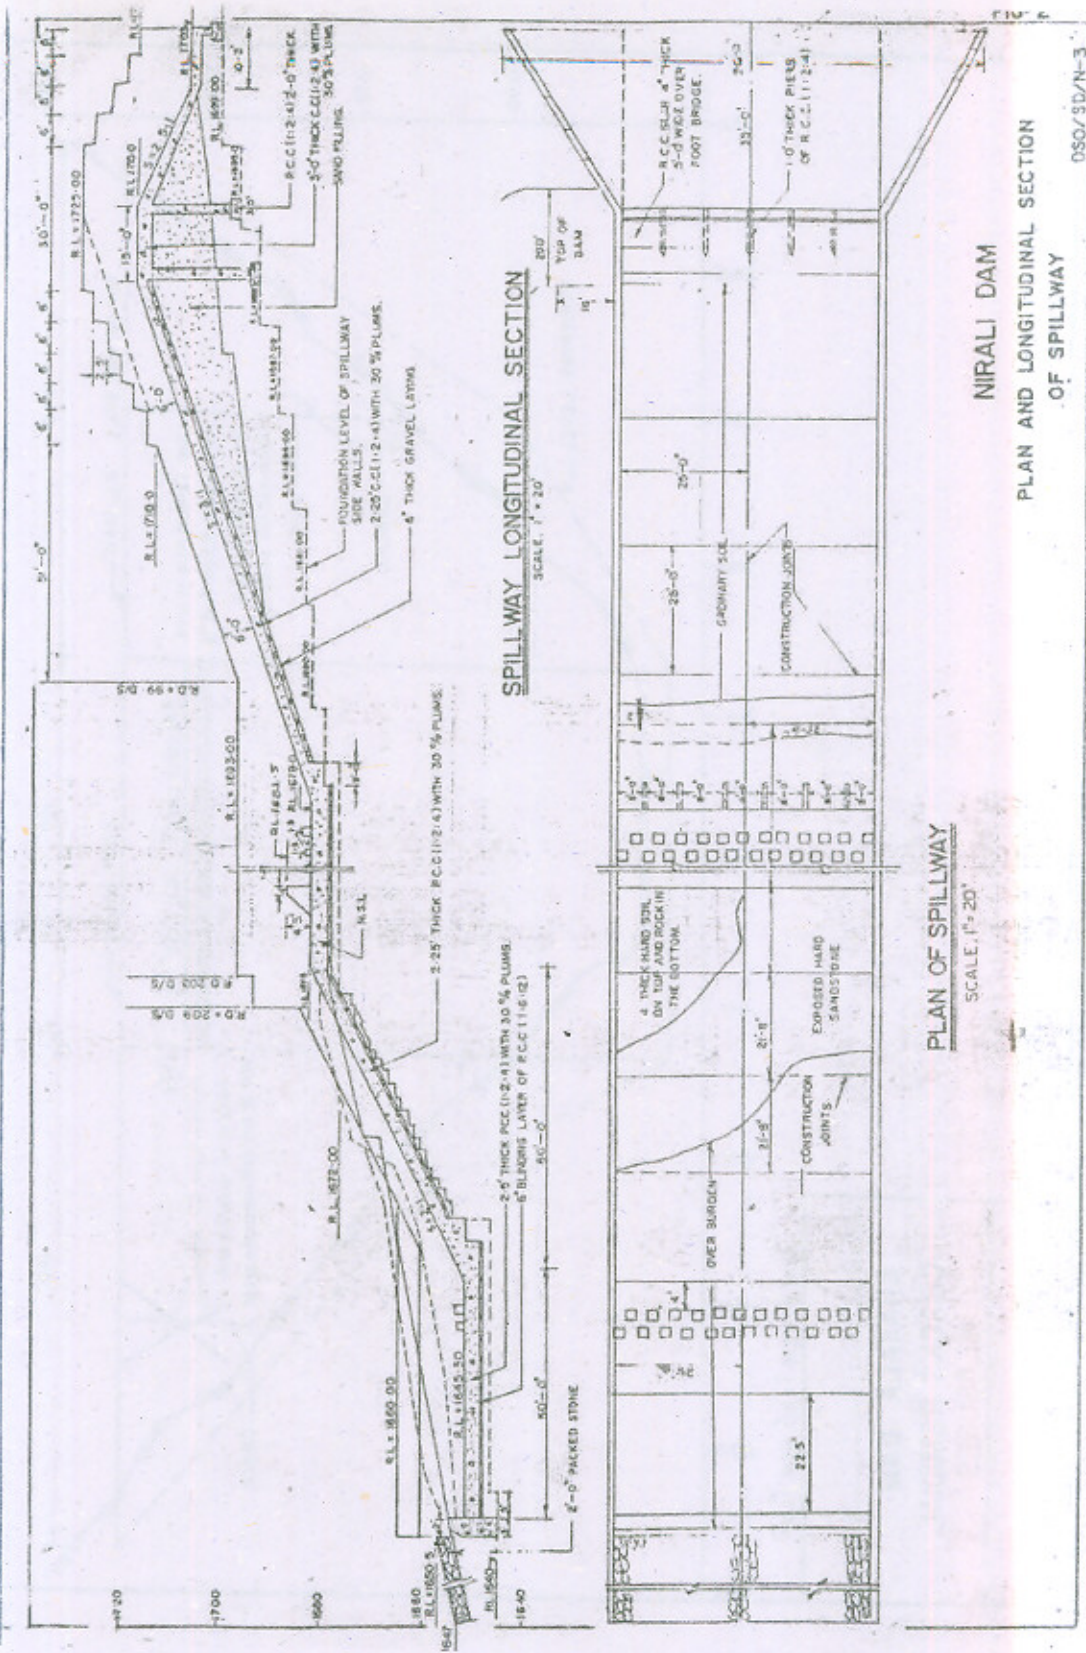
NIRALI DAM
PLAN AND LONGITUDINAL SECTION
OF SPILLWAY

Nirali Dam is 77 feet high built in 1970. Nirali dam spillway has been saved by timely action. The upper chute was laid on sand fill loosely compacted. Leakages at toe of stilling basin was known figure 1 but no action was taken to investigate the cause. Typical example of lack of review of design..

Dhok Talian and Nirali spillway would have been saved by Review of Design.
