**DAMAGES TO THE
RIGHT POCKET OF SUKKUR BARRAGE AND
EMERGENCY RESTORATION WORKS (2004-2005)**

**Barkat Ali Luna, Malik Ahmad Khan, Ch. Muzaffar Hussain,
Dr. Muhammad Salik Javed**

SYNOPSIS

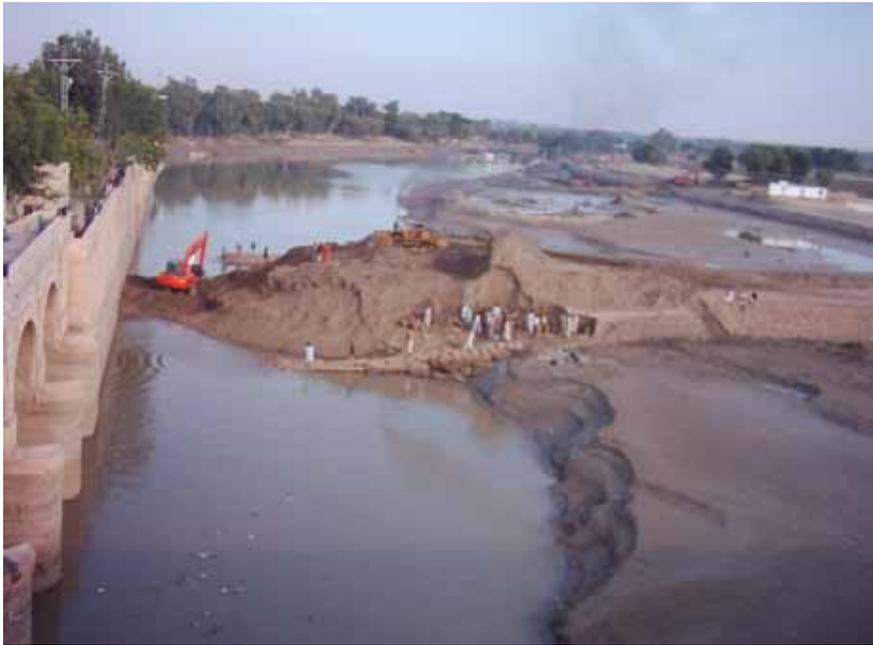
Upstream Cofferdam under Construction

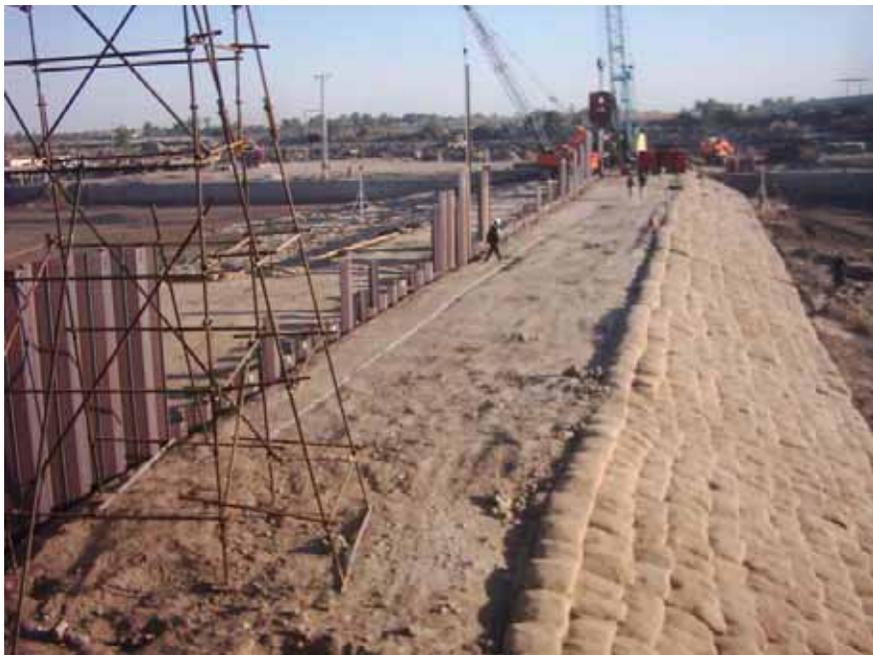
Sheet Piles in Upstream Cofferd Dam

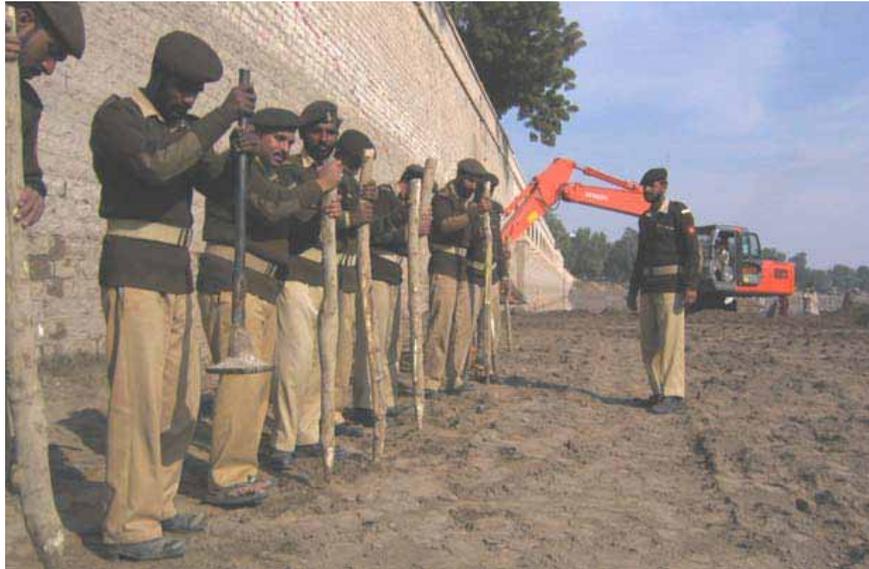
Puddling in progress

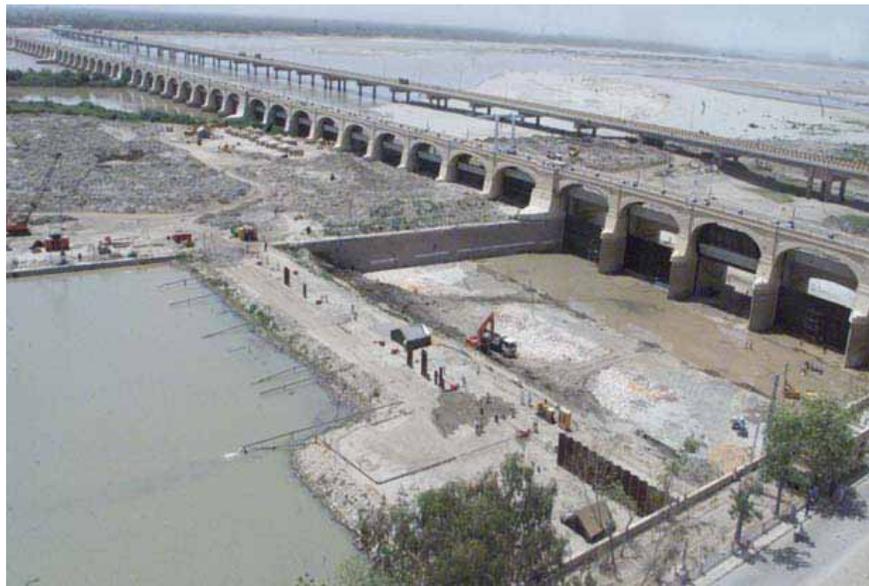
Completed Upstream Cofferd Dam

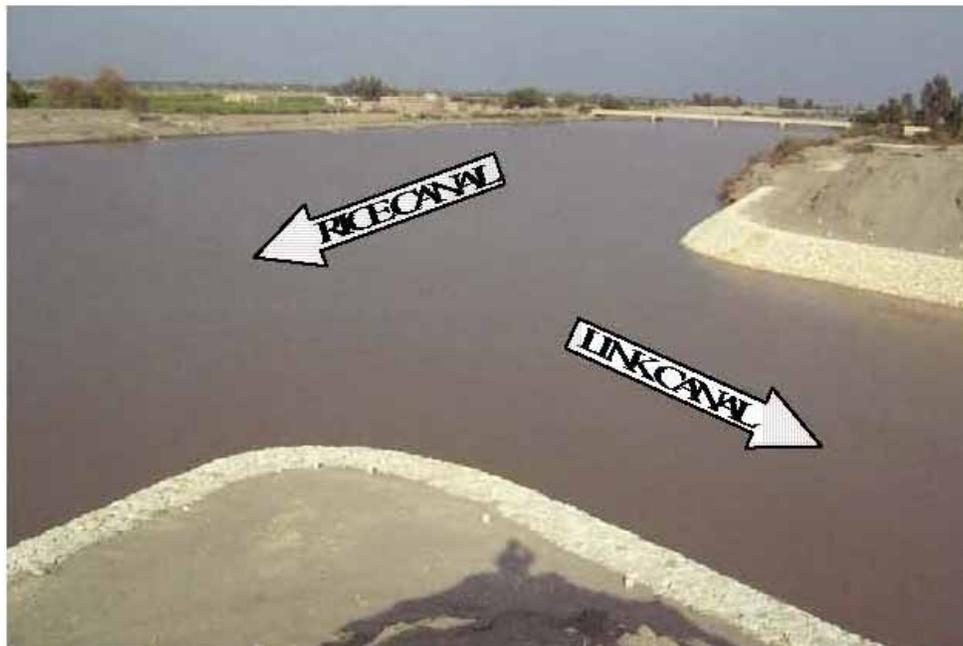
Link Canal at Ruk Complex

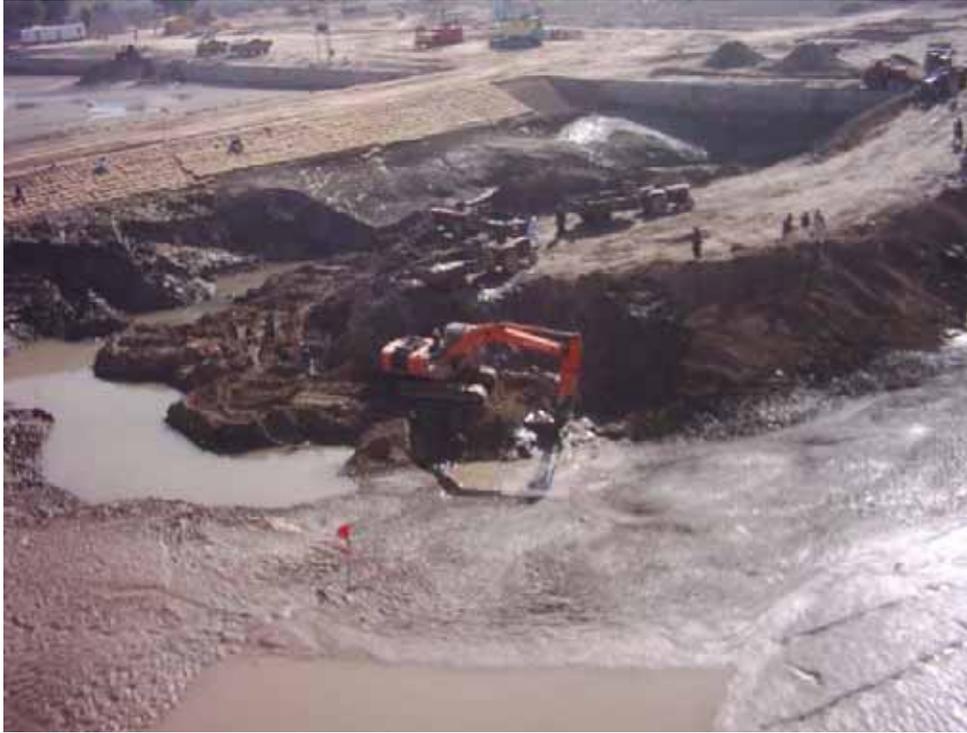
Removal of Silt/Debris from the Right Pocket

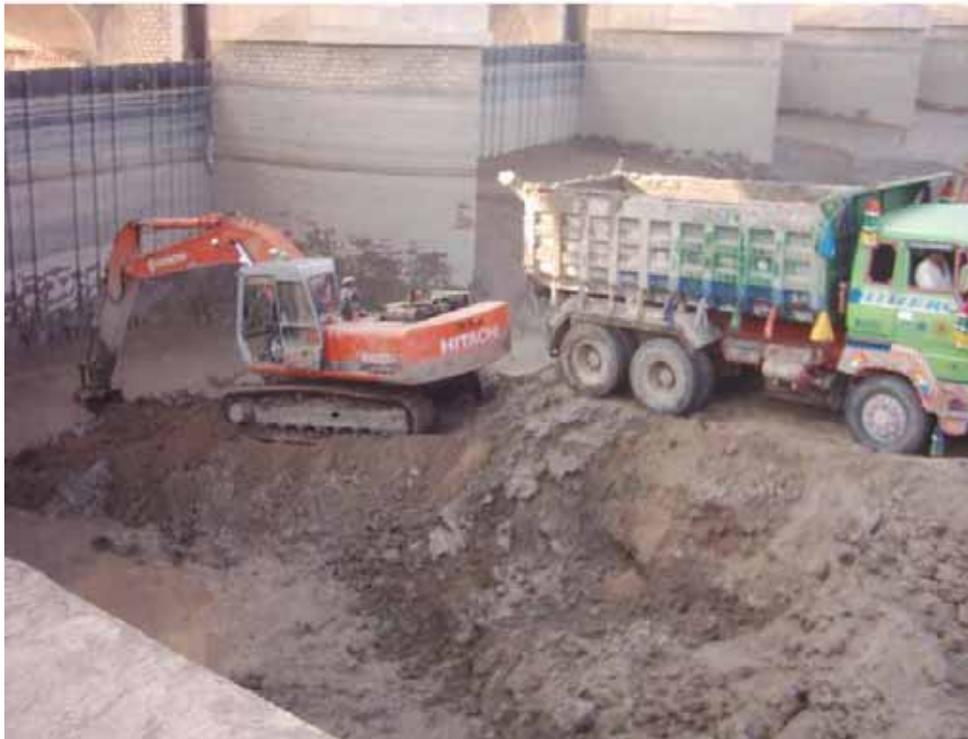
Removal of Silt/Debris from the Right Pocket

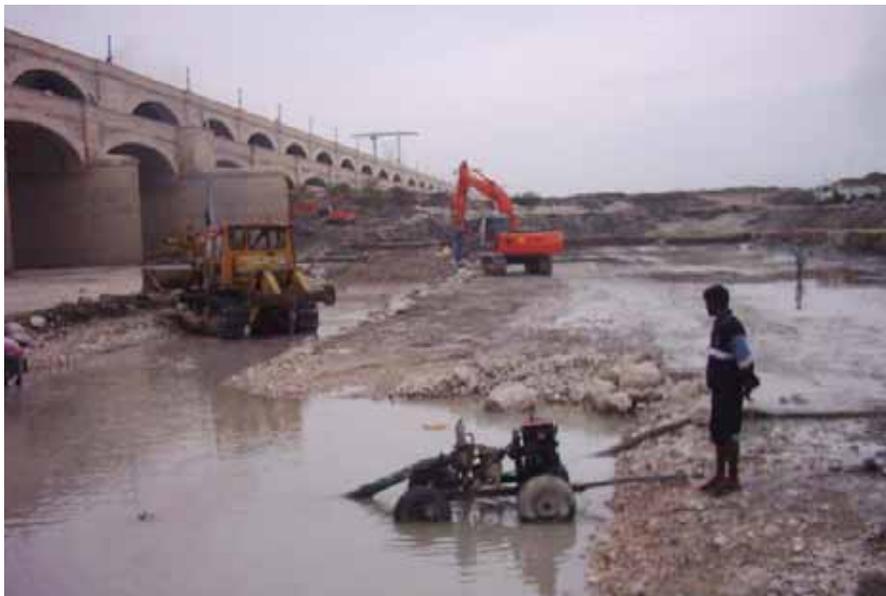
Bailing out Surface Water

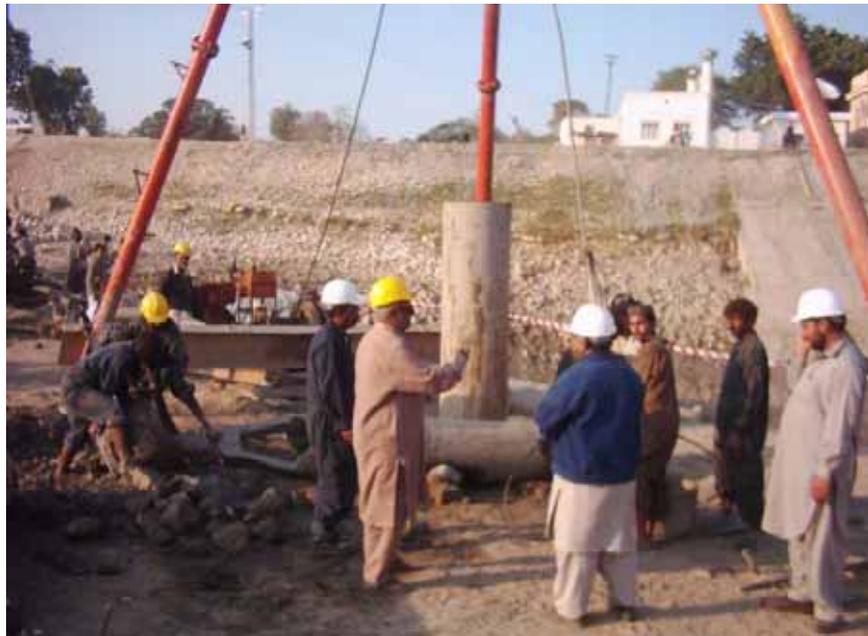
Tubewell Drilling in Operation

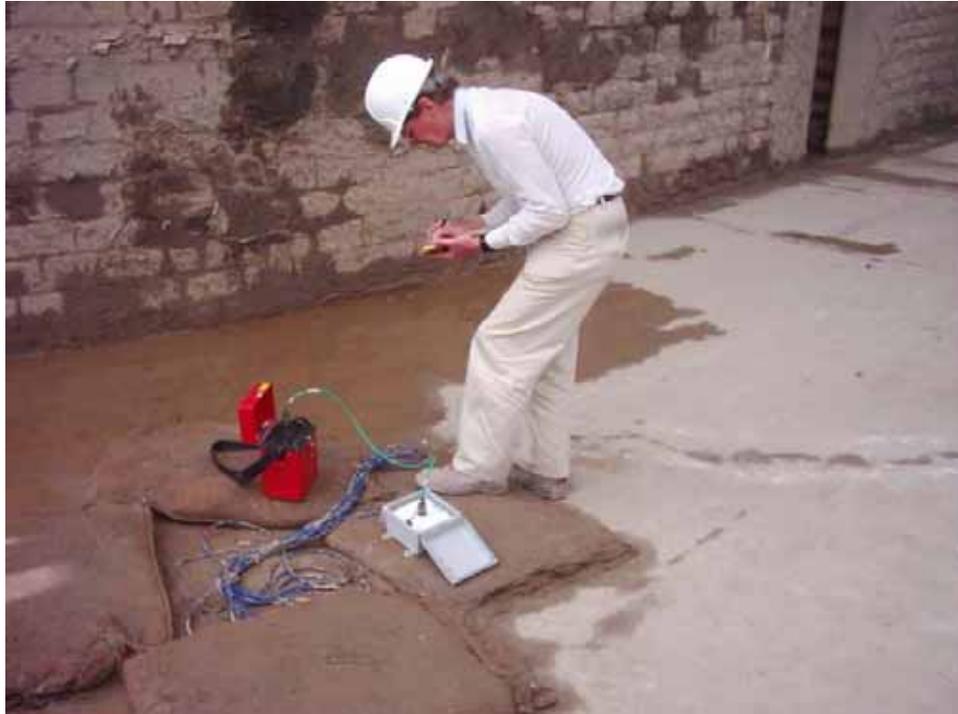
Observations being taken on Piezometers

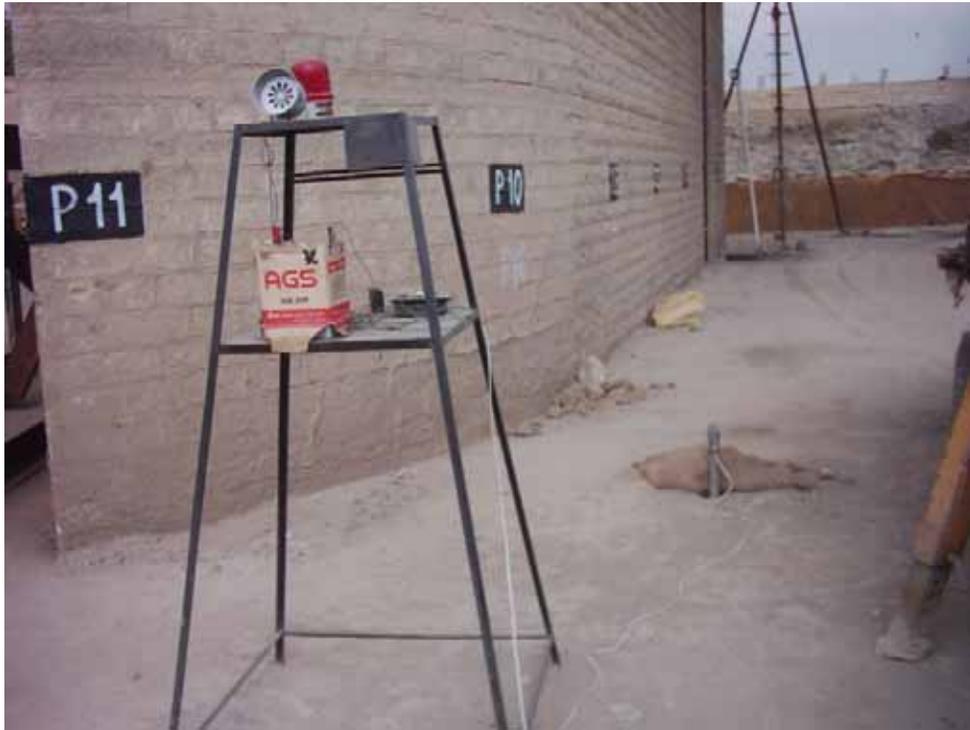
Automatic Alarm System

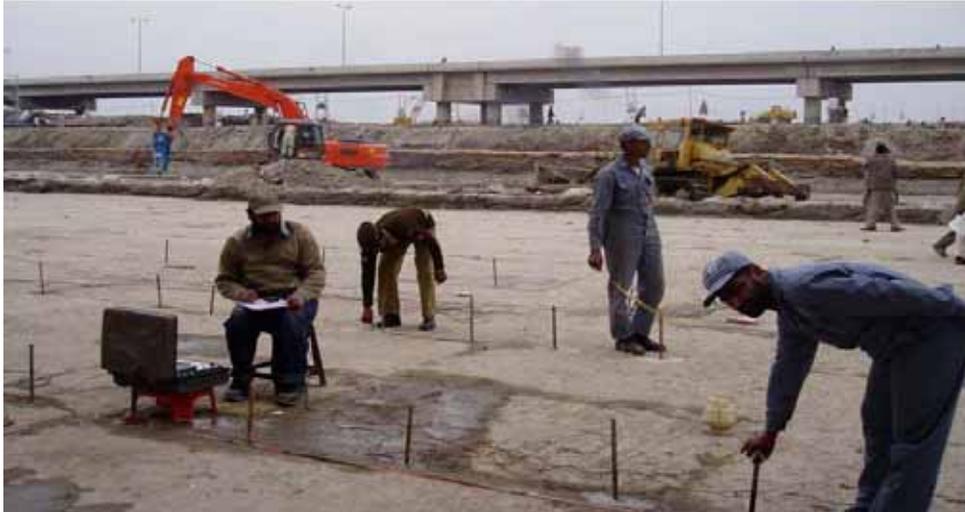
Geophysical Survey Activities

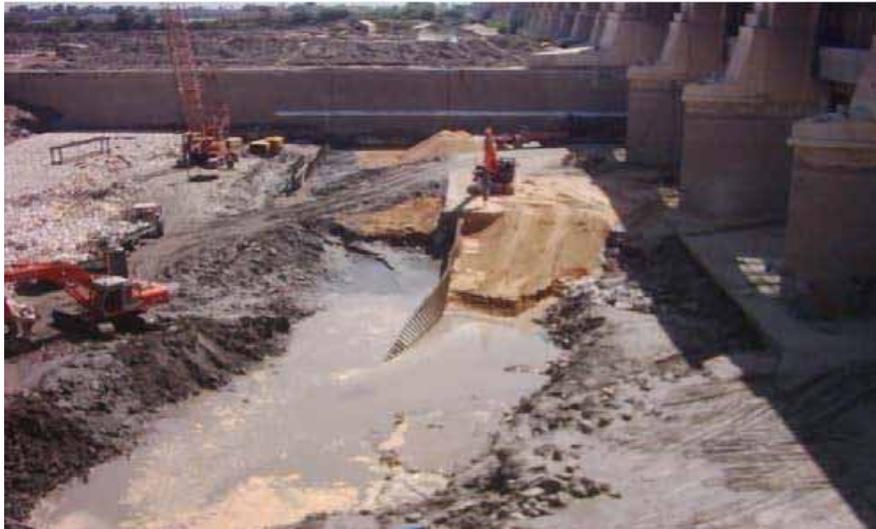
Sand Filling and Compaction at a Glance

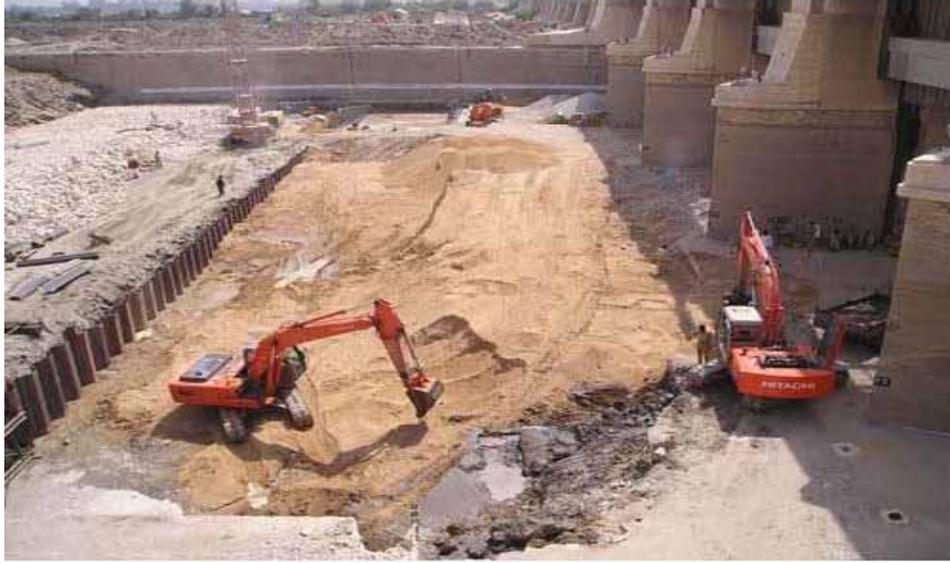
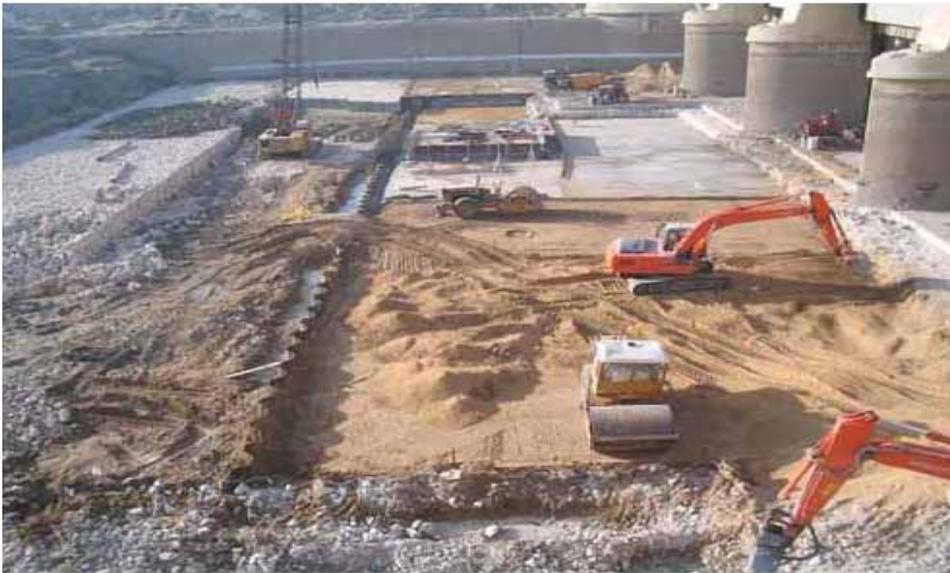
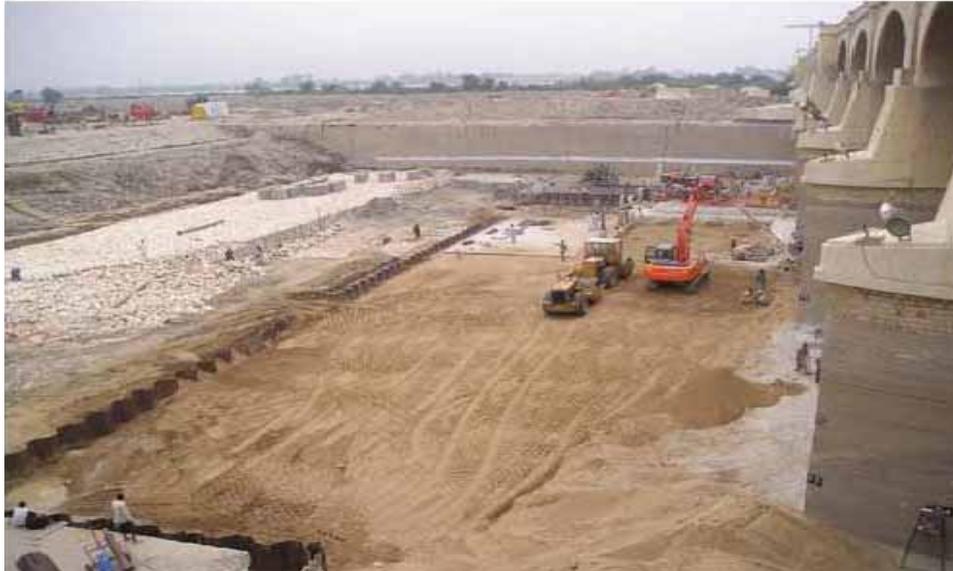
Sand Filling and Compaction at a Glance

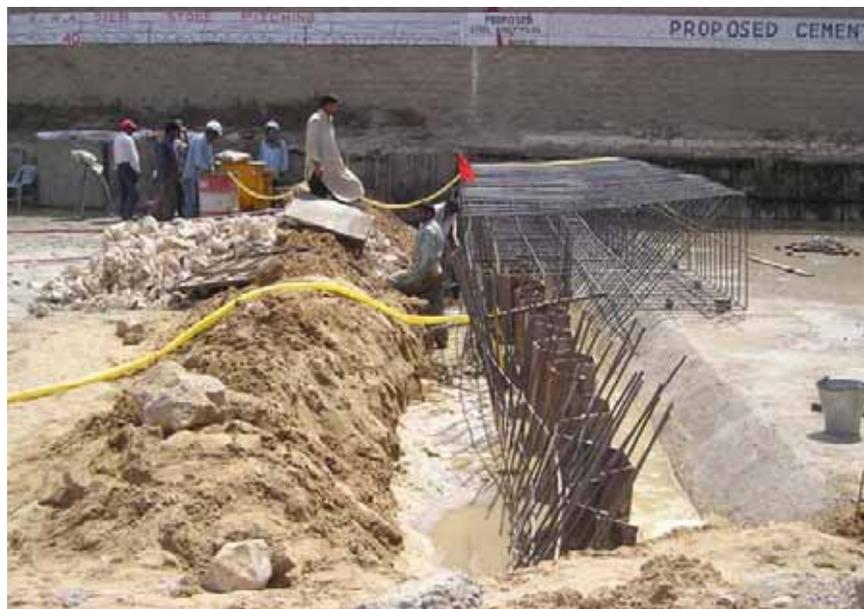
Upstream Sheet Pile Cap

- i) **Sheet Piling at Upstream End of Extended Floor:** A new line of sheet piles was driven at the upstream end of the extended floor in the right pocket. These sheet piles were driven to different levels (depth below top of floor varying from 17 feet to 30 feet) below the floor upto firm strata which was encountered below E.L 159.0. Reinforced pile capping was provided for proper anchorage. This cap was not provided in the earlier design.

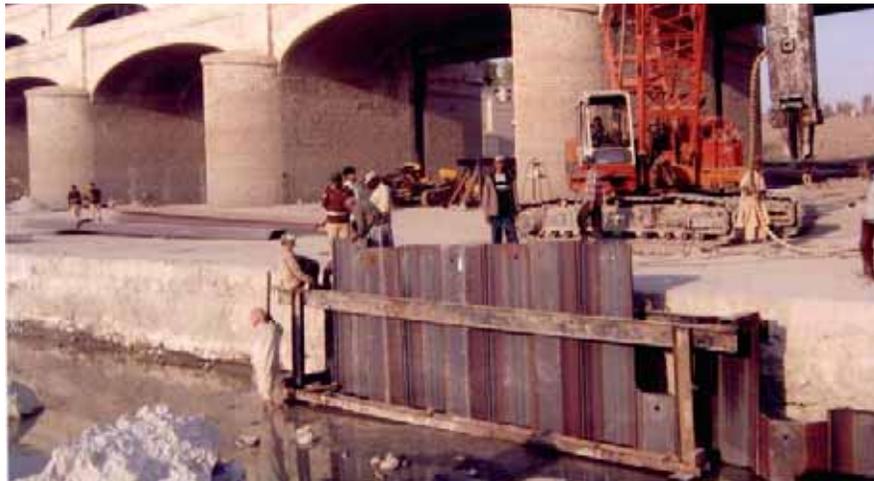
Driving of Sheet Piles in Progress

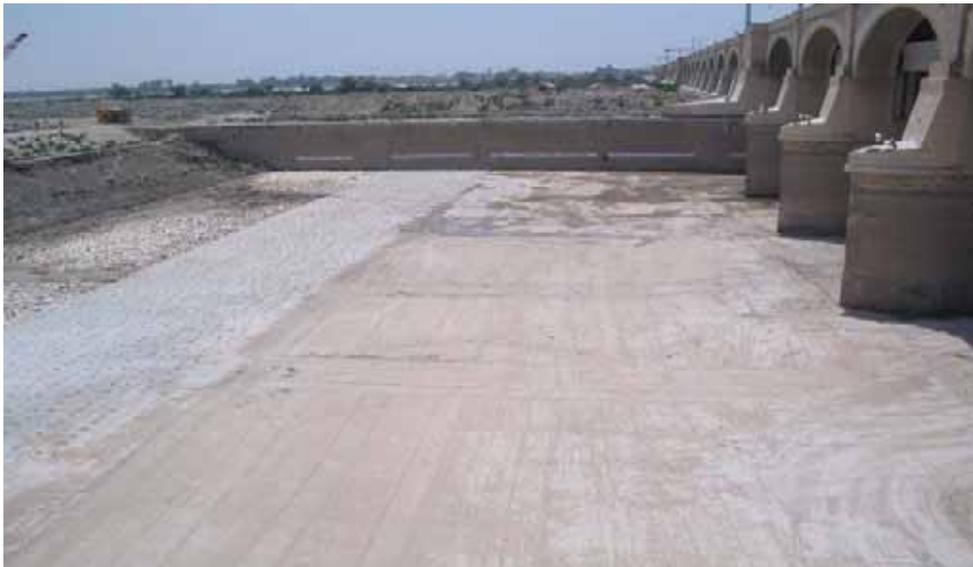
A View of New Concrete Floor after Rehabilitation

A four thousand (4000) psi concrete was used and strict laboratory control was exercised by taking concrete samples in cylinders at regular intervals and slump was also taken frequently. Double water stoppers were provided to safeguard against possible leakage through the joints.

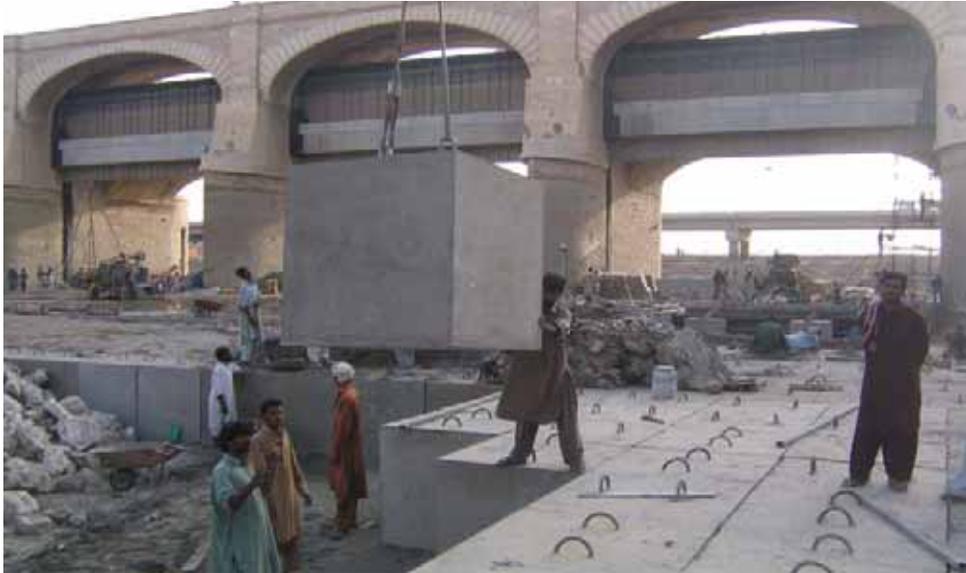
Placing of Blocks Upstream of Barrage

In the original design, only stone apron 6.0 feet thick was provided on upstream side in a length of 50 feet. After the damage, it was considered necessary to provide heavy concrete blocks which could counter swirling action immediately upstream of the concrete floor. Settling blocks 4'x4'x4' were specially manufactured and placed upstream of the concrete floor in a length of 40 feet over 2.0 feet stone apron. No space was left in between the blocks. These blocks were casted in a separate yard using sulphate resisting cement and Sekament 163 as accelerating agent for quick setting. The compressive strength was kept as 3000 psi. The strength was checked frequently to monitor quality.

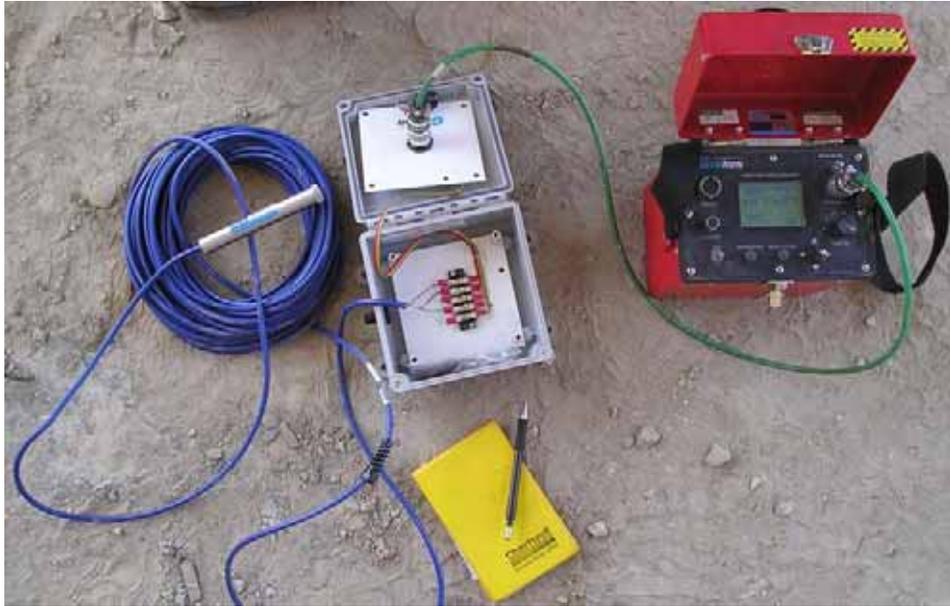
Vibrating Wire Piezometer along with Accessories

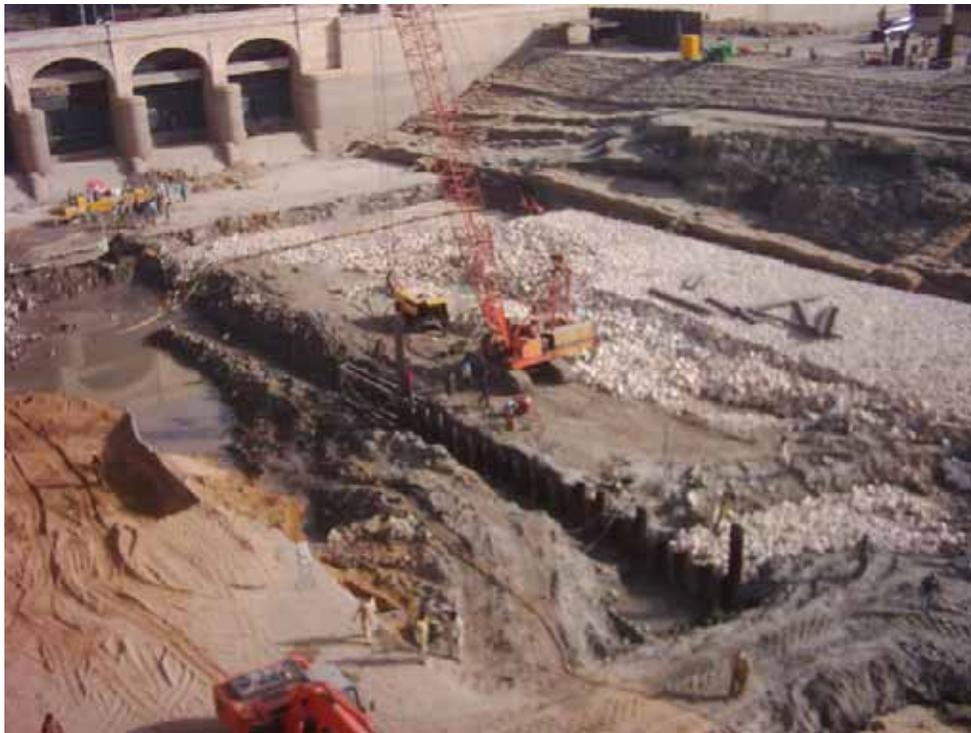
Upstream Stone Apron

The stone apron in 6 ft depth and 60 ft. length placed upstream of extended concrete floor was re-constructed with proper size stone. Similarly, stone apron downstream of the settling blocks placed over inverted filter was replenished to design depth of 6.0 feet.

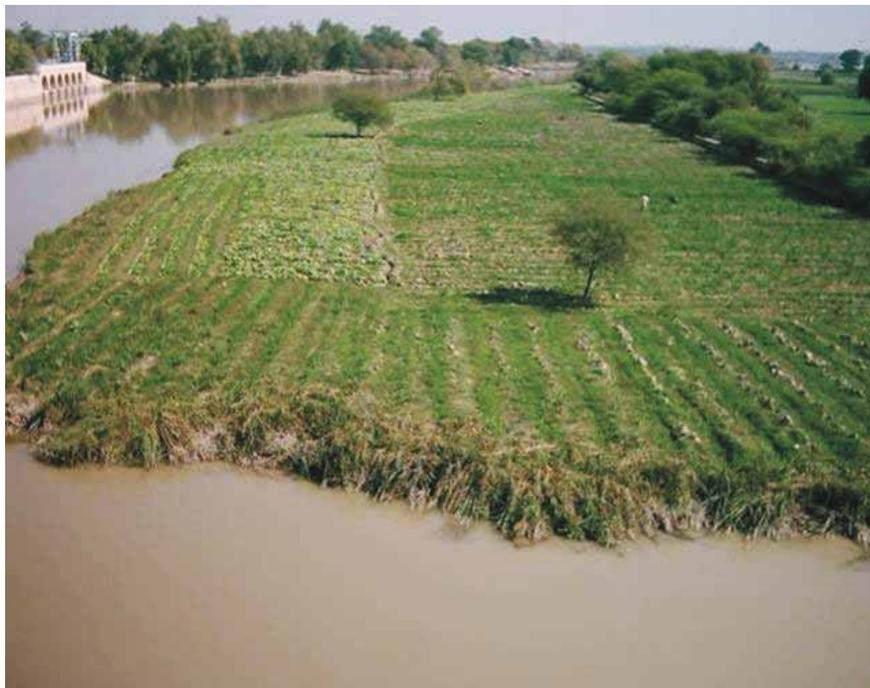
- i) Still pond system of regulation at Sukkur Barrage caused sediment deposits in the pocket which could not be cleared due to inadequate flushing operations through the pockets. As a result heavy bela formation in the right pocket caused drastic reduction in the available water-way from about 350 feet to 70 feet leading to sharp increase in discharge intensity during passage of high floods when the under-sluices were opened.

View of Bela in Right Pocket before Emergency works

- i) As concluded above, formation of large belas in the pockets causing drastic reduction of the available water-way should not be allowed. For this purpose the two pockets must be kept clear of sediment deposits as far as possible by carrying out flushing operations as and when required as per guidelines laid out in the regulation rules. Since frequent flushing closure of the canals is not admissible in the peculiar conditions of the areas served by the canals at Sukkur Barrage, special arrangements must be made for dredging of the pockets on regular basis. For this purpose, the Sindh Irrigation Department must arrange dredgers for dredging pockets of the Barrage and any other untoward shoal formations at sensitive locations elsewhere at the Barrage. A plan showing the areas to be kept clear of sediment deposits by flushing and dredging on an annual basis is enclosed as Figure 7.1. This plan can be modified based on the operational experiences in future and should be approved by the Chief Engineer Incharge of the Barrage.

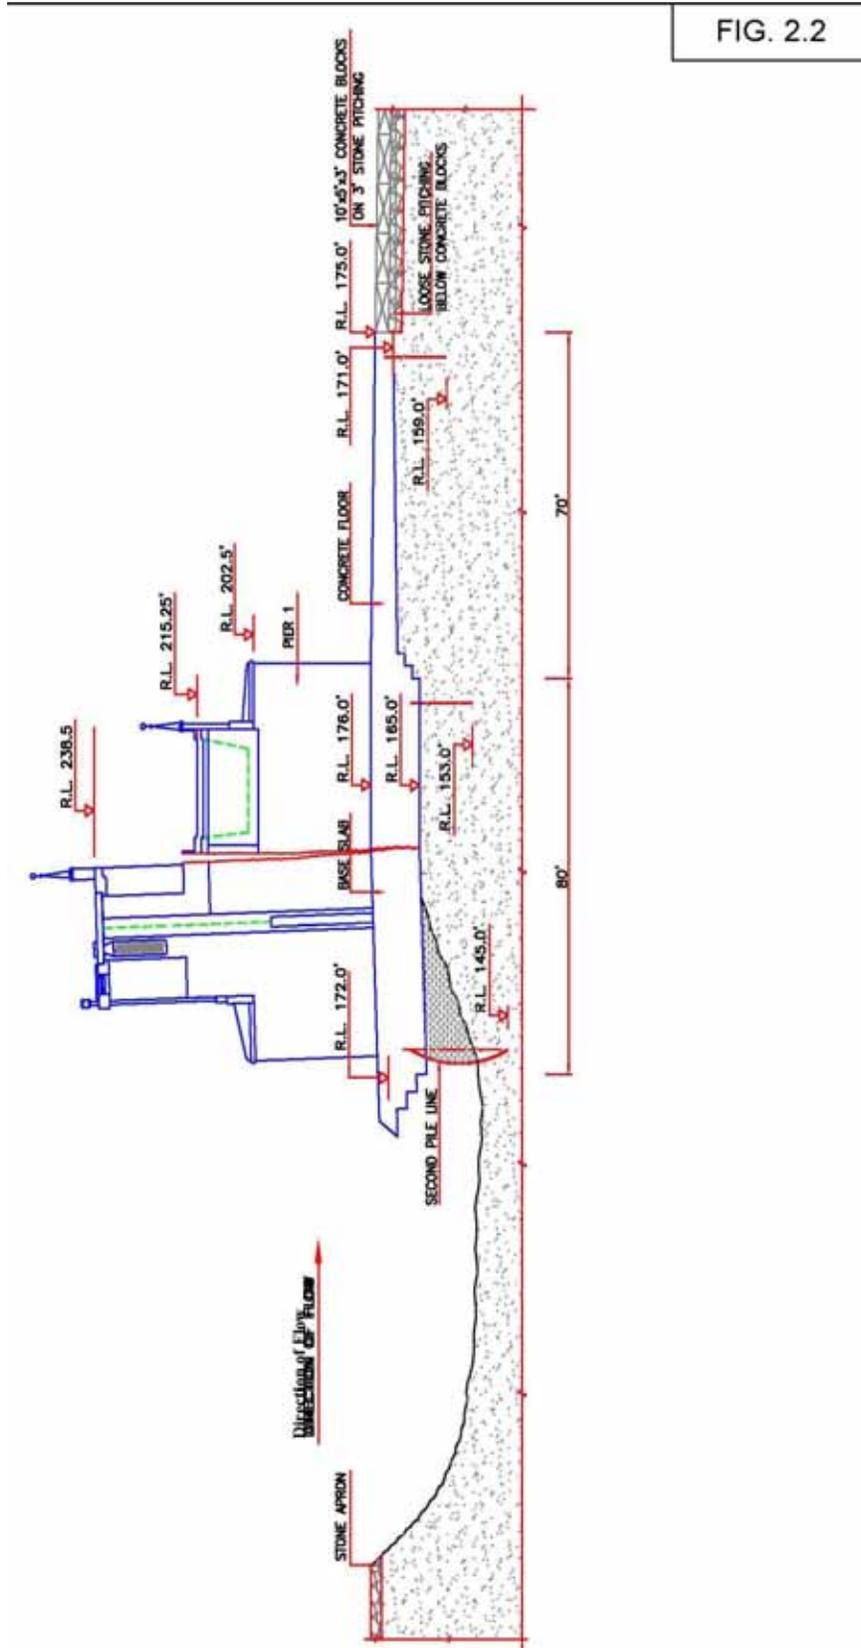
FIG. 2.2

The canals of Sukkur Barrage are closed every year normally from January 06 to 21 to facilitate detailed inspection of under water works and appurtenant components of the Barrage and to provide adequate repairs if any damages are detected. During the annual closure of 2004, while taking soundings in the right pocket u/s of the Barrage on Jan. 12, 2004, a scour pit measuring 60' x 40' x 9' (Av.) with a maximum depth of 22 feet was discovered in front of Bays No. 1, 2 and 3. The extent of the damage was so grave that the upstream stone apron, first sheet pile line, and part of the concrete floor reaching proximity of the upstream nose of the piers had disappeared in the pit. It was further noticed that the scour pit had extended up to the second line of sheet piles under the Barrage. Similarly a cavity had formed under the floor in front of the Head Regulator of Dadu Canal. The situation was interimly controlled by dumping stone in the pit and limiting the head across to 14 feet against the design limit of 18.5 feet, till such time that the proper rehabilitation works were planned and carried out. A plan and cross-section of the right pocket showing the scour hole are given in Fig. 2.1 and Fig. 2.2 respectively.

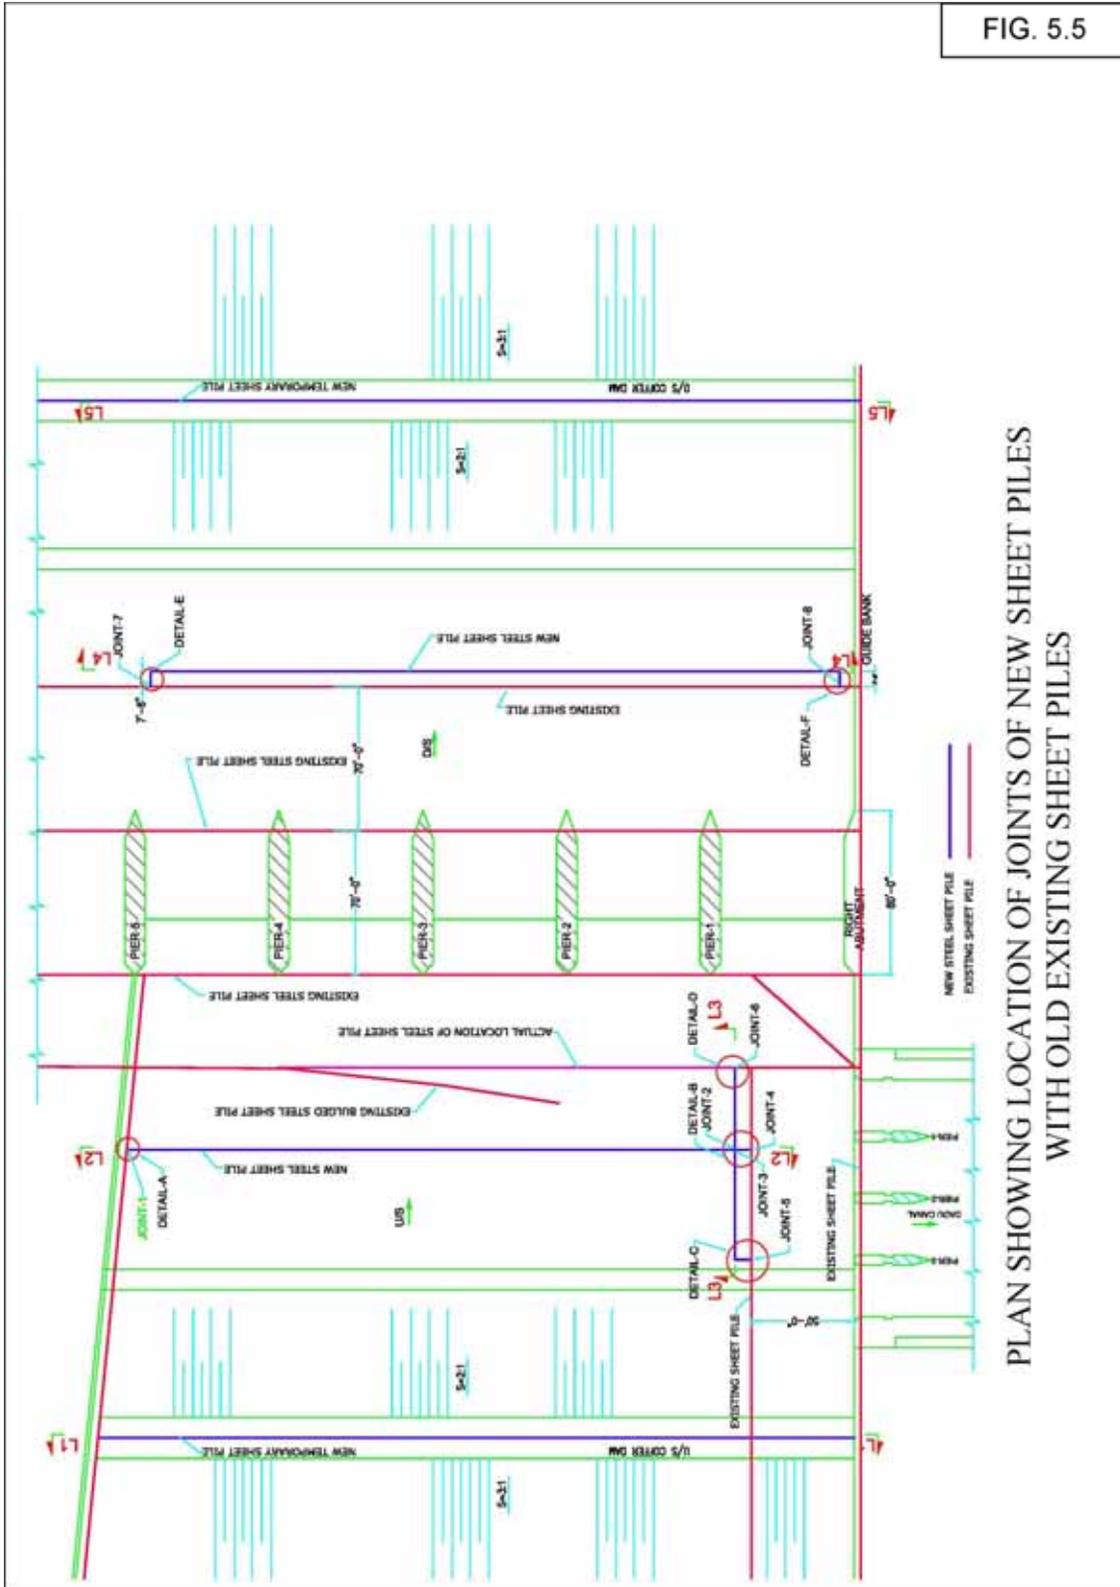
FIG. 5.5

PLAN SHOWING LOCATION OF JOINTS OF NEW SHEET PILES WITH OLD EXISTING SHEET PILES

It was a matter of great concern for the Employer and the Consultants to find foolproof method for jointing old and new sheet piles. Different methodologies were considered but during driving of the new sheet piles and after the old sheet piles were exposed, better methodologies were devised on the spot for each joint which proved very effective (Ref. Fig. 5.5 and Fig 5.6) .
