**GEOTECHNICAL EVALUATION OF A MORNING  
GLORY SPILLWAY FAILURE FOUNDED ON  
EXPANSIVE  
AND DISPERSIVE CLAY**

**Farhat Javed, Brig. Asghar Nasim**

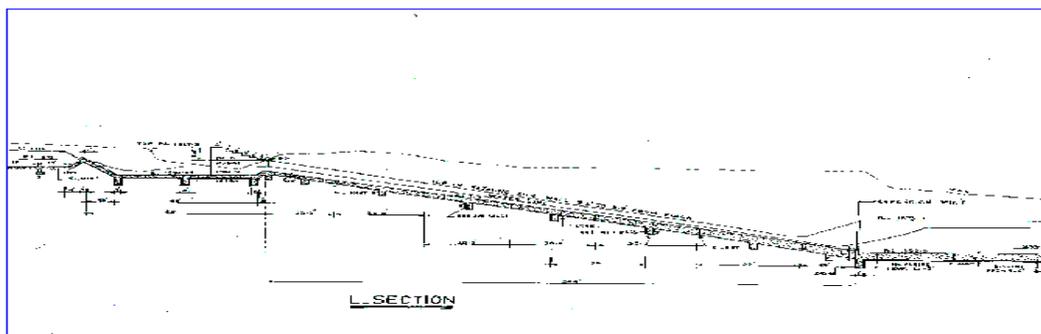
### Figure 1(c). Cross section of the spillway (pl. blow up for details)

A stilling basin has been provided at the down stream end of the spillway to induce hydraulic jump for proper dissipation of energy. Two bore holes were put down in the spillway area and it was concluded that the rock units in the spillway area are the same as those at the dam site i.e., alternating beds of sandstone and clay are present in the spillway area as well. The alignment of the spillway structure is across the strike direction. The concrete spillway structure rests mostly on clay beds except for the last two rows of concrete panels and stilling basin that rest on sandstone bed.

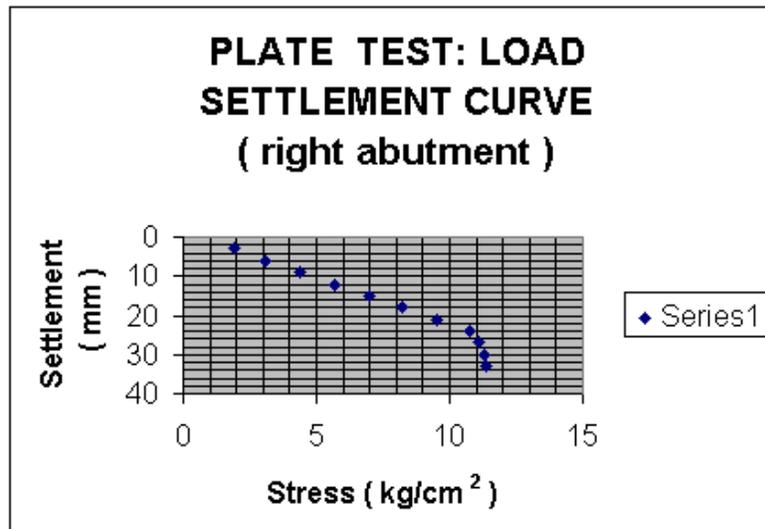
Figure 2. Results of plate load test

Standard penetration tests conducted on the foundation material yielded average blow count of 40 for 3 m depth. The corresponding allowable bearing capacity is 4.8 kg/cm<sup>2</sup> under undisturbed state. The same soil yielded a low blow count of 7 when the foundation was saturated yielding allowable bearing capacity of 0.7 kg/cm<sup>2</sup>. Equation proposed by Peck et al., (1974) for 25 mm settlement was used for these computations. Plate Load test conducted in the field in dry conditions on the U/S of the spillway crest yielded ultimate bearing capacity of 11.4 kg/cm<sup>2</sup> corresponding to 25mm settlement (Fig 2). Unconfined Compression test was conducted on nine undisturbed specimens carefully carved out of block sample. These tests yielded average unconfined compression strength of 12 kg/cm<sup>2</sup> which is in conformance with the results obtained from SPT and plate load test. Unconsolidated Undrained Triaxial Tests were conducted on two specimens. These specimens were saturated prior to shearing and yielded undrained strength of 0.9 kg/cm<sup>2</sup>. This indicates that saturation of this material can cause ten times reduction in compressive strength. Free *swell test* (Katzir & David, 1968, Das, B.M, 1990 ) was conducted in the odometer cell under a small surcharge of 0.07 kg/cm<sup>2</sup>. The test was conducted on two specimens (Fig 3) and for each the specimen swelled from original height of 20 mm to 22 mm. The swell is, therefore, 2 mm and the value of free swell comes out to be 10%. The swell pressure of Surla shale was determined through the *restrained swell test*. The specimen was placed in an odometer under a small surcharge of about 0.07 kg/cm<sup>2</sup>. The load on the specimen was increased periodically after it was inundated so that the height of the specimen remained constant. The vertical stress necessary to maintain Zero volume change is the swelling pressure. When this test was conducted on Surla clay it yielded a swell pressure of 1kg/cm<sup>2</sup>. The final moisture content of the specimen was 14.4 %.

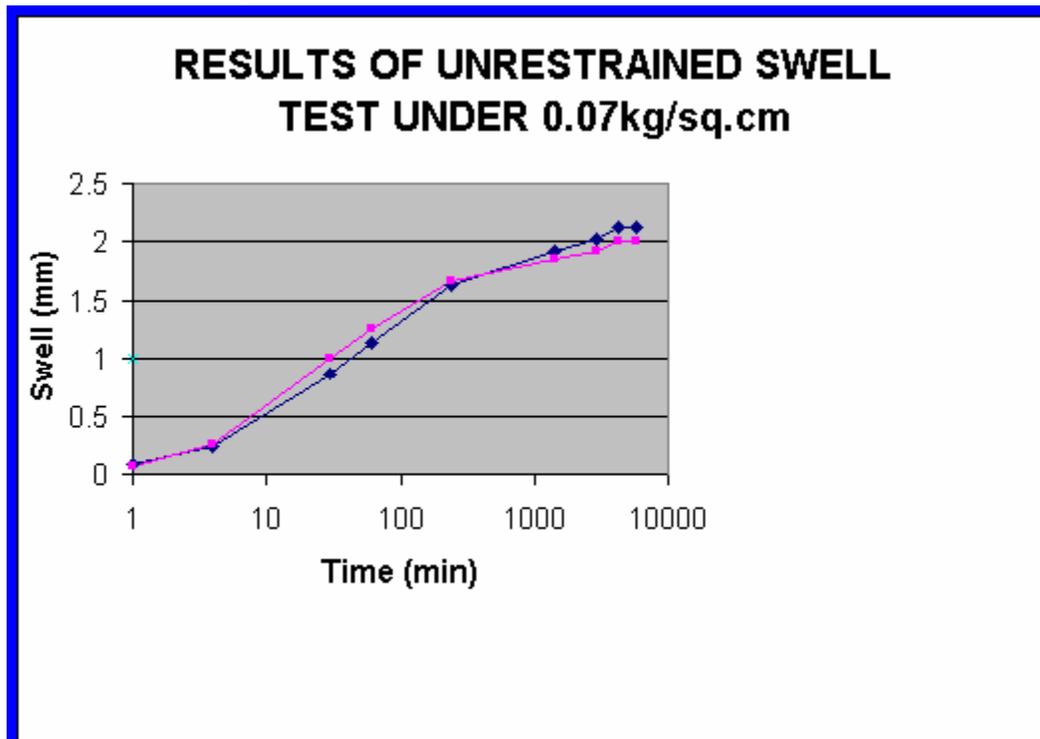
Figure 3. Results of unrestrained swell test

A number of unrestrained swell tests were also conducted on Surla clay. An initial pressure of  $0.1 \text{ kg/cm}^2$  was applied over each specimen to simulate field loading from the concrete slab. The specimen was inundated and allowed to swell. Once the swelling seized the specimen was loaded. The pressure required to bring back the specimen to the original height is the swelling pressure. Typical test results reported in Fig. 4 and Fig. 5 indicate that the average swell pressure is  $2 \text{ kg/cm}^2$ . The swell pressure from this test is roughly twice the swell pressure from

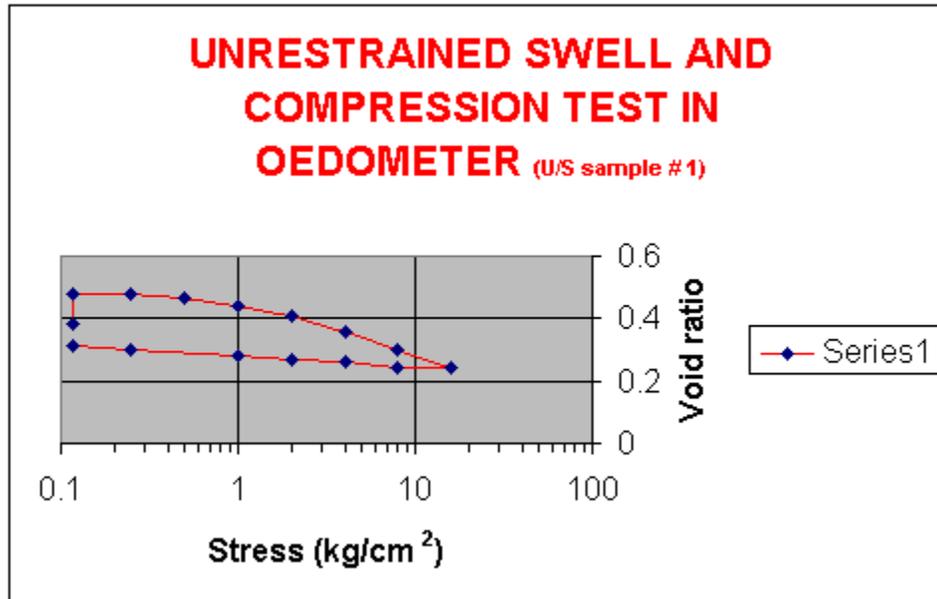
Figure 4. Results of unrestrained swell and compression test in Oedometer

the constrained swell test. The average value of  $a_v$  &  $C_c$  was determined to be  $0.005 \text{ cm}^2/\text{kg}$  and  $0.2$  respectively. Pinhole test (ASTM, 1998, Sherard et al., 1976) was also conducted on Surla clay to determine the erodability or dispersion potential. When the sample was subjected to 5 cm of head the out flowing water experienced a colour change implying that soil particles were coming out. Thus the soil has high erodability potential and is classified as D1 according to ASTM specifications.

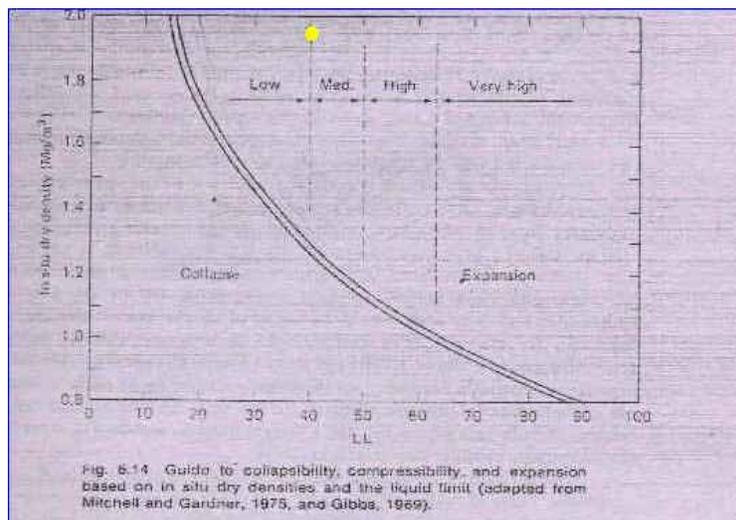
Figure 6. Liquid limit and in situ dry density of surla clay plotted on the curve proposed by Mitchell and Gardener (1975)

The region is frequented by collapsible soils and it was speculated that failure of spillway occurred due to soil collapse upon saturation. The consolidation test was performed on undisturbed samples collected from the U/S, middle and D/S portions of the spillway. These tests were expected to show collapse of soil structure upon saturation. On the contrary the soil expanded when it was saturated thus establishing that the foundation material is expansive clay. A number of methods and soil tests were used to confirm swelling characteristics of Surla dam clays. These included swelling tests and other simple laboratory tests and correlations with the classification and index properties of the soil. Swelling clays characteristically possess high liquid limit and plasticity Index. For the range of plasticity index of 15 to 28 and shrinkage limit of 10 to 16 the probable expansion of the soil is in the medium range. Thus the clay at Surla dam has medium swelling potential. Similarly when the liquid limit and in situ dry density of surla clay ( 40 and 1950 kg/m<sup>3</sup> respectively ) were plotted on the curve proposed by Mitchell and Gardener (1975) , the Surla clay plots as medium expansive( Figure 6). Seed, etal. (1962) developed the relationships (Fig.7) for artificial mixtures of sands and clays compacted to maximum unit weight by standard Proctor compaction and allowed to swell against a 6.9 kPa (1 psi) surcharge. These relationships between activity and percent clay sizes have also been shown to be applicable to natural soils. The purpose of Figure 7 is to identify a potentially swelling soil, which may require further study and tests such as an expansion or swell test. As per this graph Surla dam clay has medium swell potential. Based on *modified free* swell index for clays, as suggested by Sivapullaiah, Sitharam, and Rao (1987), the modified free swell index for Surla clay is 3.54 thus indicating that the soil has moderate swelling potential.

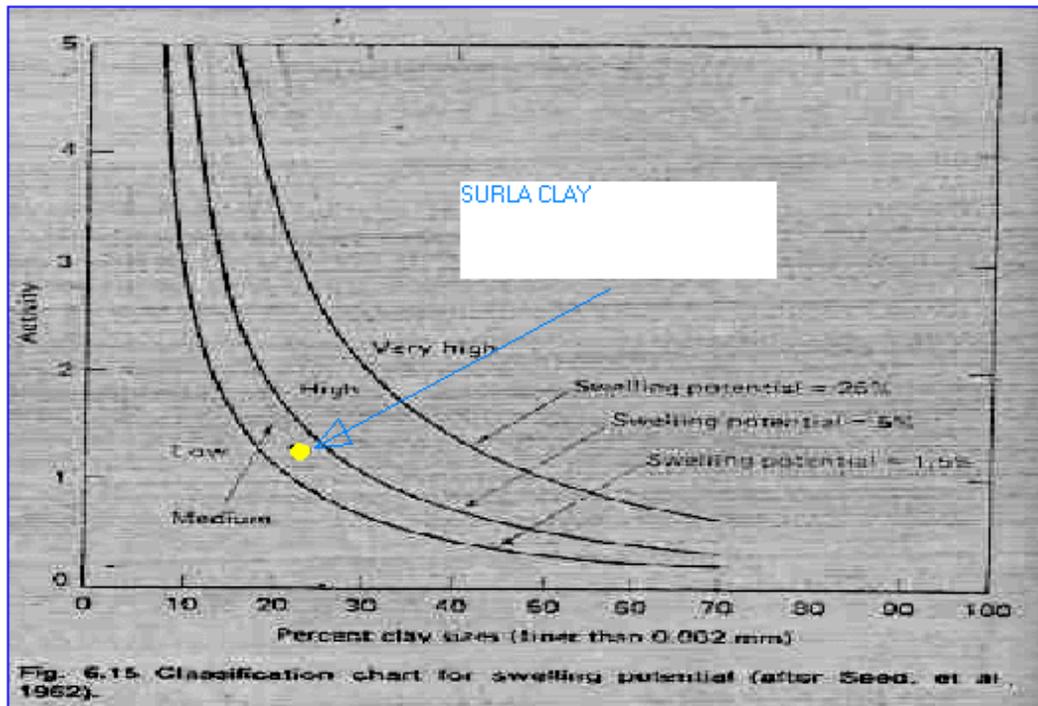
### Figure 7. Identification of potentially swelling soils using activity & % clay

These results confirm that the Tables and curves developed by various agencies and researchers are reasonably accurate for predicting swelling potential of a soil based on simple index tests. Unconfined compression, SPT and plate load tests were conducted at site to determine the bearing capacity of soil under saturated and unsaturated states. Allowable bearing capacity of the soil in its unsaturated undisturbed state is very high i.e., 4 kg/cm<sup>2</sup>. Standard Penetration Tests and plate load Tests under saturated conditions were also conducted in situ by pre-wetting foundation material. These results also yielded a bearing capacity much in excess of the pressure applied by the self weight of the structure i.e., 0.1 kg/cm<sup>2</sup>. Triaxial tests were conducted on undisturbed samples in saturated state to determine the bearing capacity of foundation material in saturated state to model foundation saturation after impoundment of reservoir yielding allowable bearing capacity of 0.34 kg/cm<sup>2</sup>. It implies that the spillway is safe against soil bearing failure and some other mechanism caused distress.
