**TACKLING LANDSLIDES DURING EXTENSION OF
KKH**

Engr. Sohail Kibria, Basit Masud

This paper describes the details of the geotechnical studies carried out for addressing landslide problems and the optimum remedial measures conceived for extension of KKH.

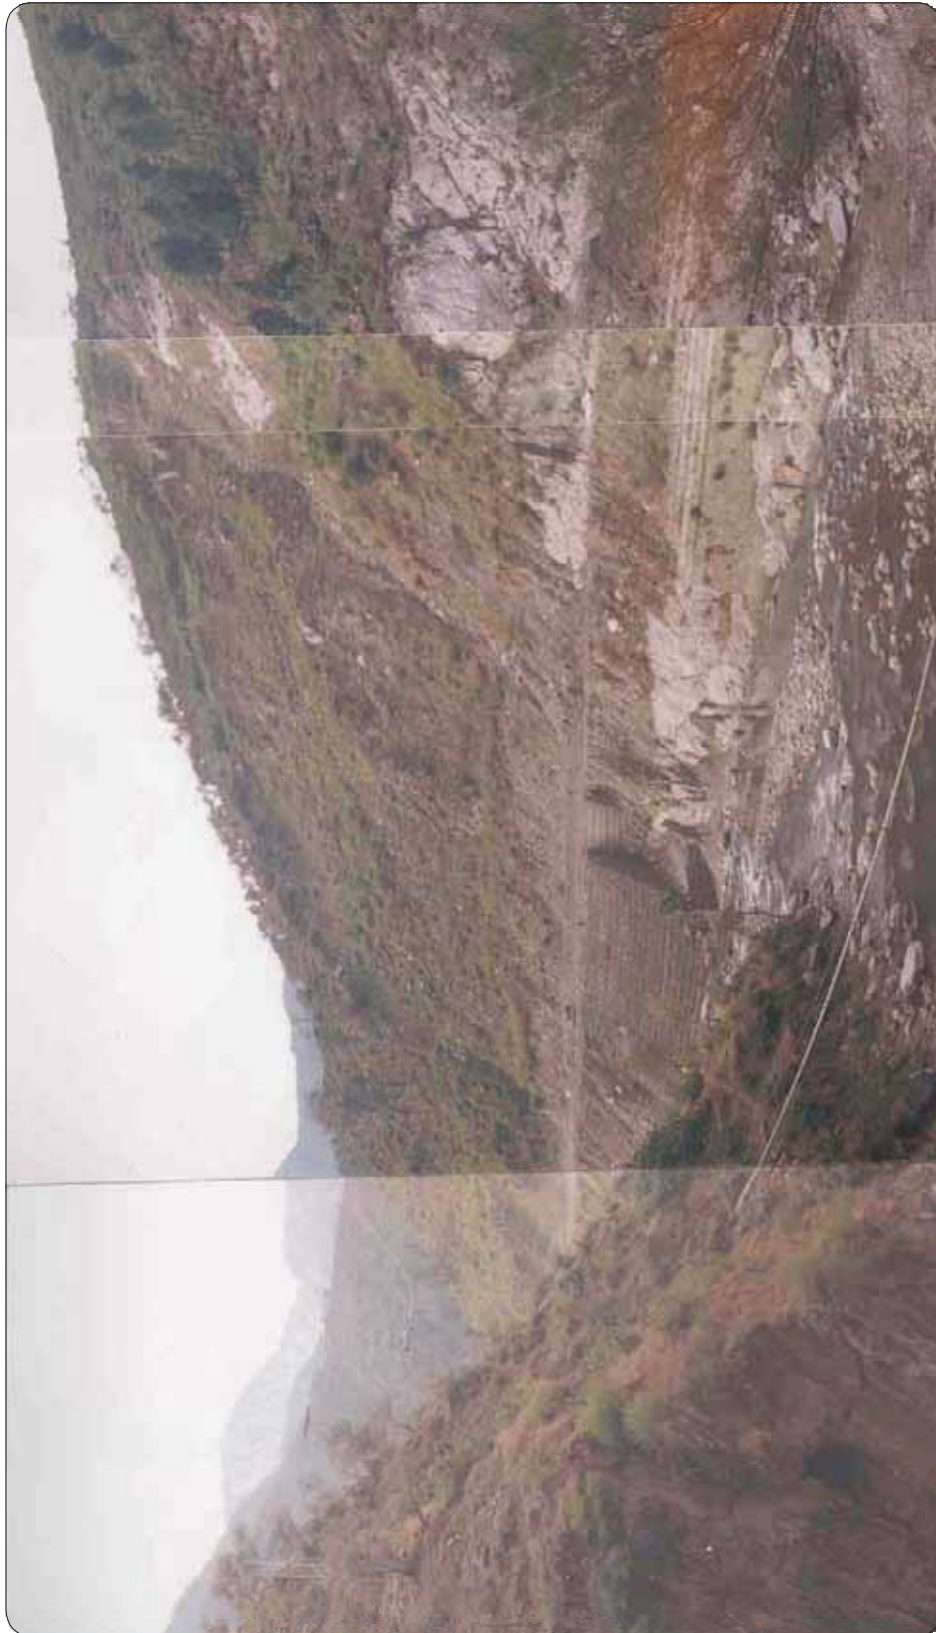
Figure 4: An overview of Thakot landslide area.

LANDSLIDE AREA	PRINCIPAL GEOLOGICAL MATERIALS	DIP ANGEL (Deg)	SLOPE ANGLE (Deg)	MAIN REASON FOR SLIDING	POSSIBLE REMEDIAL MEASURES
Thakot (RD 185+000 and RD 185+200)	Schist rock exposed, moderately weathered, moderately jointed covered with colluvial soil. Boulders comprising the colluvial material belong to bedrock.	60 to 70	50	Low shear strength of colluvial material. High slope angle. Sudden shaking of ground during earthquakes and erosion of bedrock and colluvial material exposed in nullah.	Existing retaining wall to be reinforced. 200 m long and 3.5 m wide stone-pitched rock trap ditch to be provided along the slope. 200 m long and 2.5 m high gabian protection wall along the road side. 200 m long plum concrete retaining wall on sound bedrock on valley side. A culvert near toe of slope. Two gabian spurs against nullah erosion. Interceptor drain to safely transmit surface water from the crown of the landslide to stable area.

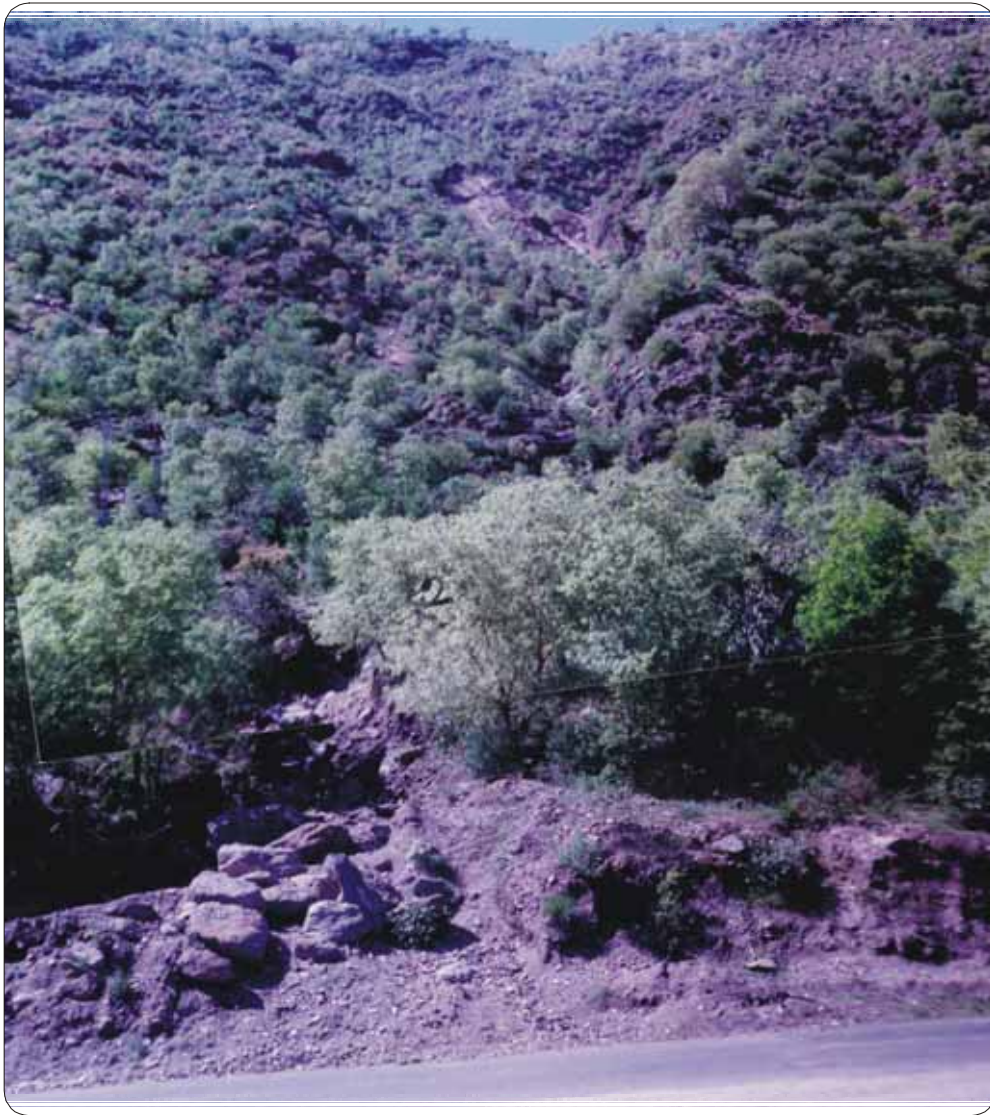
Figure-5: An overview of Dandai debris slide.

Dandai (RD 194+385 to RD 194+420)	The landslide area can be classified as a debris flow surrounded by metamorphic rocks of schist grade inclined at steep angles. The loose deposits comprising the debris flow are the phyllitic schists from the upslope area.			Surface water percolating downward into unconsolidated materials. Low grade schist rock disintegrates upon exposure to water.	Gabian check dams on upslopes. 2 to 3 m wide culvert to clear debris. Breast wall along with road side drain. Constant maintenance and clearance of roadside drain.
Jijal (RD 48+800 and RD 51+800)	This falls in earthquake active zone. The predominant rocks are serpentinites and pyroxinites. Fractured nature of rock, weathering and disintegration have produced large amounts of scree on slopes.		70 to 75	Rain water and gravitational forces mobilize the rock falls, scree slides and disintegrated bedrock material into debris flows.	Gabian wall to be provided between rock trap ditch and road pavement. Road to be shifted 4 to 5 m towards valley side by provision of a series of masonry retaining walls. 3 m wide culvert to be provided at the area susceptible to gully flow. A 2-3 m wide rock trap ditch to be provided at the toe of the hills.

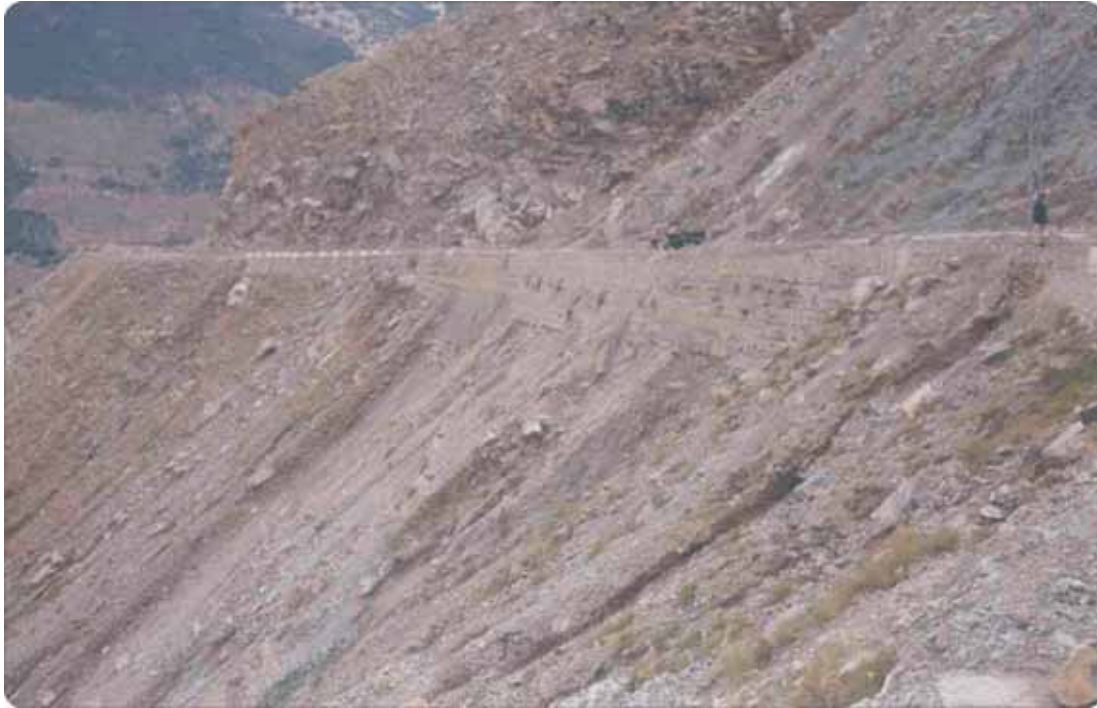
Figure- 6: Another example of scree and debris material subject to sliding on both upslope and downslope portions of Jijal landslide site.

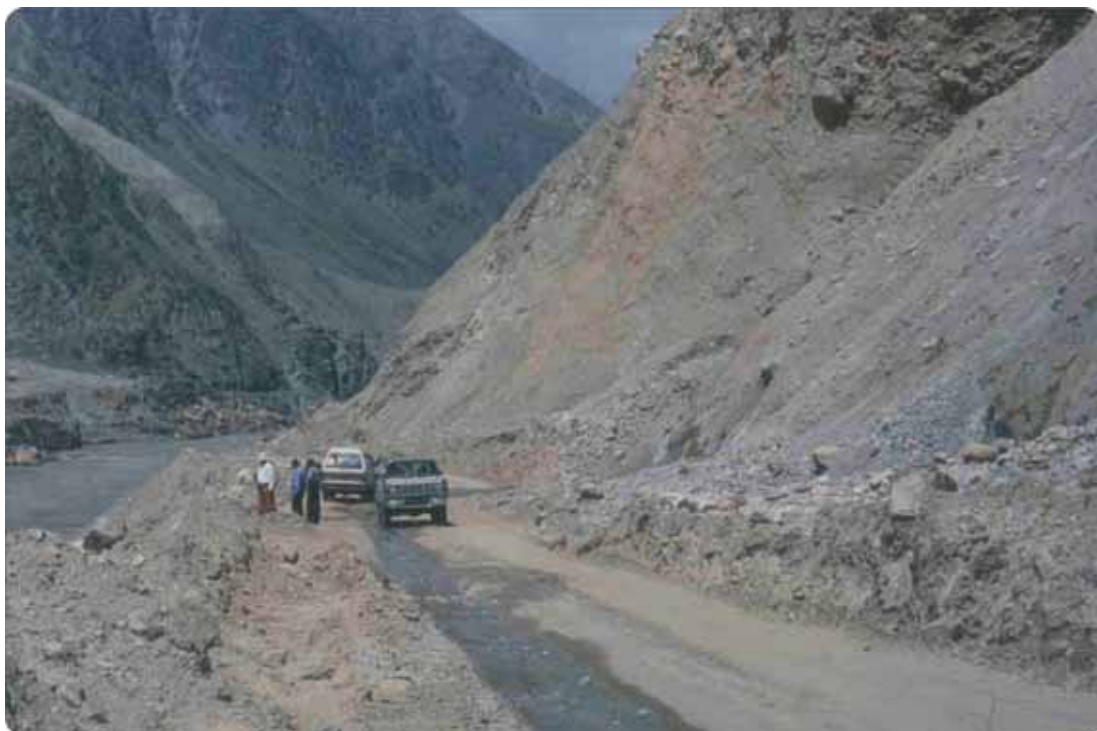
Figure 7: Another view of steep slopes at the Tatta Pani landslide site covered with loose and unconsolidated materials.

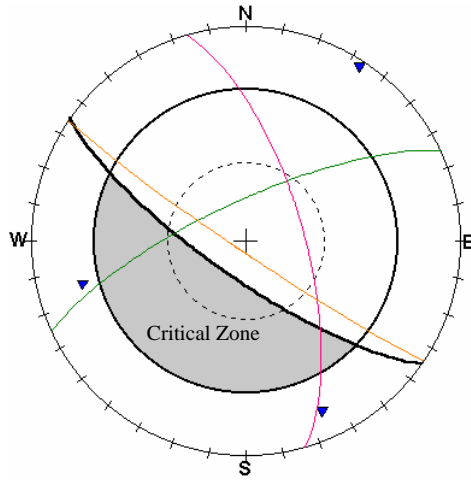
Friction Angle = 30°
 Slope Orientation = 215°
 Cut Slope Angle = 76°
 Potential Failure Modes: Stable

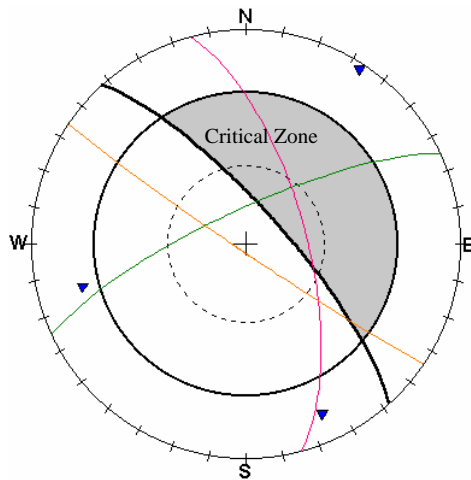
Friction Angle = 30°
 Slope Orientation = 48°
 Cut Slope Angle = 76°
 Potential Failure Modes: Toppling, Wedge Failures

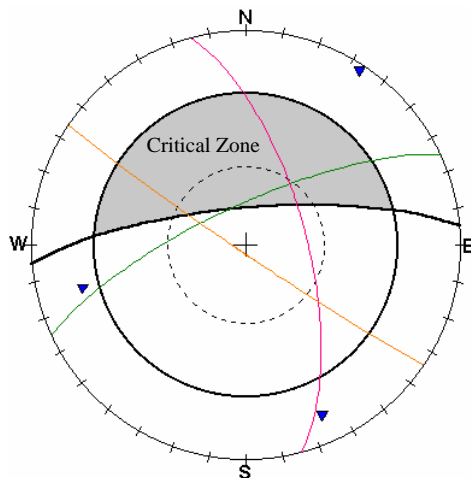
Friction Angle = 30°
 Slope Orientation = 355°
 Cut Slope Angle = 76°
 Potential Failure Modes: Plane Failures (Along Dip Slopes), Wedge Failures
