UNDER-PINNING SATGHARA REST-HOUSE.

By. K. R. SHARMA, ASSISTANT ENGINEER, P. W. D. IRRIGATION.

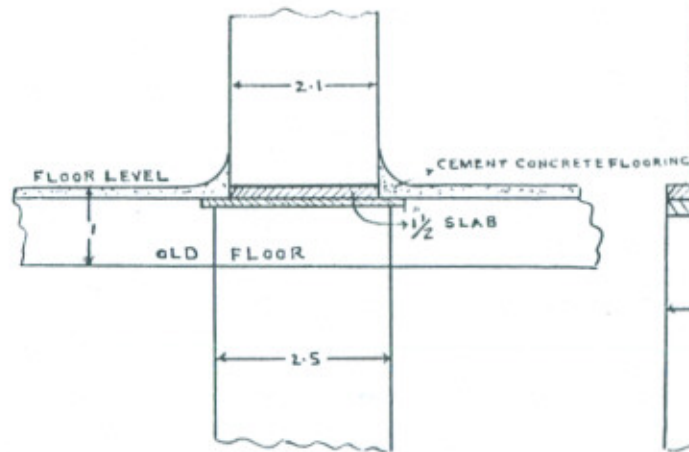
Nº 1

Sketch No. 1 shows the under-pinning of the doors and windows. Sketch No. 2 shows the under-pinning of the inside walls of the main rooms. These walls were high, and, therefore, could be opened out for sufficient length on account of the arching action. However, to be on the safe side, holes were made in the wall at intervals of 2.5 feet, opening out about 6 feet length in one operation. Care was taken to pierce the holes at about a foot above the moist bricks, where kallar had risen. Karries of 5"×5" size were put through the holes. It was seen that the top of the holes was flat touching the karri at every point. The karries were supported on temporary pillars 0.8' × 0.8' in mud. The karries were wedged up securely on the pillars before dismantling the wall below. Each unit of 3 feet width was built up to the full height, before the karri in this section was removed. Holes made for karries were filled in as shown in Sketch No. 2.

SKETCH SHOWING THE UNDER PINNING OF INTERIOR WALLS

Mr. Sardari Lal Malhotra said that he wished to point out one or two defects in the design as shown in the sketches. He instanced sketch No. 1 of diagram No. 2, where the damp proof course had been shown at the level of the floor which overlapped it, and remarked that if that was the way things had been done, kallar would appear again. The damp proof course ought to have been laid at least $\frac{1}{4}$ " above the floor level and clear of it.

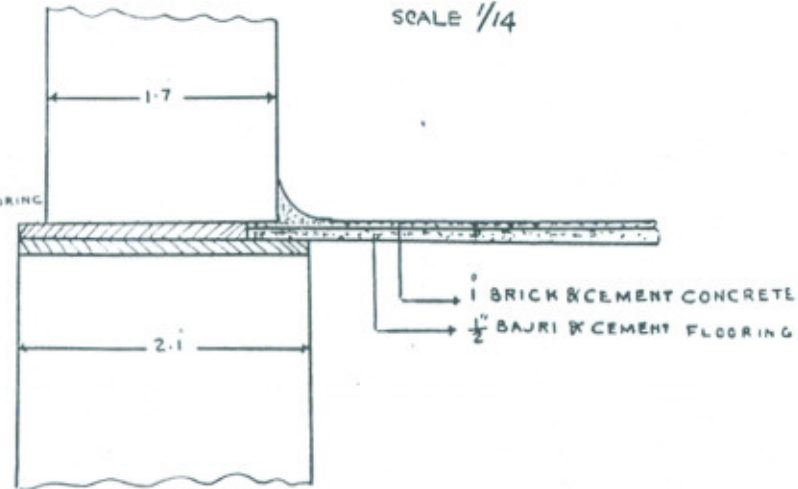
Nº 2

Sketch No. 2 shows the laying of the slabs for the outer walls of the main rooms. It was ensured that the joints were broken by overlap of at least one foot.

UNDER PINNING OUTER MAIN ROOM WALLS

Further, in sketch No. 2, of diagram No. 2, the lime concrete of the floor had been shown projecting into the wall and abutting against the top slab of the damp proof course. This arrangement was defective and did not afford any protection against Kallar.

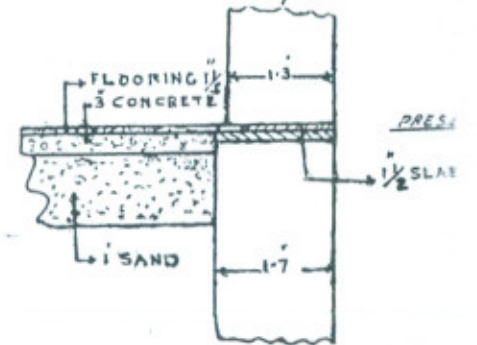
Nº 3

The arrangement of the slabs under the verandah pillar is shown in Sketch No. 3 in Diagram No. 2. This arrangement ensures complete overlap of the top slabs and of the verandah floors over the bottom slabs.

SKETCH SHOWING THE UNDER PINNING OF VERANDAH OUTER WALL

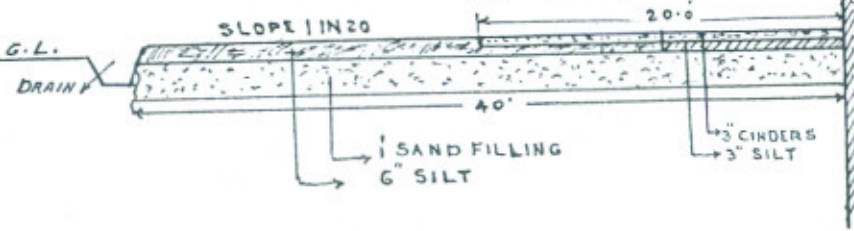
N^o 4

24. **Compound round the Rest-House.**—The earthen platform round the Rest-House is about 40 feet width. It consisted purely of kallar earth as already stated above. It was decided to dig it out all round to a depth of 1·5 feet and to fill it in as given in Sketch No. 4 Diagram No. II.

The platform now consists of 1·0 foot clean silt from the canal bed covered with good berm earth from the canal berms to a depth of half a foot. Up to 20 feet all round the building cinders 3 inches deep are laid. The plinth is now 1·3 feet higher than the surface of the earth. A good slope of 1 in 50 is provided all round to drain off rain water quickly into the drains.

SECTION SHOWING OUTSIDE PLATFORM

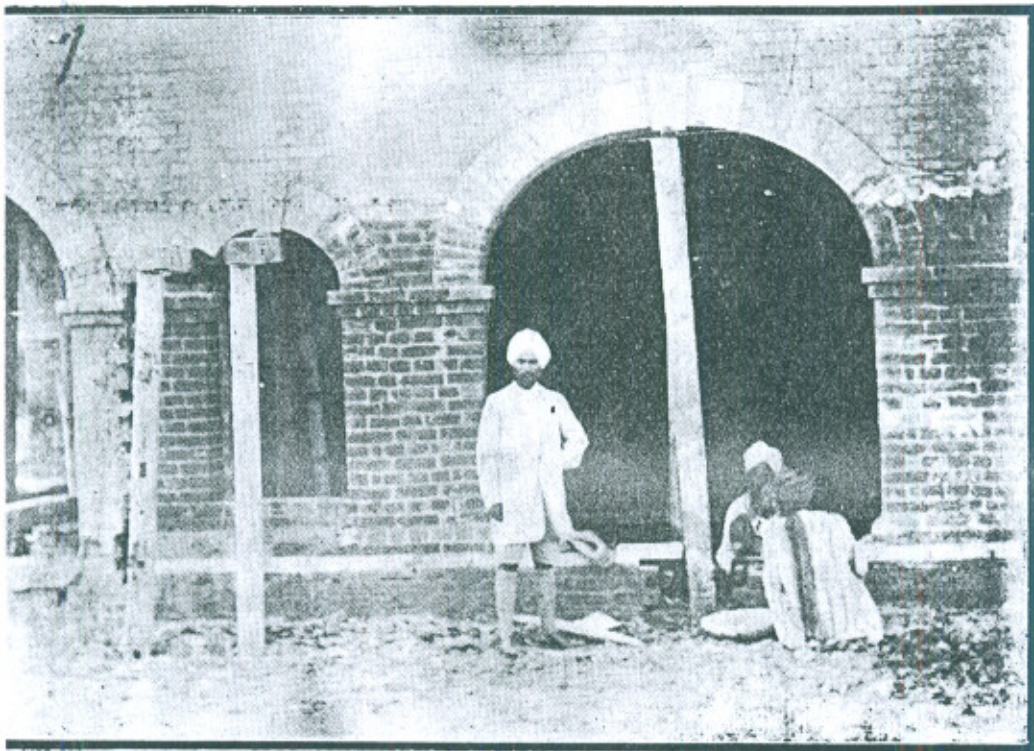
Photograph No. 1 shows the raising of the plinth in the verandahs and the under-pinning of the arch pillars. Even the arches were renewed to the height up to which kallar had risen. Similarly, Photographs Nos. 2 and 3 show the under-pinning of the verandah pillars. Half of each verandah pillar was dismantled first, plinth was raised and damp-proof course put in and then the wall was completed up to the springing. The second half was similarly managed. An overlap of 9 inches of the top slabs over the bottom ones was arranged, and it was considered to be sufficient. Centring simply consisted of vertical supports near the walls under the girders coming over the arch, another vertical support under the crown of the arch and horizontal karries just at the springing or the point to which kallar had risen.

Underpinning of Verandah Pillars.

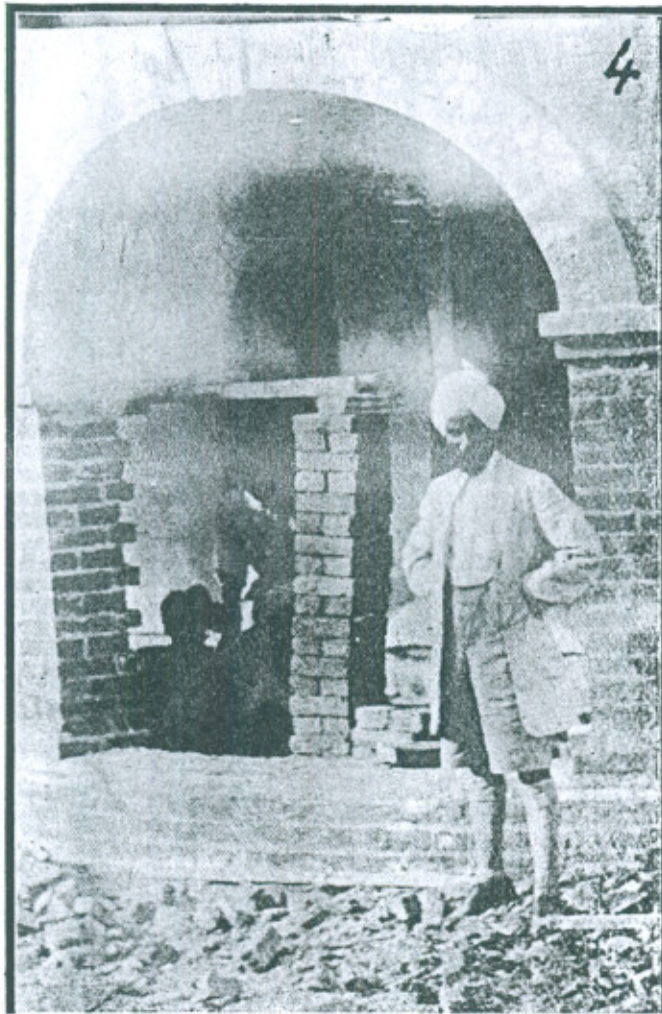
PHOTO No. 4.

Photograph No. 4 shows similar temporary supports for the cross arch in the front verandah, after the outer wall had been under-pinned.

Underpinning of the cross in the front Verandah.

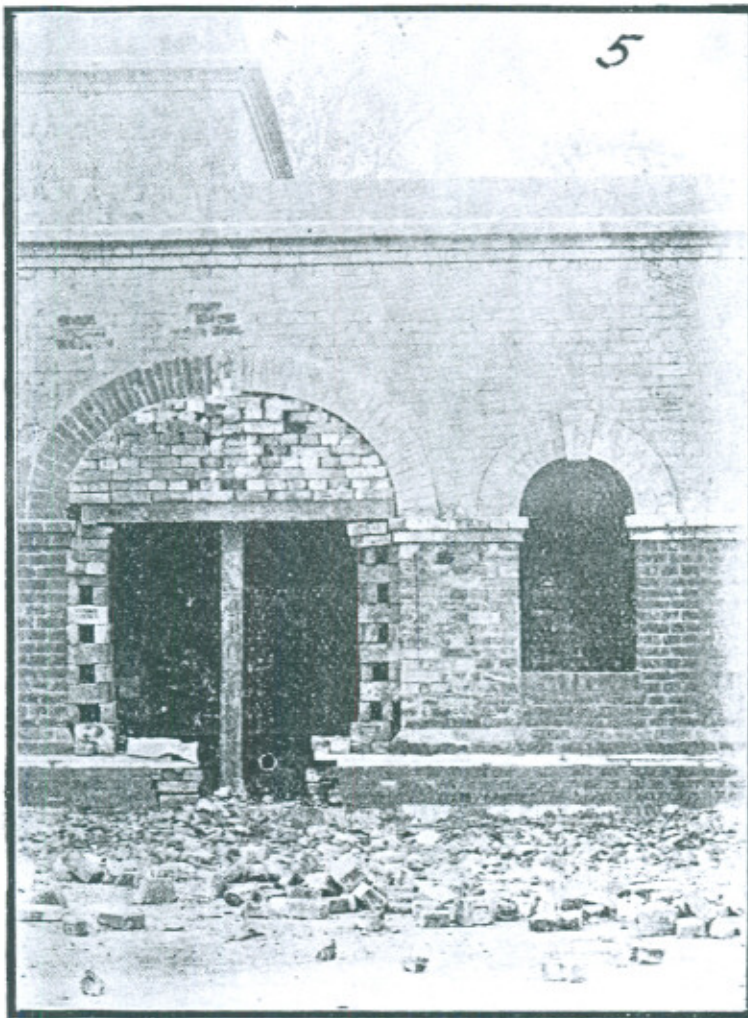
PHOTO No. 5.

Photograph No. 5 shows the verandah arch which had to be rebuilt up to crown on one side. The complete centring was made for the right half and two holes were pierced above the second half to pass the horizontal karries. The left half was easily dismantled and built without any mishap.

*Underpinning of the Verandah pillar and rebuilding the arch
up to crown.*

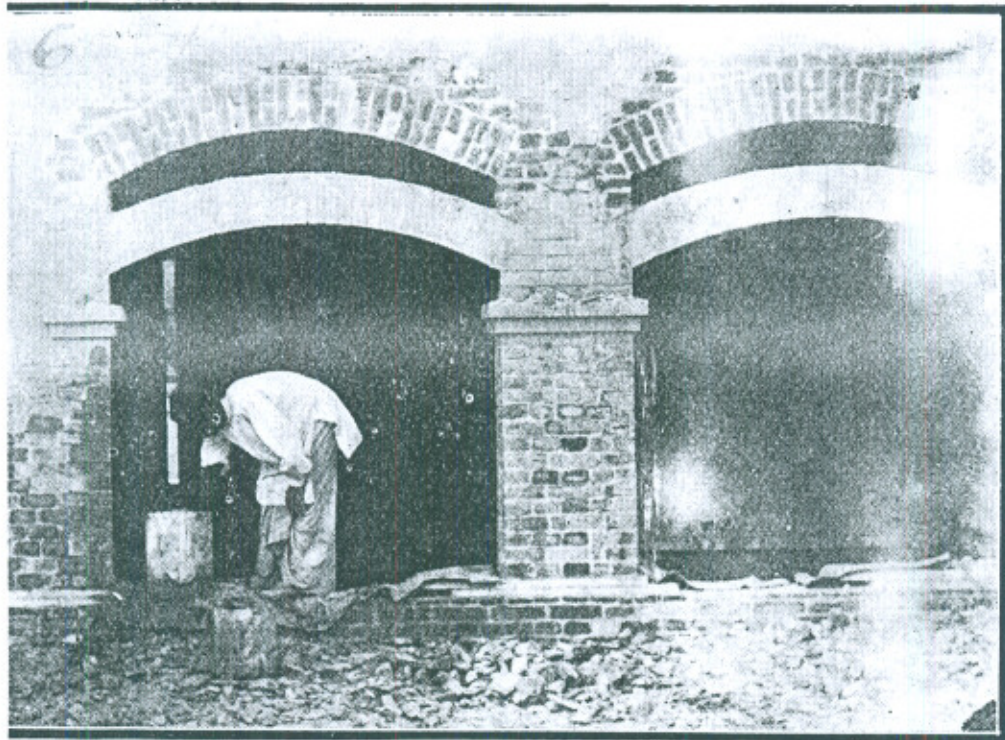
The arches in the back verandah were segmental, and it was found that they looked very low. It was, therefore, decided to raise them by 1.5 feet. Temporary supports in this case consisted of three ballies as in the case of doors with additional vertical supports under the verandah girders. The arches were completed one after the other. The old arch served as centering for the new arch. Photograph No. 6 shows the completed work without the slightest crack appearing in the building.

Completed work of the raised back Verandah Arches.

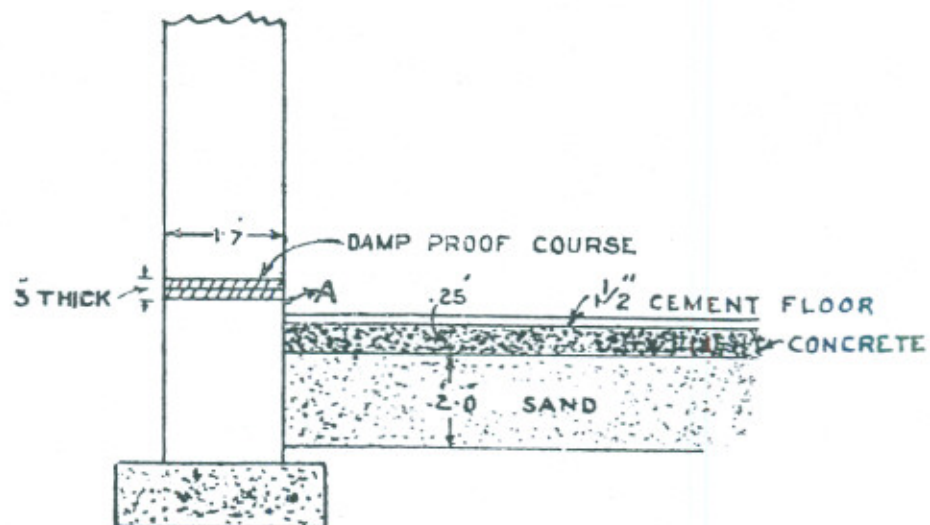
The Author replying to the discussion said with reference to the remarks of Mr. Sardari Lal Malhotra that the floor in all rooms and verandahs consisted of 2'0 feet depth of sand covered with .25 feet foundation concrete and followed by 1½ inch thick conglomerate cement flooring. He did not agree with the suggestion of Mr. Sardari Lal Malhotra that the joint of the floor with the walls should be vertical and at a lower level than the damp proof course as sketched below.

The salts had actually risen up to the very bottom of the damp proof course and there was nothing below this level to check their rise. It would result in concentration of the salts at A by evaporation. The damage to the floor would start at the surface of the floor even if the proposed floor were effective. A vertical joint, as at A, between two different materials, the masonry of the wall and the concrete of the floor, was bound to crack, affording free passage of the salts to the surface of the floor. The joint proposed by the Author shown in the sketches in diagram No. II ensured complete overlap of the 1½" thick cement floor over the bottom layer of the damp proof course slabs and a good joint was ensured in rich cement. There was no chance of direct evaporation of the salts in the wall below the damp proof course. There had been no signs of the failure of the joints of the floor with the walls anywhere in Satghara Rest House during the past two years.
