## Road Problems in Slip Affected Areas

M. A. WAHEED AND MUZAFFAR IQBAL SHEIKH

## ROAD PROBLEMS IN SLIP AFFECTED AREAS

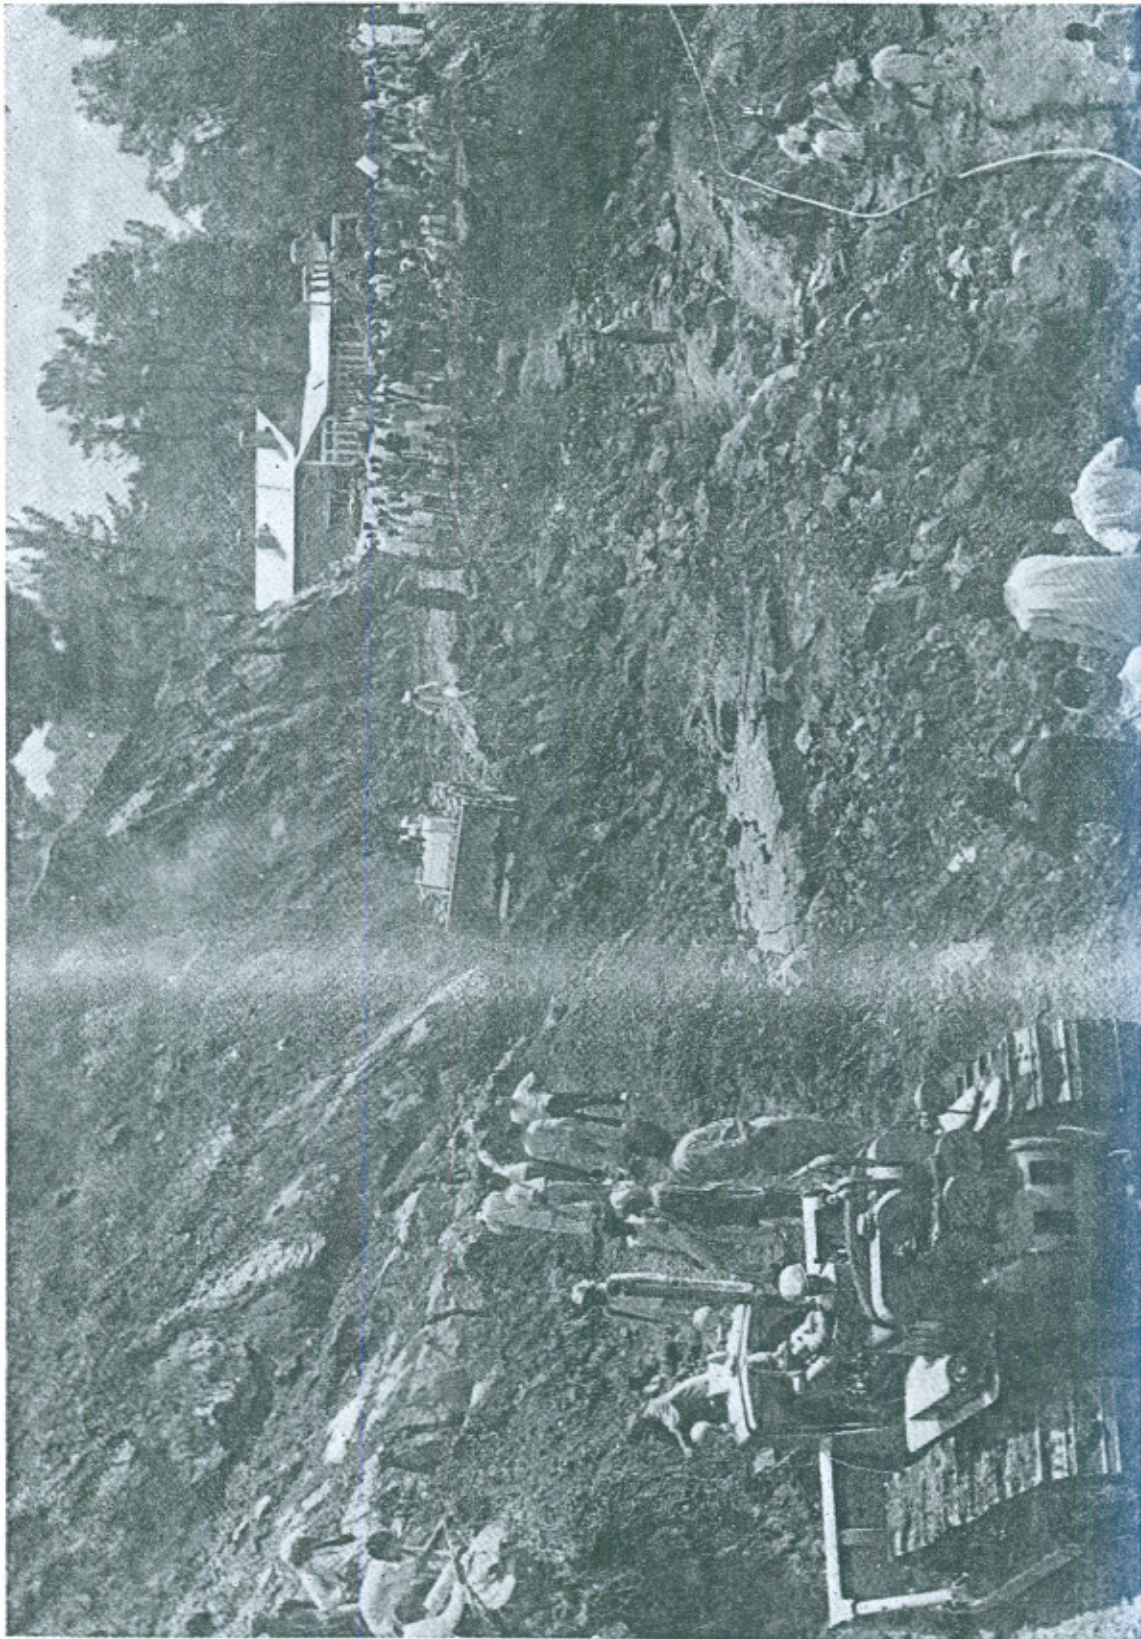
A view of slip affected area in mile 39 showing making of Diversion.

3. Temporary diversions on the up hillside of the original alignments were then cut with the help of bulldozers.

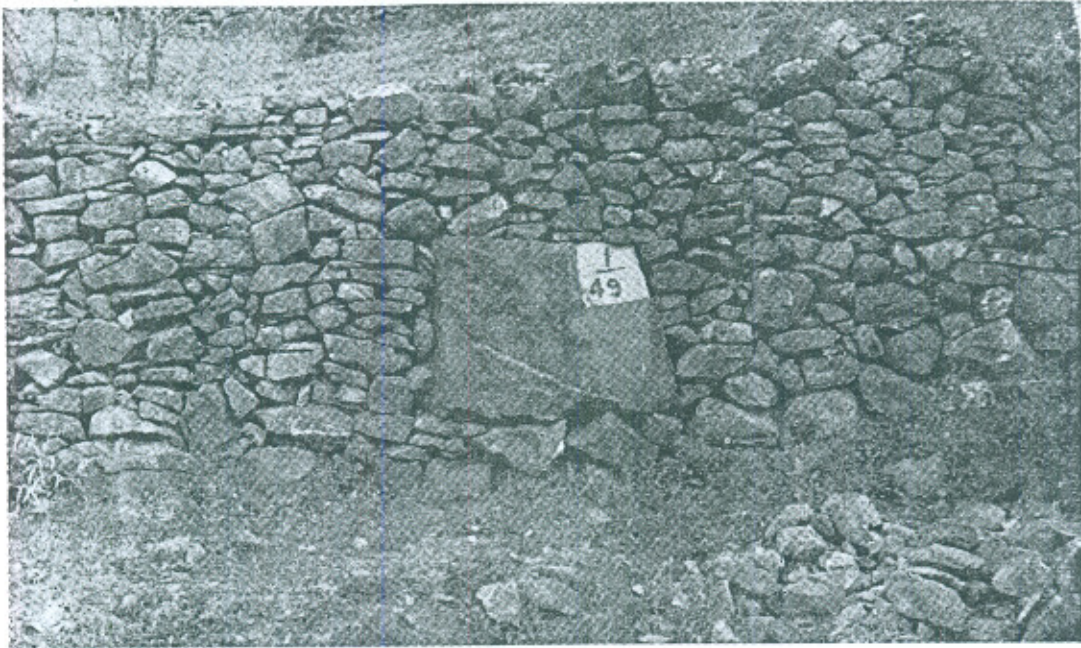
Photo No. 2

(a) **Stone walls.** The stone walls are usually built to check both over-slips and under-slips. In case of under-slips, the height is about 8 to 10 feet maximum. Such walls are usually constructed in a thickness of one to two stones only, using undressed stones of approx. 9'' $\times$ 9'' $\times$ 6'' size. These walls can be constructed dry or with mud mortar or by grouting each layer with cement concrete. In case of two stones thickness wall, big stones of double the width are usually used at every 5 feet in each layer to act as bond stones. When concrete is used for grouting, no boxing is required. Such a wall constructed dry is shown in Photo No. 2.

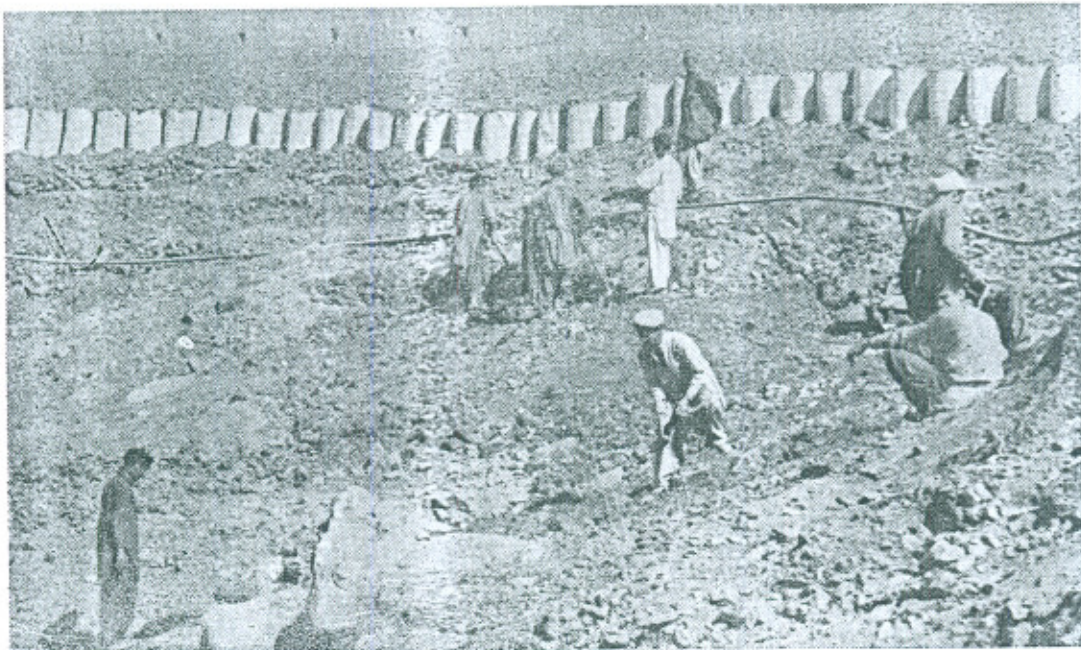
(b) **Vertical Drum Wall.** Walls with empty useless drums can be constructed by placing the drums vertically on end in a row. These drums are filled with local material and embedded in ground. Such a wall is good to check over-slips and under-slips of 2 to 3 feet height only. Such walls can also be constructed within slip areas at frequent intervals to make terraces and benches. These are also useful in checking the minor movement of mass within the areas which are prone to slides. A wall constructed with such specification is shown in Photo No. 3

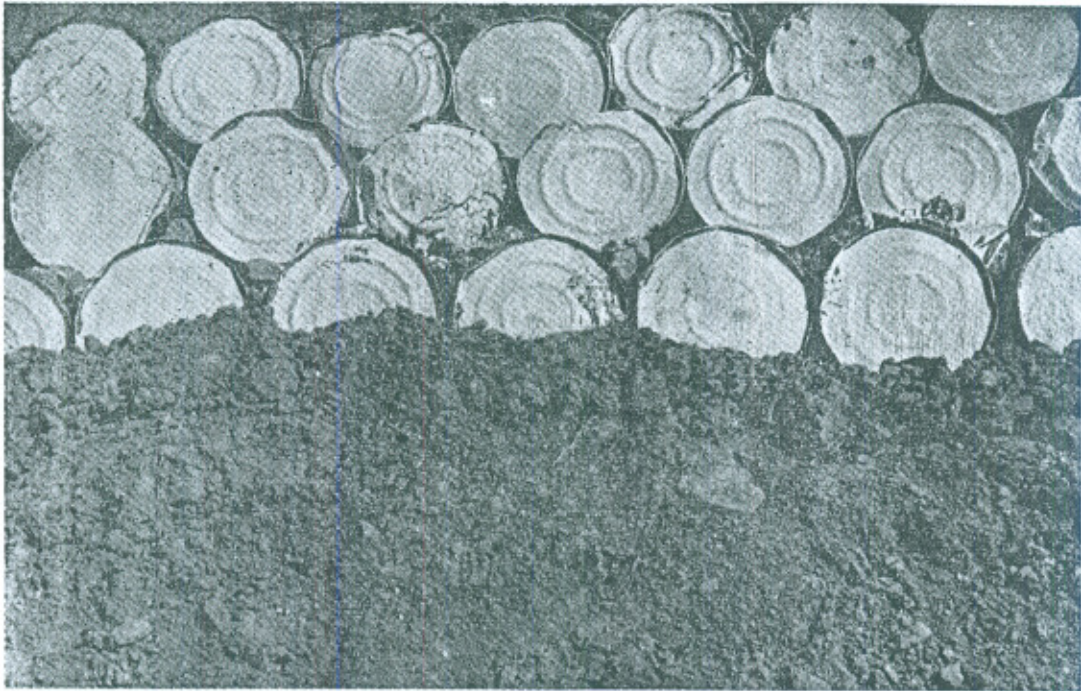
(c) **Horizontal Drum Wall.** Walls with empty, useless drums can be constructed by placing the drums horizontally in a row. Where such a wall is constructed, a foundation is dug, and empty drums filled with local materials are laid horizontally. Successive layers are then constructed over these by similarly placing the drums. But every layer is given a horizontal step, which is good for the stability of the wall. The gaps formed due to circumference of drums act as deep holes. Such walls are useful both for checking over-slip and underslips of 8 to 10 feet height maximum.

A similar wall constructed in slide area lying below mile 36 is shown in Photo No. 4

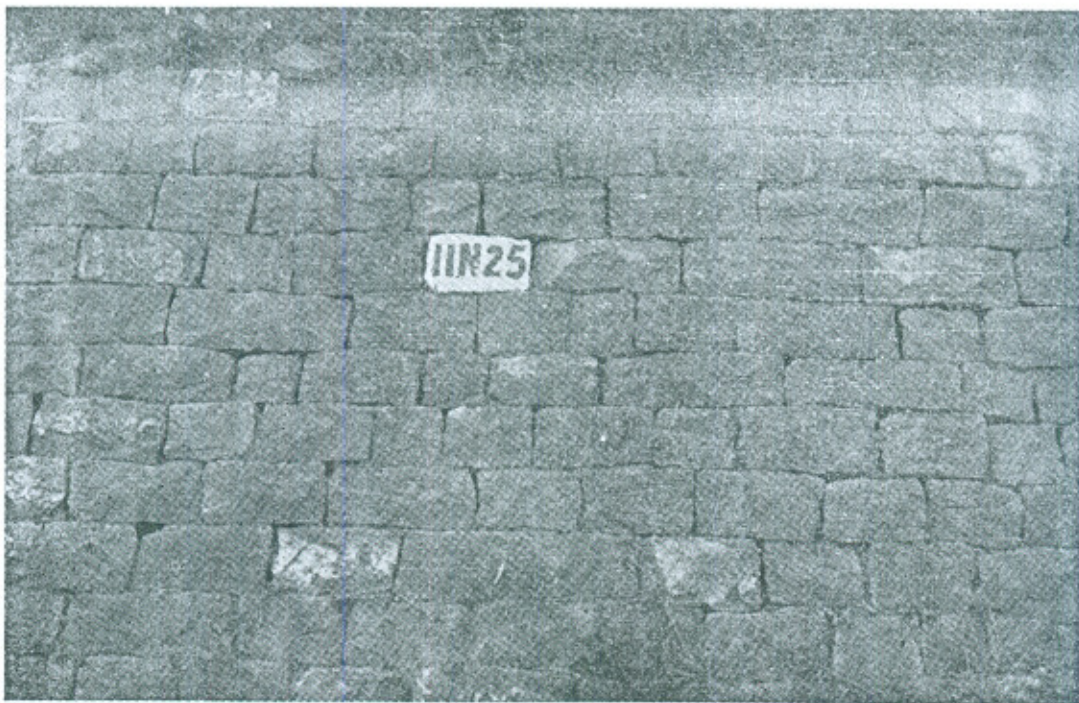
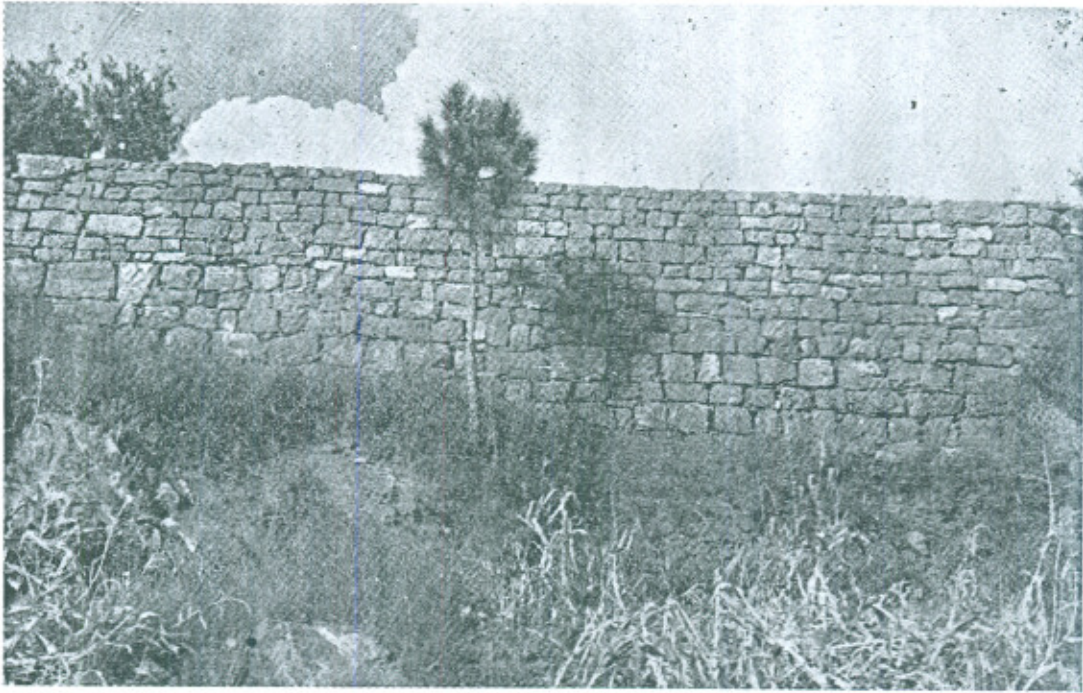
Photo No. 5

Walls up to a height of 12 feet can be constructed in dry stone masonry with hammer dressed stones, both as breast walls and retaining walls by keeping top width at 2 feet and having a slope of 1 in 4. The back of the wall is kept vertical and the front portion is given the above-mentioned slope. Such walls have been very useful had have had a life of over twenty years. Bond stones at every 5 feet should be provided in each layer which should have length equal to the width of wall in that layer. Such walls constructed in slip area around Murree hills are shown in Photos Nos. 5 and 6.

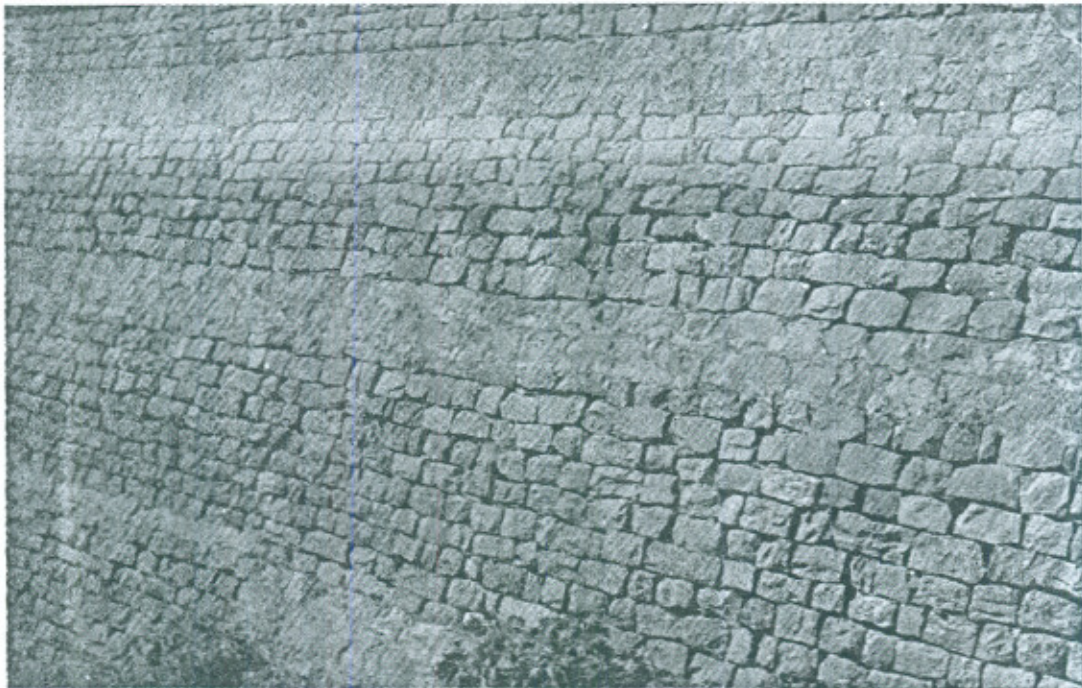
Photo No. 7

- (i) Dry stone walls with bands of C. R. Masonry in 1 : 6 cement mortar at every 4 feet having a thickness of 2 feet across the full width of wall. Such a wall is shown in Photo No. 7.  
The foundation is to be made in 1 : 6 cement mortar.
- (ii) Dry stone walls with 1 : 3 : 6 cement concrete bands at every 4 feet having a thickness of 6" across the full width of wall. Such a wall is shown in Photo No. 8.
- (iii) Walls constructed with local hammer dressed stones in 1 : 6 cement mortar. Such walls are desired where height is abnormal or the pressure at back is excessive.

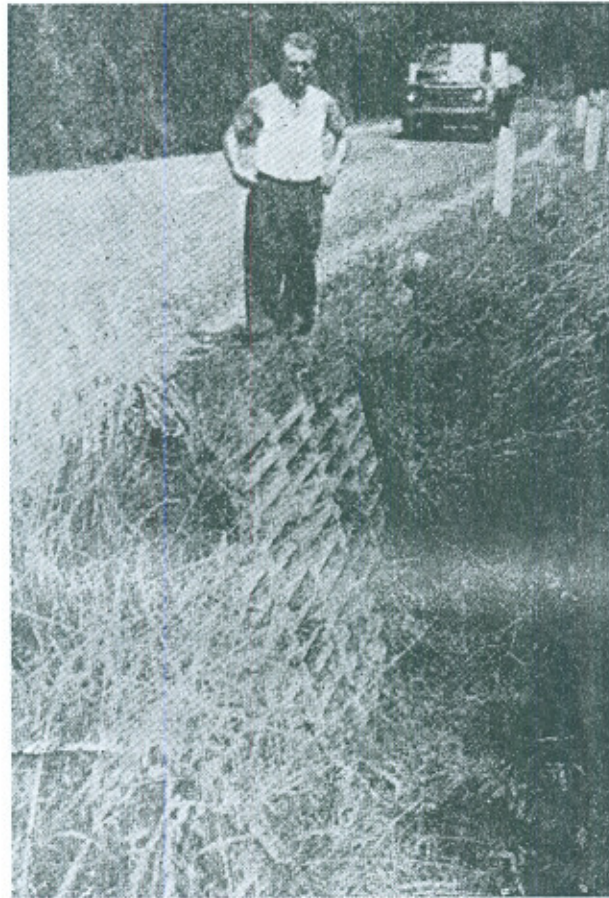
Photo No. 12

Such units were developed because of the fact that gasket type were not very robust. A wall constructed with such units made of precast cement concrete 1 : 2 : 4 is also shown in Photo No. 12.

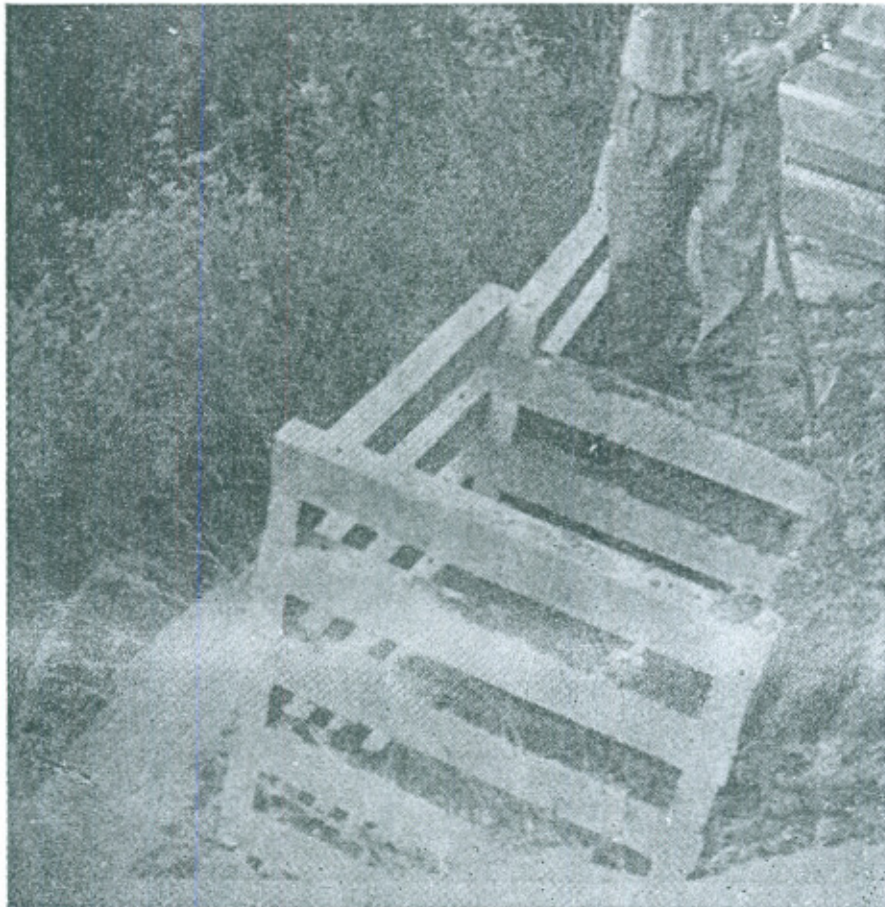
Photo No. 12

Precast RCC units 5" x 3" x 3'—6" having holes in corner when placed and tied together in a shape shown in Photo No. 13.

From a box type wall. The cavity so formed by these members can be filled with broken rock or shingle rammed inside the wall. The back fill should also be compacted very properly.
