N. W. R.
NEW JUMNA BRIDGE
 TYPE DRAWING OF PIER & WELL
 SCALE 24 FEET = 1 INCH.

N. W. R. NEW JUMNA BRIDGE DETAILS OF GIRDERS

- M. W. R. -
- NEW JUMNA BRIDGE -
DETAILS OF GIRDERS
SCALE 1/8 INCH = 1 FOOT

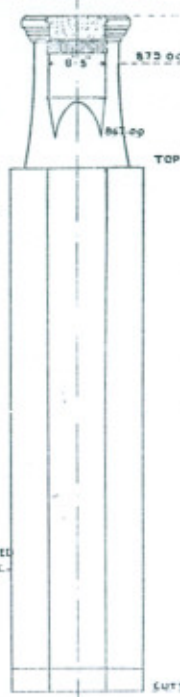
SECTION AT B.B.

SECTION AT A.A.

SECTION AT C.C.

TOP PLAN

PLAN AT SPRINGING OF ARCH.

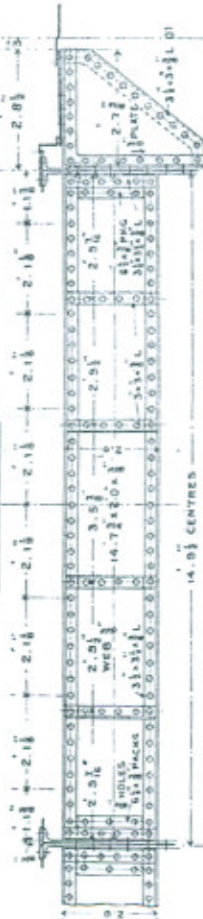
- OUTER STRINGER -

- CENTRE STRINGER -

- MAIN STRINGER -

- HALF CROSS GIRDER -

By the 11th May, the bottom boom, cross girder, main stringer (or rail carrier) and the girders (outer stringer and centre girders) for the roadway were erected.
