Remodelling Balloki Headworks

RANA MUHAMMAD ASLAM CHOHAN*

*Deputy Project Director, Remodelling Balloki Headworks Project, Balloki.

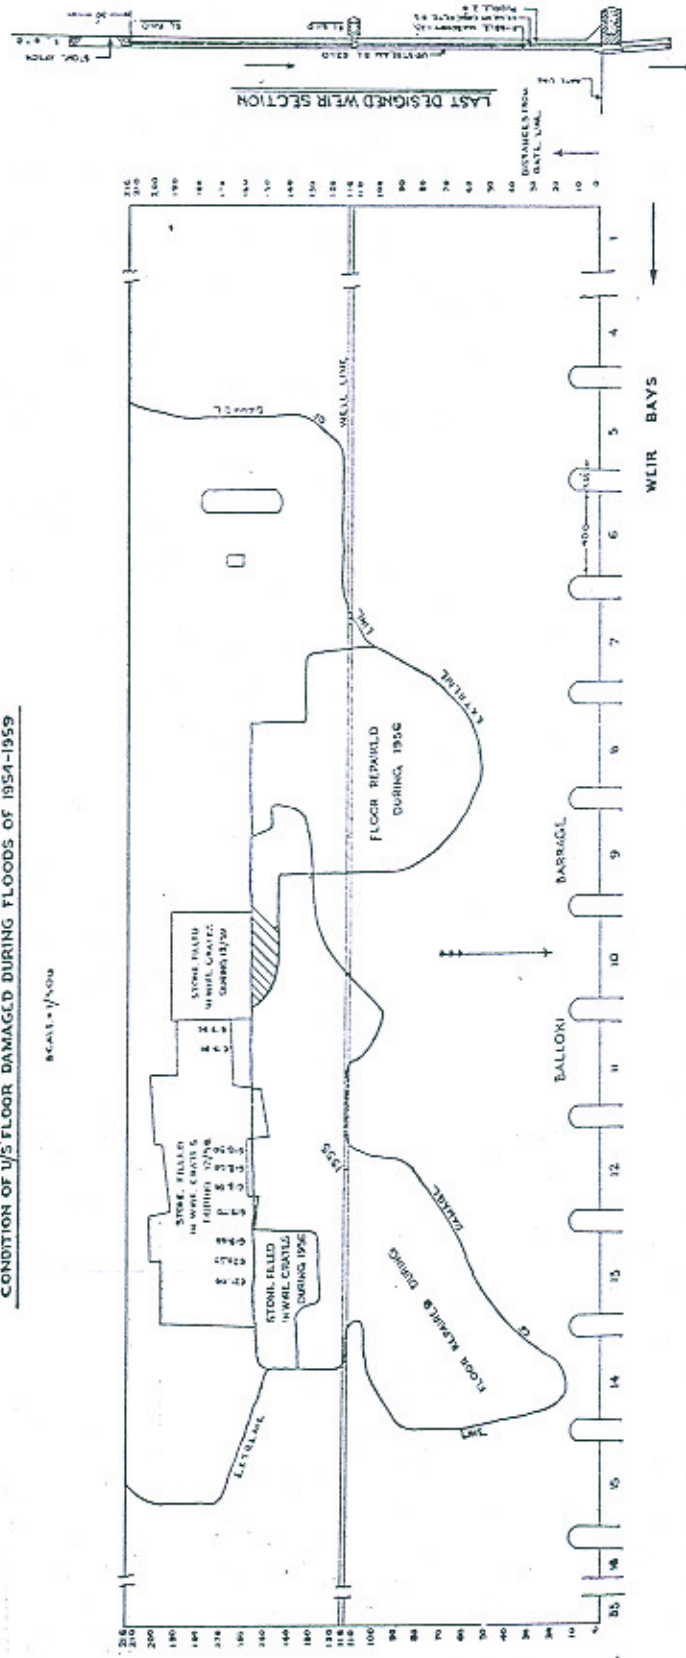
PLATE NO. 4

The high floods of the years 1929, 1954, and 1956 washed off a sufficient length of floor and cut-off on the upstream and in the succeeding years, settlements and cracks developed further. The structure therefore stood in a deplorable condition (as depicted in Plate No. 4) and its safe working could not be relied upon.

REMODELLING BALLOKI HEAD-WORKS
 PLAN SHOWING
 CONDITION OF 1/5 FLOOR DAMAGED DURING FLOODS OF 1954-1959

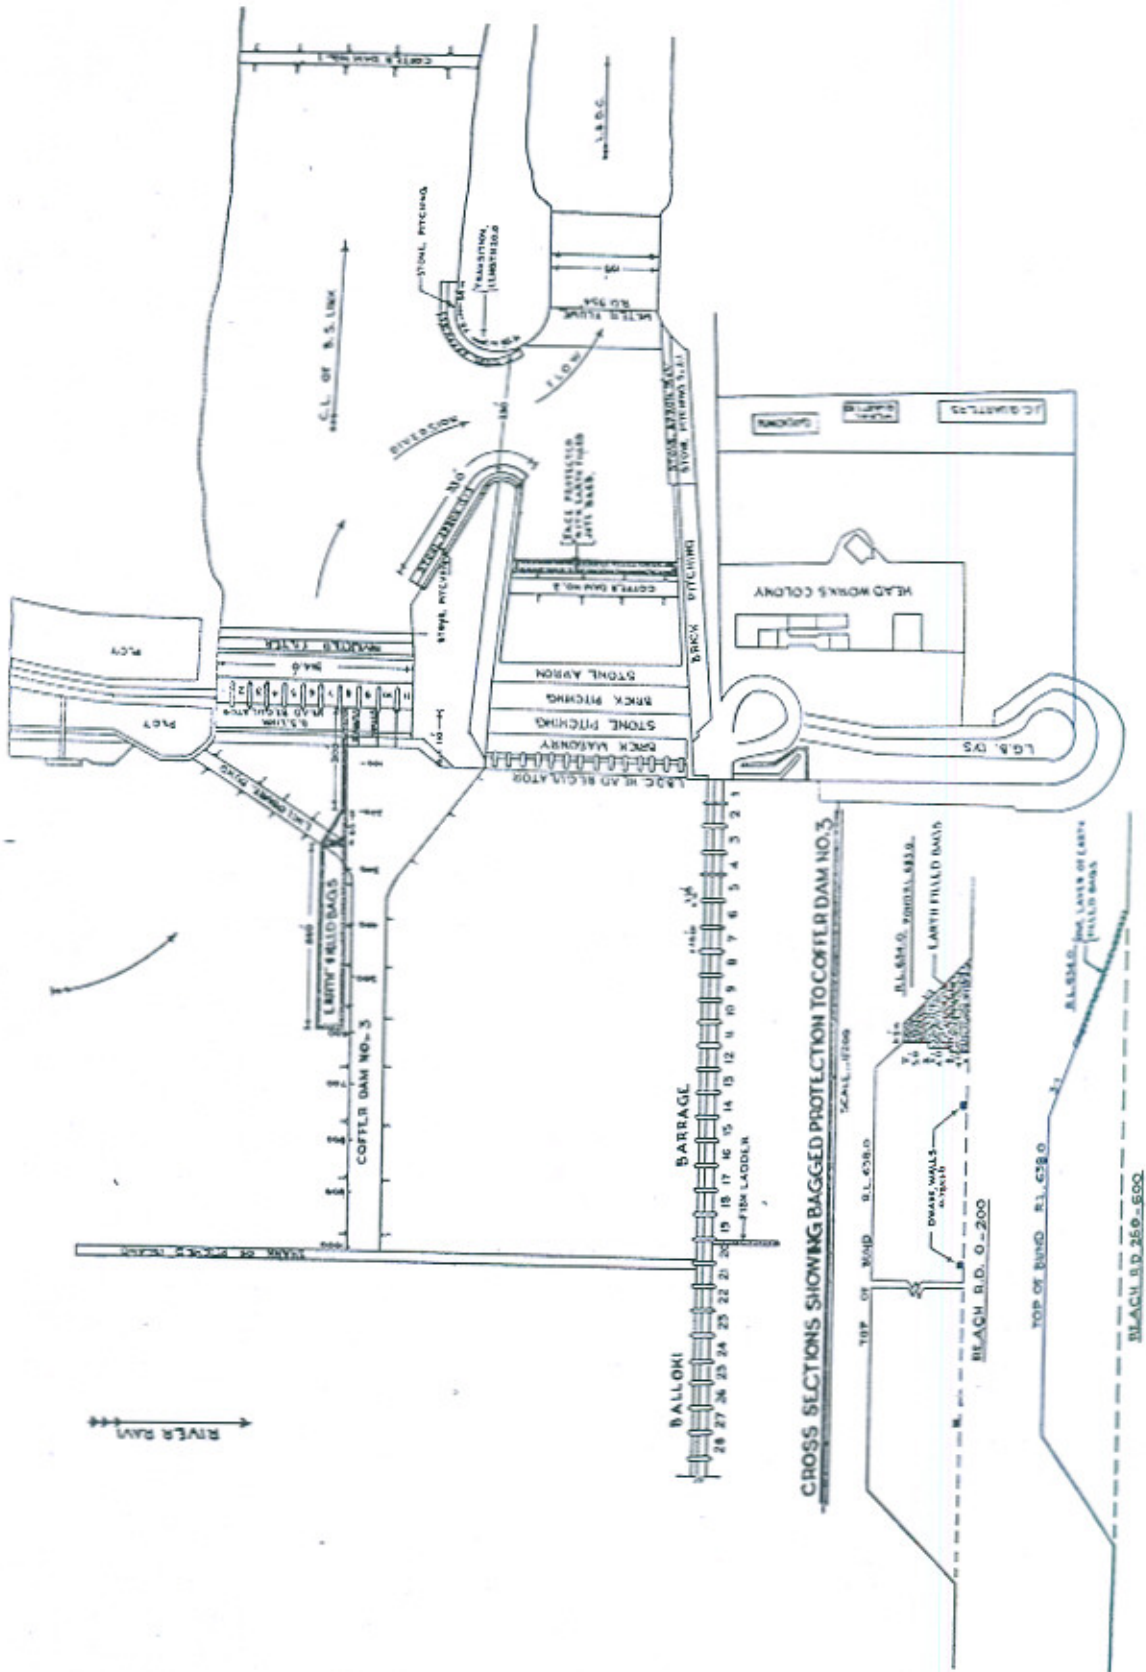
PLATE NO. 10

REMODELLING BALLOKI HEAD WORKS
 PLAN SHOWING
 FEEDING ARRANGEMENTS AND PROTECTION
 OF COFFER DAM NO. 3 ON THE U/S.

For erection of Coffor Dam No. 3 on Upstream, the pond was depleted and canal closure effected on 10-11-64. The public traffic was diverted along the alternative route and all the Earth Moving Machinery available with Machinery Pool Organization deployed on the job. Protection of this Coffor dam for its safety in the reach resting over the pacca floor, stone apron and junction with the masonry wall had been attracting lot of attention. Originally it had been planned to grout the sub-strata or remove the stone apron for making an earth to earth joint and to provide a masonry retaining wall in alignment with pier No. 7 of Balloki-Sulemanki Link Head Regulator, for curtailing the base width of Coffor dam, but the proposal had to be ruled out as being time-consuming and necessitating a long canal closure. Therefore a simple solution in the following manner (as shown in Plate No. 10) was applied:—
