REPAIRS AND REMODELLING OF RASUL WEIR, 1929-1931.

By T. A. FOY, EXECUTIVE ENGINEER, I. B.

On the 28th August, 1929 the river Jhelum came down in high flood owing to heavy rain throughout the Jhelum valley. This flood caused extensive damage to Rasul weir and it is the purpose of this paper to give the history of the flood and of the consequent repairs; these repairs led to the remodelling work which is also described.

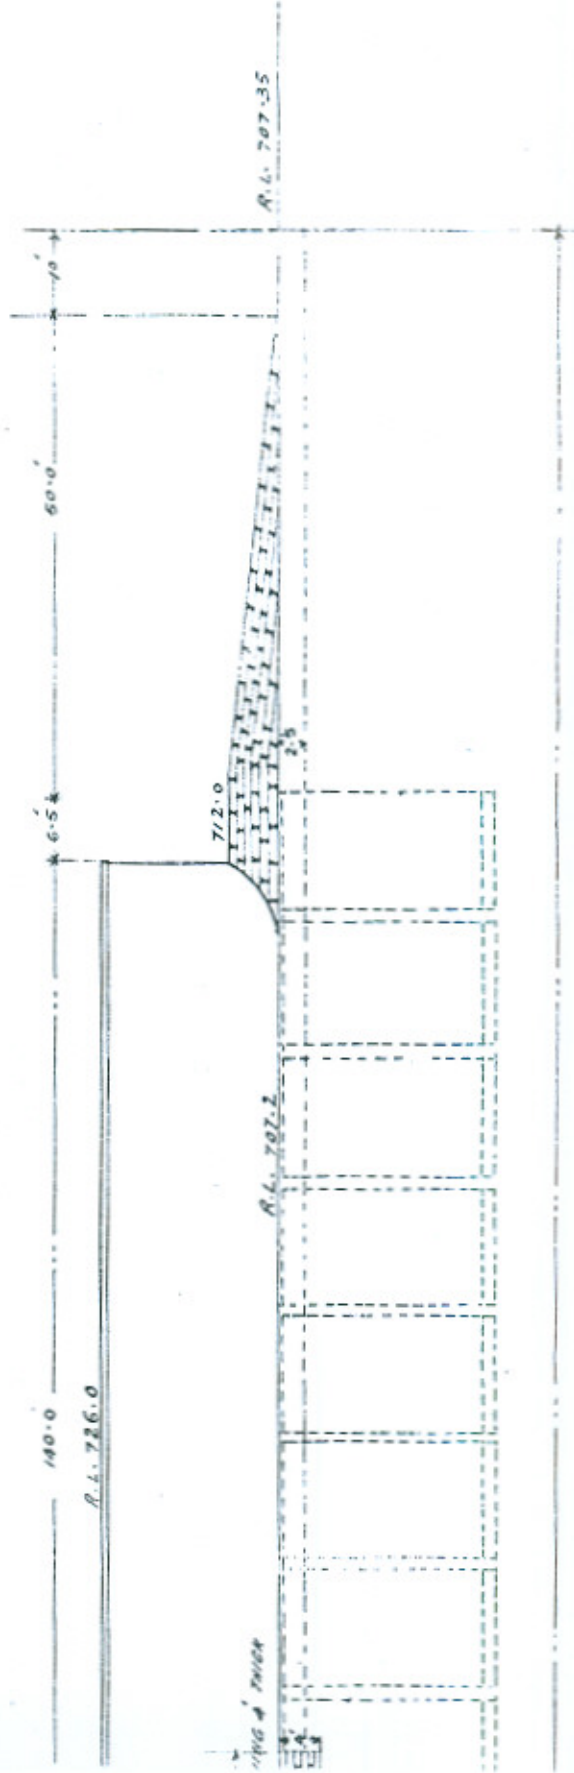
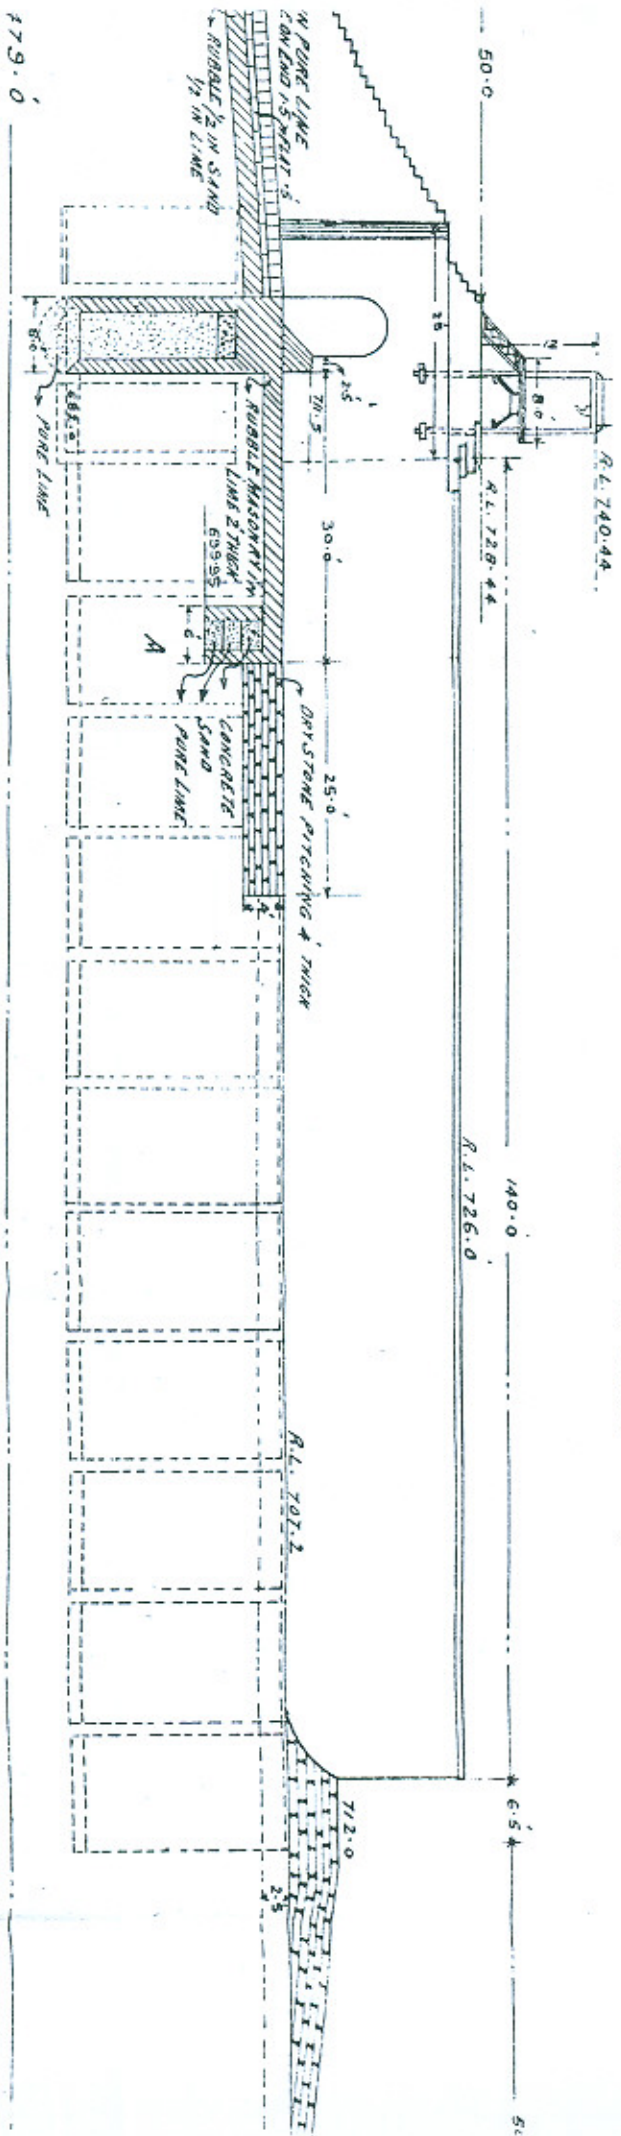
RASUL WEIR AND GROUVE

The weir section, as shown on plate 1, consisted of a flat upstream floor 30 ft. wide laid at the comparatively high level of 707.2 in bay 1 and stepping up .15' per bay. This upstream floor was protected by 25 ft. width of stone pitching laid at the same level as the floor. The downstream floor was laid with an approximately 1 in 15 glacis from the upstream floor down to R. L. 701.2, the length of the sloped portion being 90 feet with a further 6' flat formed by line D of wells. Downstream of the glacis there was a 40 ft. width of stone masonry blocks and below that a 30 ft. width of loose stone pitching. The weir section was divided up by 4 lines of wells, A, B, C, and D. The upstream line of wells A was of shallow depth extending for 8 feet below the upstream floor and founded nominally on sand, though the sand contains an occasional admixture of small shingle. The A line of wells, though originally intended to be built as wells and sunk, was in practice built as a continuous obstruction and was in fact a drop wall 8 feet deep.

The B line of wells is under the crest and extends down to R. L. 685; it is founded on the alleged boulder bed which, we have reason to believe, consists very largely of small shingle up to 6 inches size.
