## PAPER No. 253

### OBSERVATIONS ON LINED (HAVELI) CANAL

BY SOM NATH KAPUR, I.S.E.

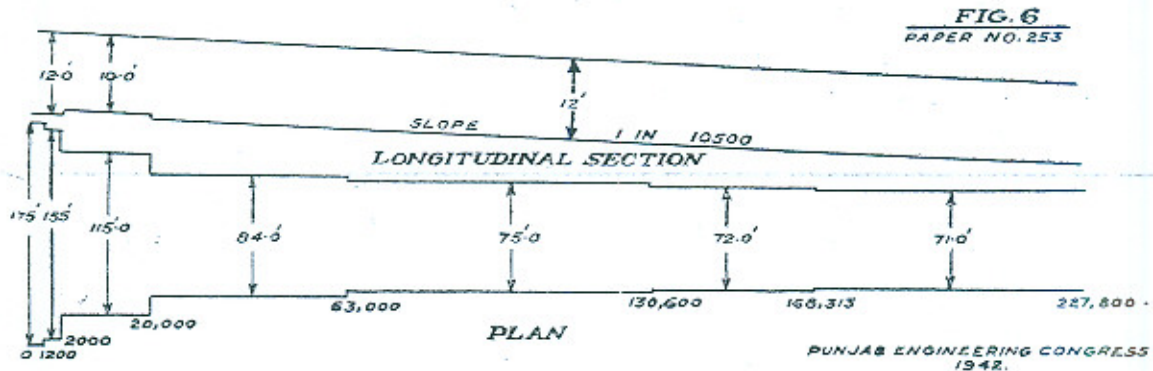
The section of Haveli Canal changes several times as shown below. The velocities and F. S. discharge are also given for the various sections

Reach	0—1,200	1,200—2,000	2,000—20,000	20,000—63,000	63,000—130,600	130,600—168,313	168,313—tail
B.W. ..	175'	155'	115'	84'	75'	72'	71'
D. ..	12·0'	12·0'	10'	12'	12'	12'	12'
V. ..	3·32	3·12	4·23	4·59	4·59	4·49	4·54
Q. ..	7,452	6,250	5,249	5,244	4,747	4,486	4,478

It would seem that the velocity increases in certain sections and if the water line were to be constant it would mean a jump in total energy line which is not possible and therefore afflux is caused at all these sites.

Reach 2,000 to 20,000 produces a hump and at low supplies it must therefore cause considerable afflux. Further these abrupt changes must cause a certain amount of afflux as explained below. Let  $OO'$  be the supply line with no discharge off-taking at A and let depth ( $d$ ) be the natural depth for this discharge for the section. If discharges in reach BA is increased to correspond to a depth  $D$ , there will be no drop at point A and water line would follow  $OLO'$  and N. L. would measure the afflux.

It would, therefore, seem desirable that design should provide decreasing velocities towards the tail and the changes in sections if there is to be no drop in water levels should be smooth and gradual and should cover about 500 Lft. of the channel so that transition is gradual and causes no afflux.

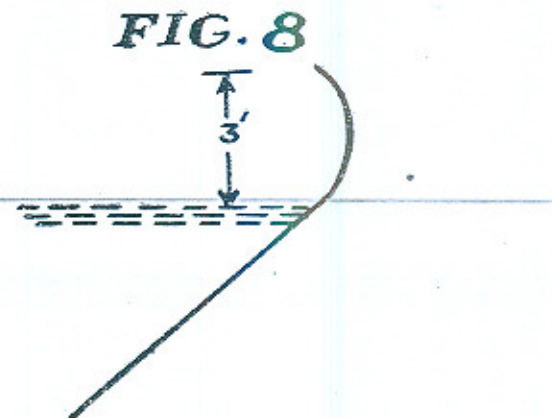
The smoother the surface of a lined channel the higher will be the waves during storms. To prevent waves getting over the lining various alternatives of roughening the free board portion should be tried. It may be provided by odd bricks projecting out or giving the top a profile as shown in the margin so as to break the waves. In any case the free board should be ample and on main canals be not less than 3 ft.

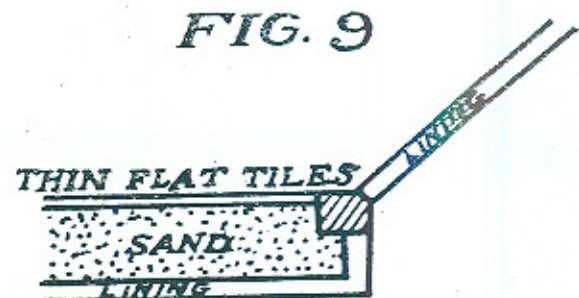
The spring levels in the head reach of the canal are generally higher and after the canal is opened they tend to rise further on account of ponding up at the Headworks or seepage from the canal itself. Lest the high spring levels during periods of low supplies should cause an uplift of the bed of the lining two sets of gates as previously stated have been provided at 20,000 and 35,000 to hold up necessary depth of water. Constant depth of water on the bed of canal however is a perpetual nuisance as it neither permits any repairs if necessary to the bed nor closing and unwatering of canal in this reach in case a serious accident occurred. With the present system a mistake in regulation on part of a gauge reader might damage the lining. A fool-proof method of providing against lift would therefore appear necessary. In lower reaches, it might have proved economical to dig the bed deeper, to line the bed with 6" layer, fill it up with sand to 3" below designed bed level and then provide a flat tile on the top. This would mean a cheap gravity section. In the head reach to avoid seepage from the canal itself it may be desirable to line the entire channel. An alternative has been suggested to keep a longer length of the channel in the head reach unlined but this seems to be moving in a vicious circle because the sub-soil reservoir up to the start of lined reach would be definitely fed by supply levels of the canal for a longer reach. The rise in sub-soil would therefore be quicker in the

upper reach and may rise ultimately to such an extent as to cause uplift pressures under the lined reach lower down unless a good deep cut-off was provided under the upstream end and sides where the lining started.
