**DAMAGES TO THE
RIGHT POCKET OF SUKKUR BARRAGE AND
EMERGENCY RESTORATION WORKS (2004-2005)**

**Barkat Ali Luna, Malik Ahmad Khan, Ch. Muzaffar Hussain,
Dr. Muhammad Salik Javed**

SYNOPSIS

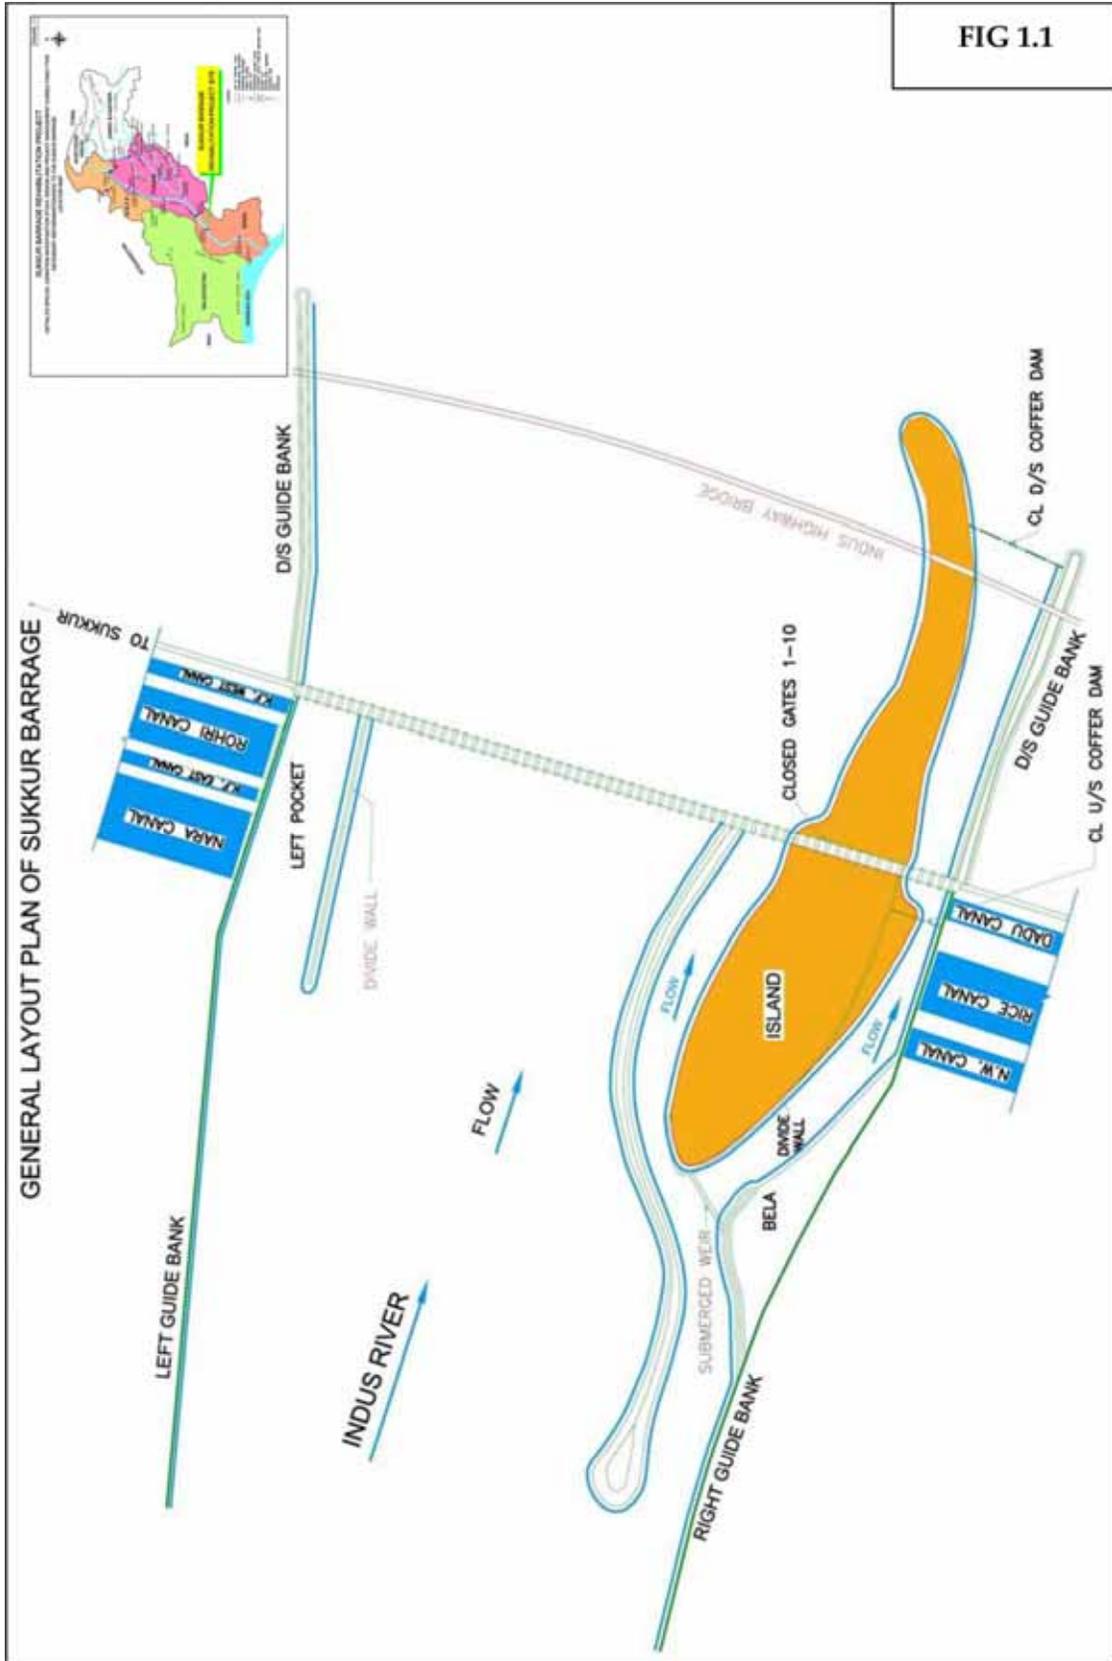
FIG 1.1

Sukkur Barrage, originally designed to safely pass a maximum discharge of 15 lac cusecs, comprises 66 bays each of 60 ft clear span and is divided into three sections; the right undersluices, the main weir and the left undersluices. The right and left undersluices have 5 and 7 bays respectively and are separated from the main weir by right and left divide walls on the upstream side. The middle weir portion is divided into six compartments of 9 spans each. The compartments are separated from one another and from the undersluices by 25 ft wide abutment piers. The ordinary piers between the spans are 10 ft wide. A lay out plan and profile of the Barrage are given in Fig. 1.1 and Fig. 1.2.

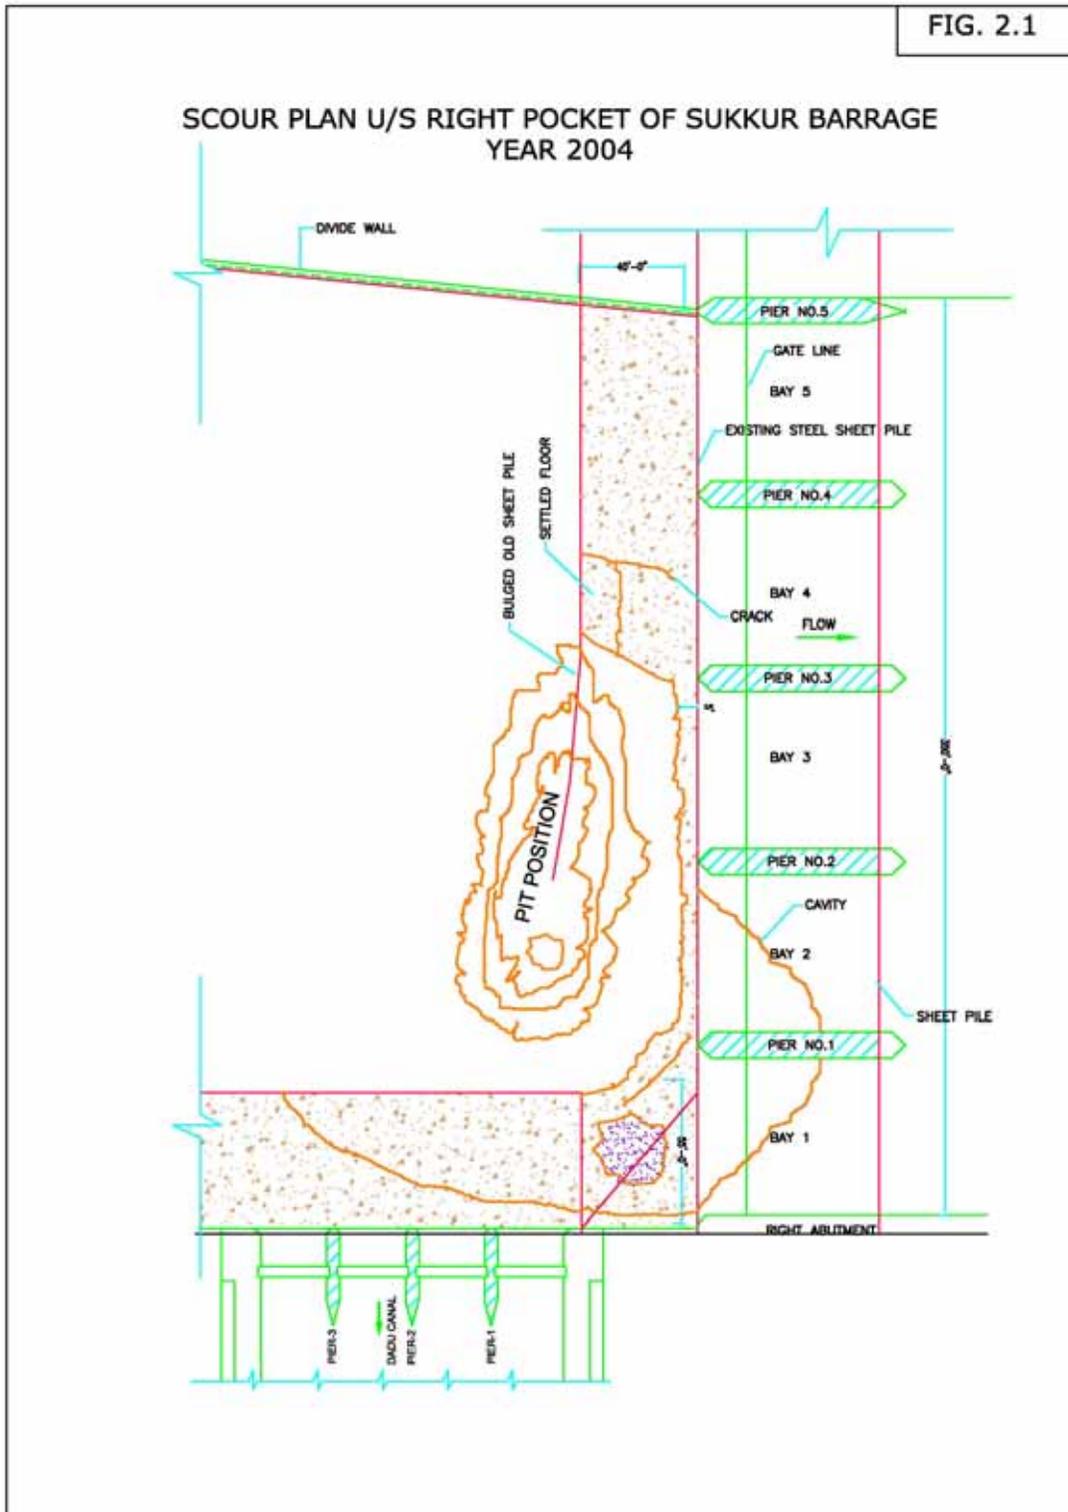
The canals of Sukkur Barrage are closed every year normally from January 06 to 21 to facilitate detailed inspection of under water works and appurtenant components of the Barrage and to provide adequate repairs if any damages are detected. During the annual closure of 2004, while taking soundings in the right pocket u/s of the Barrage on Jan. 12, 2004, a scour pit measuring 60' x 40' x 9' (Av.) with a maximum depth of 22 feet was discovered in front of Bays No. 1, 2 and 3. The extent of the damage was so grave that the upstream stone apron, first sheet pile line, and part of the concrete floor reaching proximity of the upstream nose of the piers had disappeared in the pit. It was further noticed that the scour pit had extended up to the second line of sheet piles under the Barrage. Similarly a cavity had formed under the floor in front of the Head Regulator of Dadu Canal. The situation was interimly controlled by dumping stone in the pit and limiting the head across to 14 feet against the design limit of 18.5 feet, till such time that the proper rehabilitation works were planned and carried out. A plan and cross-section of the right pocket showing the scour hole are given in Fig. 2.1 and Fig. 2.2 respectively.

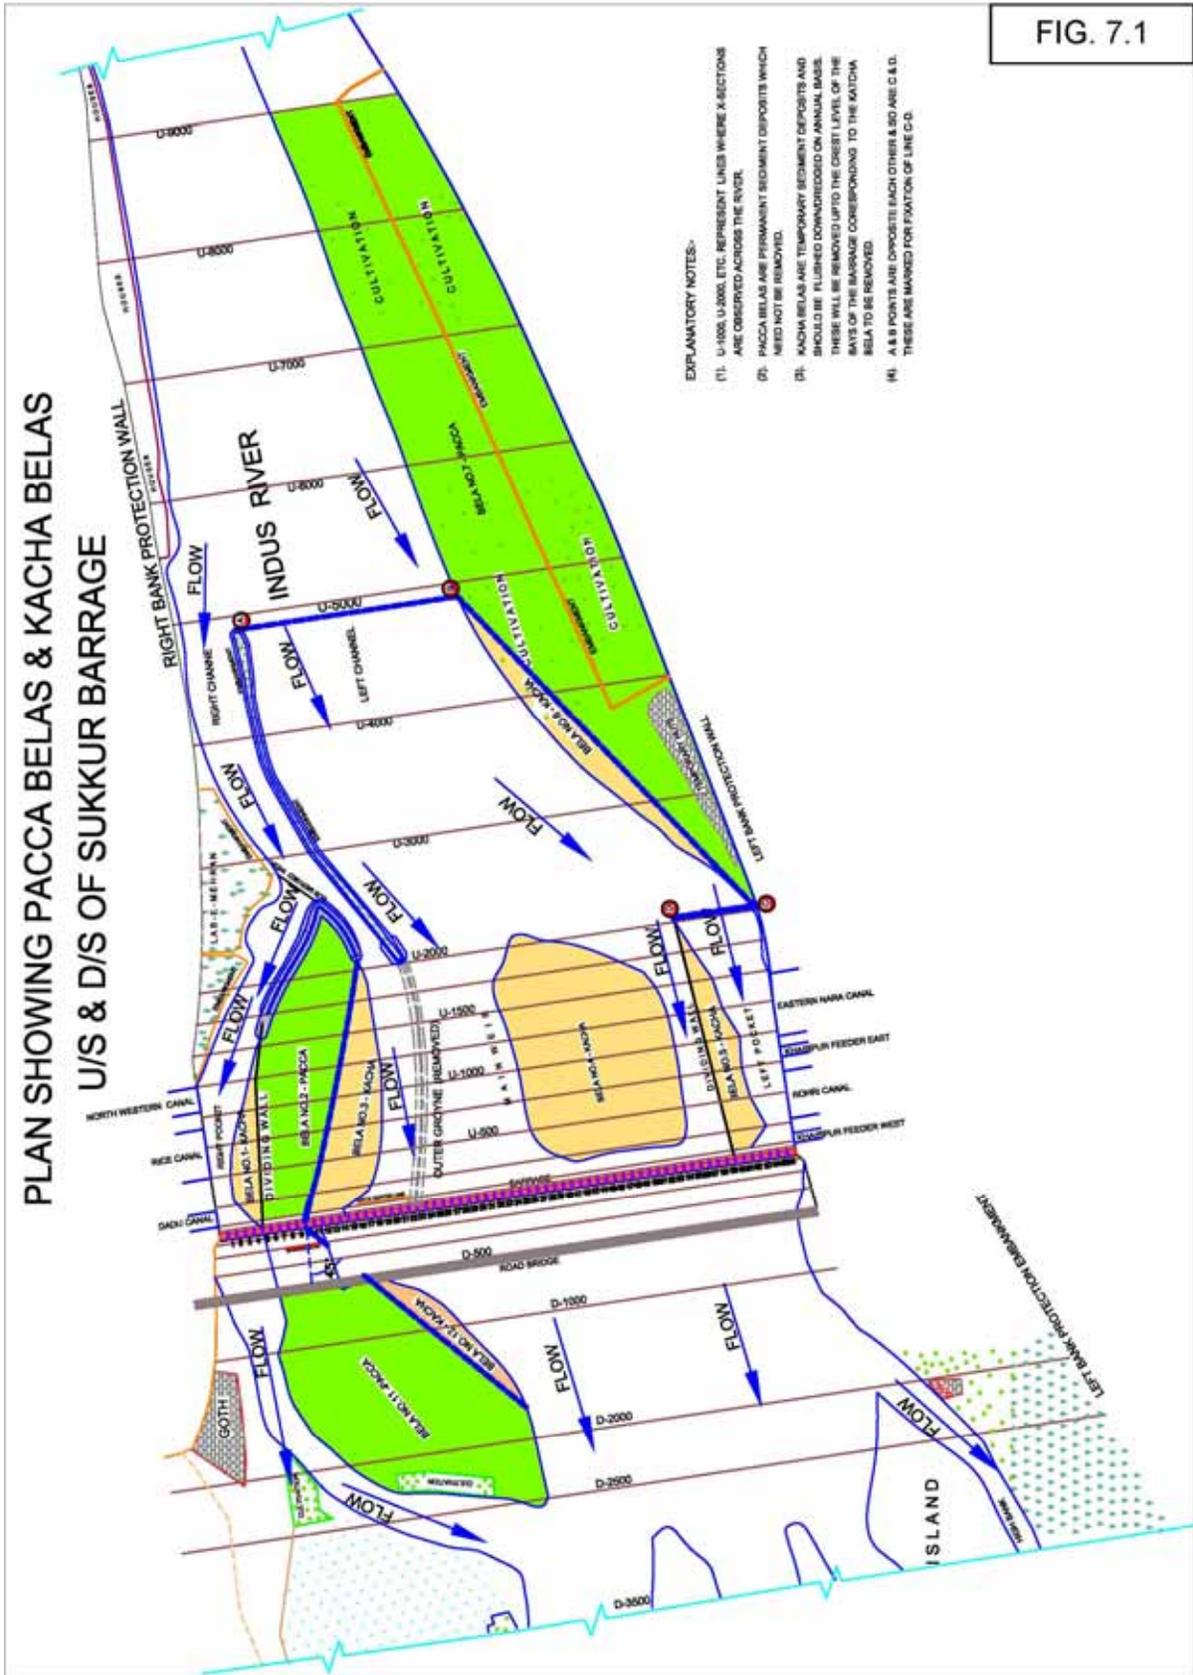
FIG. 7.1

- i) As concluded above, formation of large belas in the pockets causing drastic reduction of the available water-way should not be allowed. For this purpose the two pockets must be kept clear of sediment deposits as far as possible by carrying out flushing operations as and when required as per guidelines laid out in the regulation rules. Since frequent flushing closure of the canals is not admissible in the peculiar conditions of the areas served by the canals at Sukkur Barrage, special arrangements must be made for dredging of the pockets on regular basis. For this purpose, the Sindh Irrigation Department must arrange dredgers for dredging pockets of the Barrage and any other untoward shoal formations at sensitive locations elsewhere at the Barrage. A plan showing the areas to be kept clear of sediment deposits by flushing and dredging on an annual basis is enclosed as Figure 7.1. This plan can be modified based on the operational experiences in future and should be approved by the Chief Engineer Incharge of the Barrage.

PLAN SHOWING PACCA BELAS & KACHA BELAS U/S & D/S OF SUKKUR BARRAGE
