**SECOND REMODELLING PROPOSED FOR
BALLOKI HEADWORKS**

Muhammad Aslam Chohan

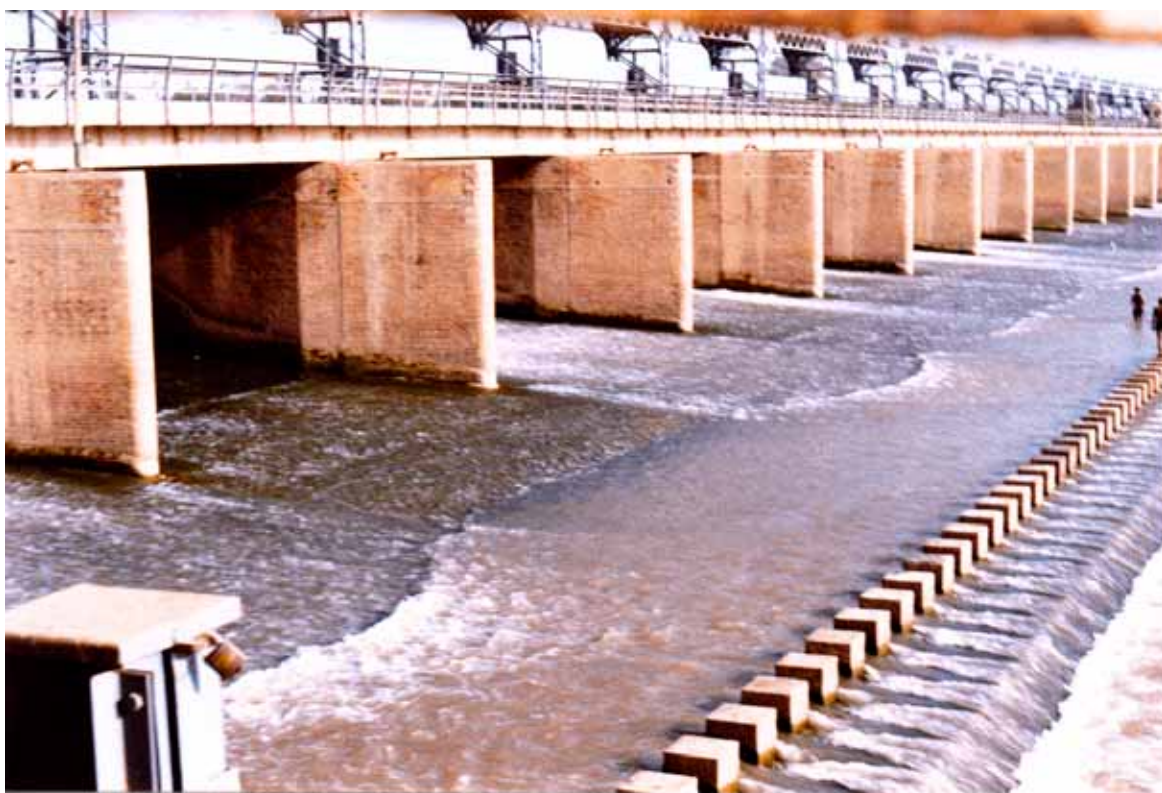
Figure – 4

BALLOKI BARRAGE

Downstream view of Balloki Barrage showing conical extended piers, non-existence of glacis, very flat slope of floor and position of baffle wall with row of friction blocks over it & triangular blocks chute at its downwards slope end (introduced on remodelling in 1964-65).
