THE CONSTRUCTION OF A DOUBLE TRACK GIRDER BRIDGE ACROSS THE JUMNA RIVER ON THE NORTH-WESTERN RAILWAY BETWEEN KALANOUR AND SARSAWA.

BY A. I. SLEIGH, F.C.H., ASSOC. M. INST. C. E.,
SUPERINTENDENT, KALKA-SIMLA RAILWAY.

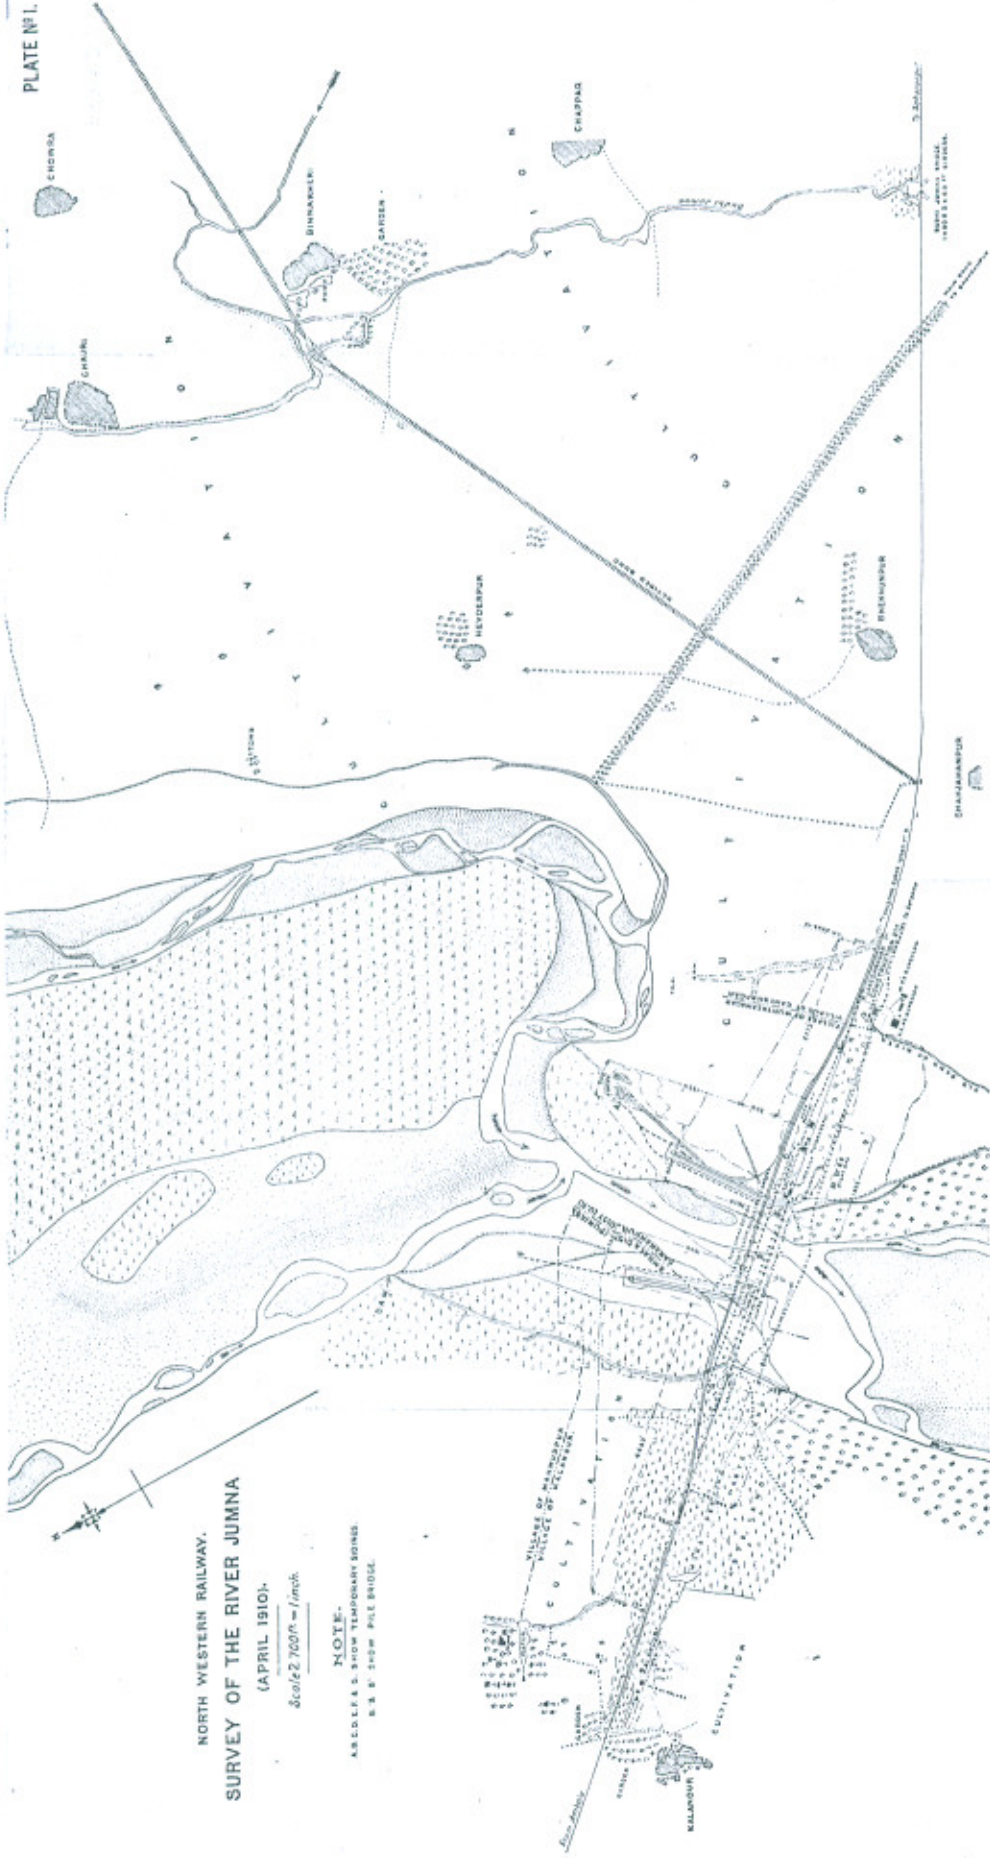
PLATE No. 1.

**NORTH WESTERN RAILWAY.
SURVEY OF THE RIVER JUMNA
(APRIL 1910.)**

Scale 2 700 ft. = 1 inch.

AREAS & SHOW TEMPORARY BRIDGE
S.S. & S.W. FROM PILE BRIDGE.

In order to make use of the existing guide bank on the left bank of the river (*vide* Plate No. 1) two alternative alignments presented themselves—

Plate 1 shows roughly the various sidings in use during the construction of the bridge, and the position of the store depot, lime kiln, workshops, offices, etc.
