THE CONSTRUCTION OF THE ROAD BRIDGES OVER  
THE CHENAB AND PALKHU AT WAZIRABAD.

BY W. S. DORMAN, M. INST. C. E.

Introduction—Type of bridge—Cost—Time taken to complete work—Curbs—Wells—Gantries—Methods of sinking—Cost of sinking—Rate of progress—Difficulties encountered—Filling wells—Construction of piers—Bed plates—Cost of girders—Methods of erection—Reinforced concrete decking—Expansion joints—Damage from floods—Appendices.

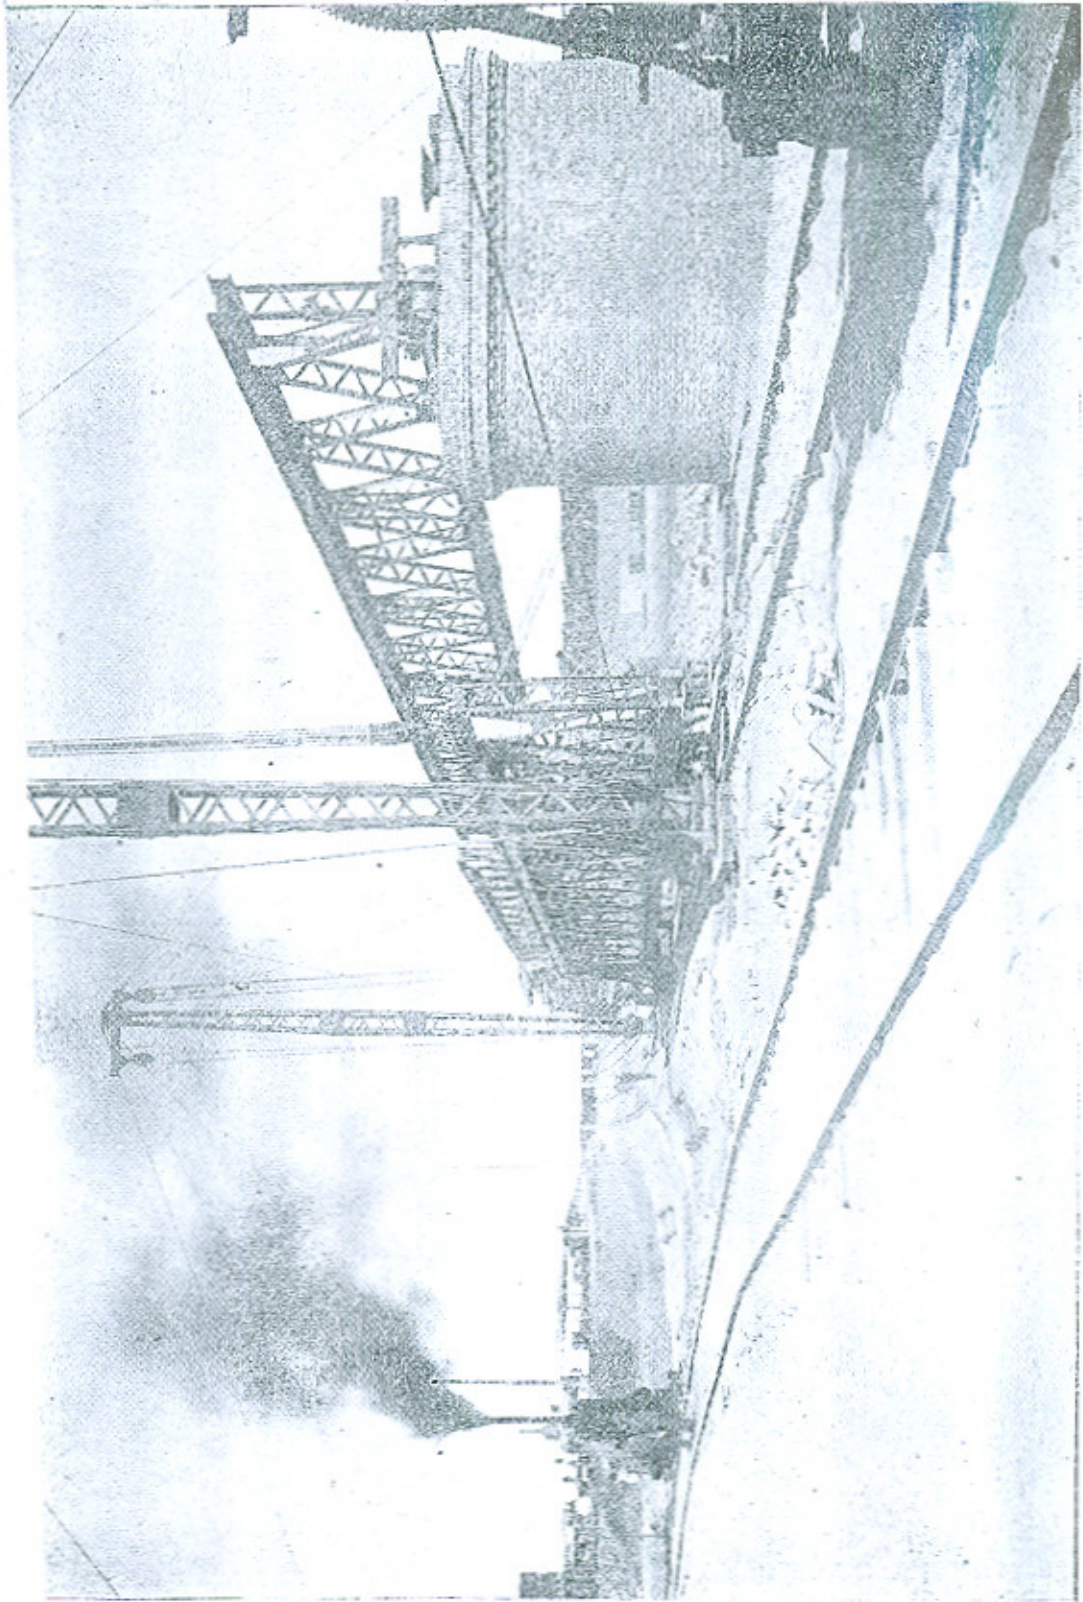
CHENAB BRIDGE—WELL-SINKING OPERATIONS.
